Abstract

ATSB TRANSPORT SAFETY REPORT
Aviation Occurrence Investigation AO-2010-069
Final

Collision with terrain, VH-KZF 25 km east of Geraldton Airport, Western Australia 14 September 2010

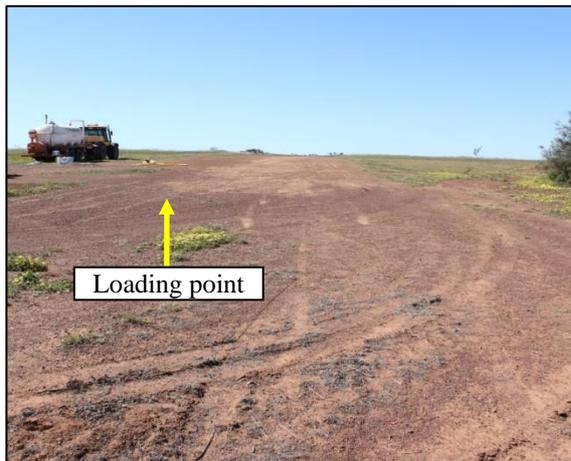
The pilot was met at the airstrip by an assistant (loader) with a truck that contained the chemical, mixing equipment and refuelling supplies for the planned spraying activities. Each flight that day required the aircraft's spray tank (hopper) to be loaded with a combined 600 L of water and chemical that was pumped from the loader's truck. That truck was located about 50 m along the runway from the take-off threshold (Figure 1).

After loading, the pilot commenced the initial takeoff from the loading point in a south-easterly direction (Figure 1). Nine subsequent flights were successfully completed using the same runway and loading process.

Figure 1: Loading point viewed from the take-off end of runway 13

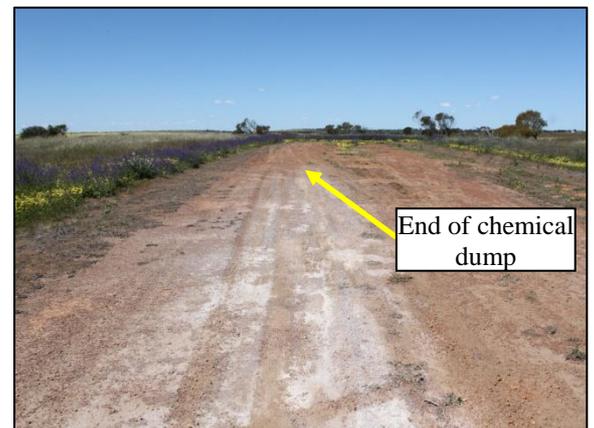
During the investigation a 15 m long area of dried, white crystalline deposit was observed about 90 m before the end of the runway (Figure 2). That deposit was consistent with the dried chemical being used on the day. The spread of the chemical deposit was indicative of the pilot activating and then stopping a chemical dump from the aircraft's hopper. More of the dried chemical was identified around the accident site, indicating that the entire hopper was not dumped on the runway.

Figure 2: Dried chemical deposit viewed toward the departure end of runway 13

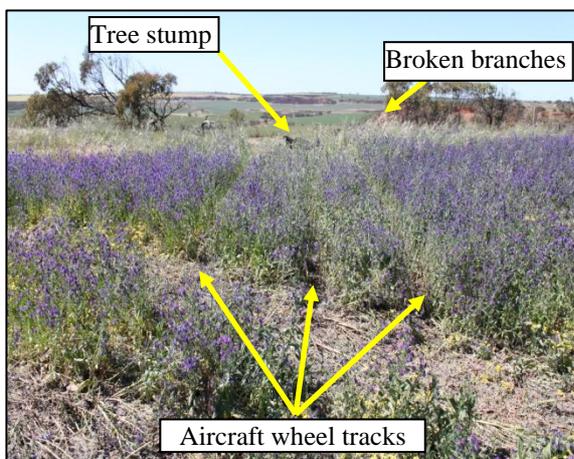
The overshoot area at the departure end of runway 13 was an unprepared surface that contained a shattered tree stump and showed evidence of three aircraft wheel tracks. A number of trees were located just beyond the end of the plateau and to the right of the aircraft's wheel tracks (Figure 3). Various broken branches from those trees showed red paint transfer that was consistent with the red paint markings on the aircraft (see Figure 4).

Figure 3: Overshoot area at the departure end of runway 13

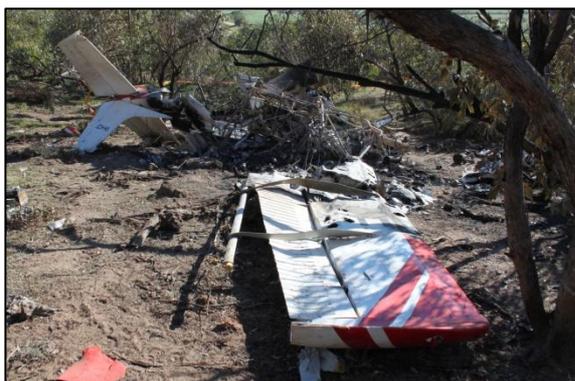
Ground scars made by the aircraft during the impact sequence indicated that the leading edge of the aircraft's right wingtip impacted the ground first. Compression damage to that wing and the inverted aircraft wreckage indicated that the aircraft collided with the ground in an estimated 90° right wing-low, nose-down attitude. The confined wreckage distribution indicated a relatively low horizontal velocity at that time.

An intense post-impact fire consumed the fuselage and the inboard sections of the left and right wings. The tailplane, which included the vertical and horizontal stabilisers, sustained minimal damage (Figure 4).

Figure 4: Aircraft wreckage
