M.V. 'MARITIME GARDENIA'

PRELIMINARY INVESTIGATION INTO  
GROUNDING IN TORRES STRAIT  
(ALERT PATCHES)  
POSITION 10°29'.5 S 142°21'.1 E  
ON 18 AUGUST 1985

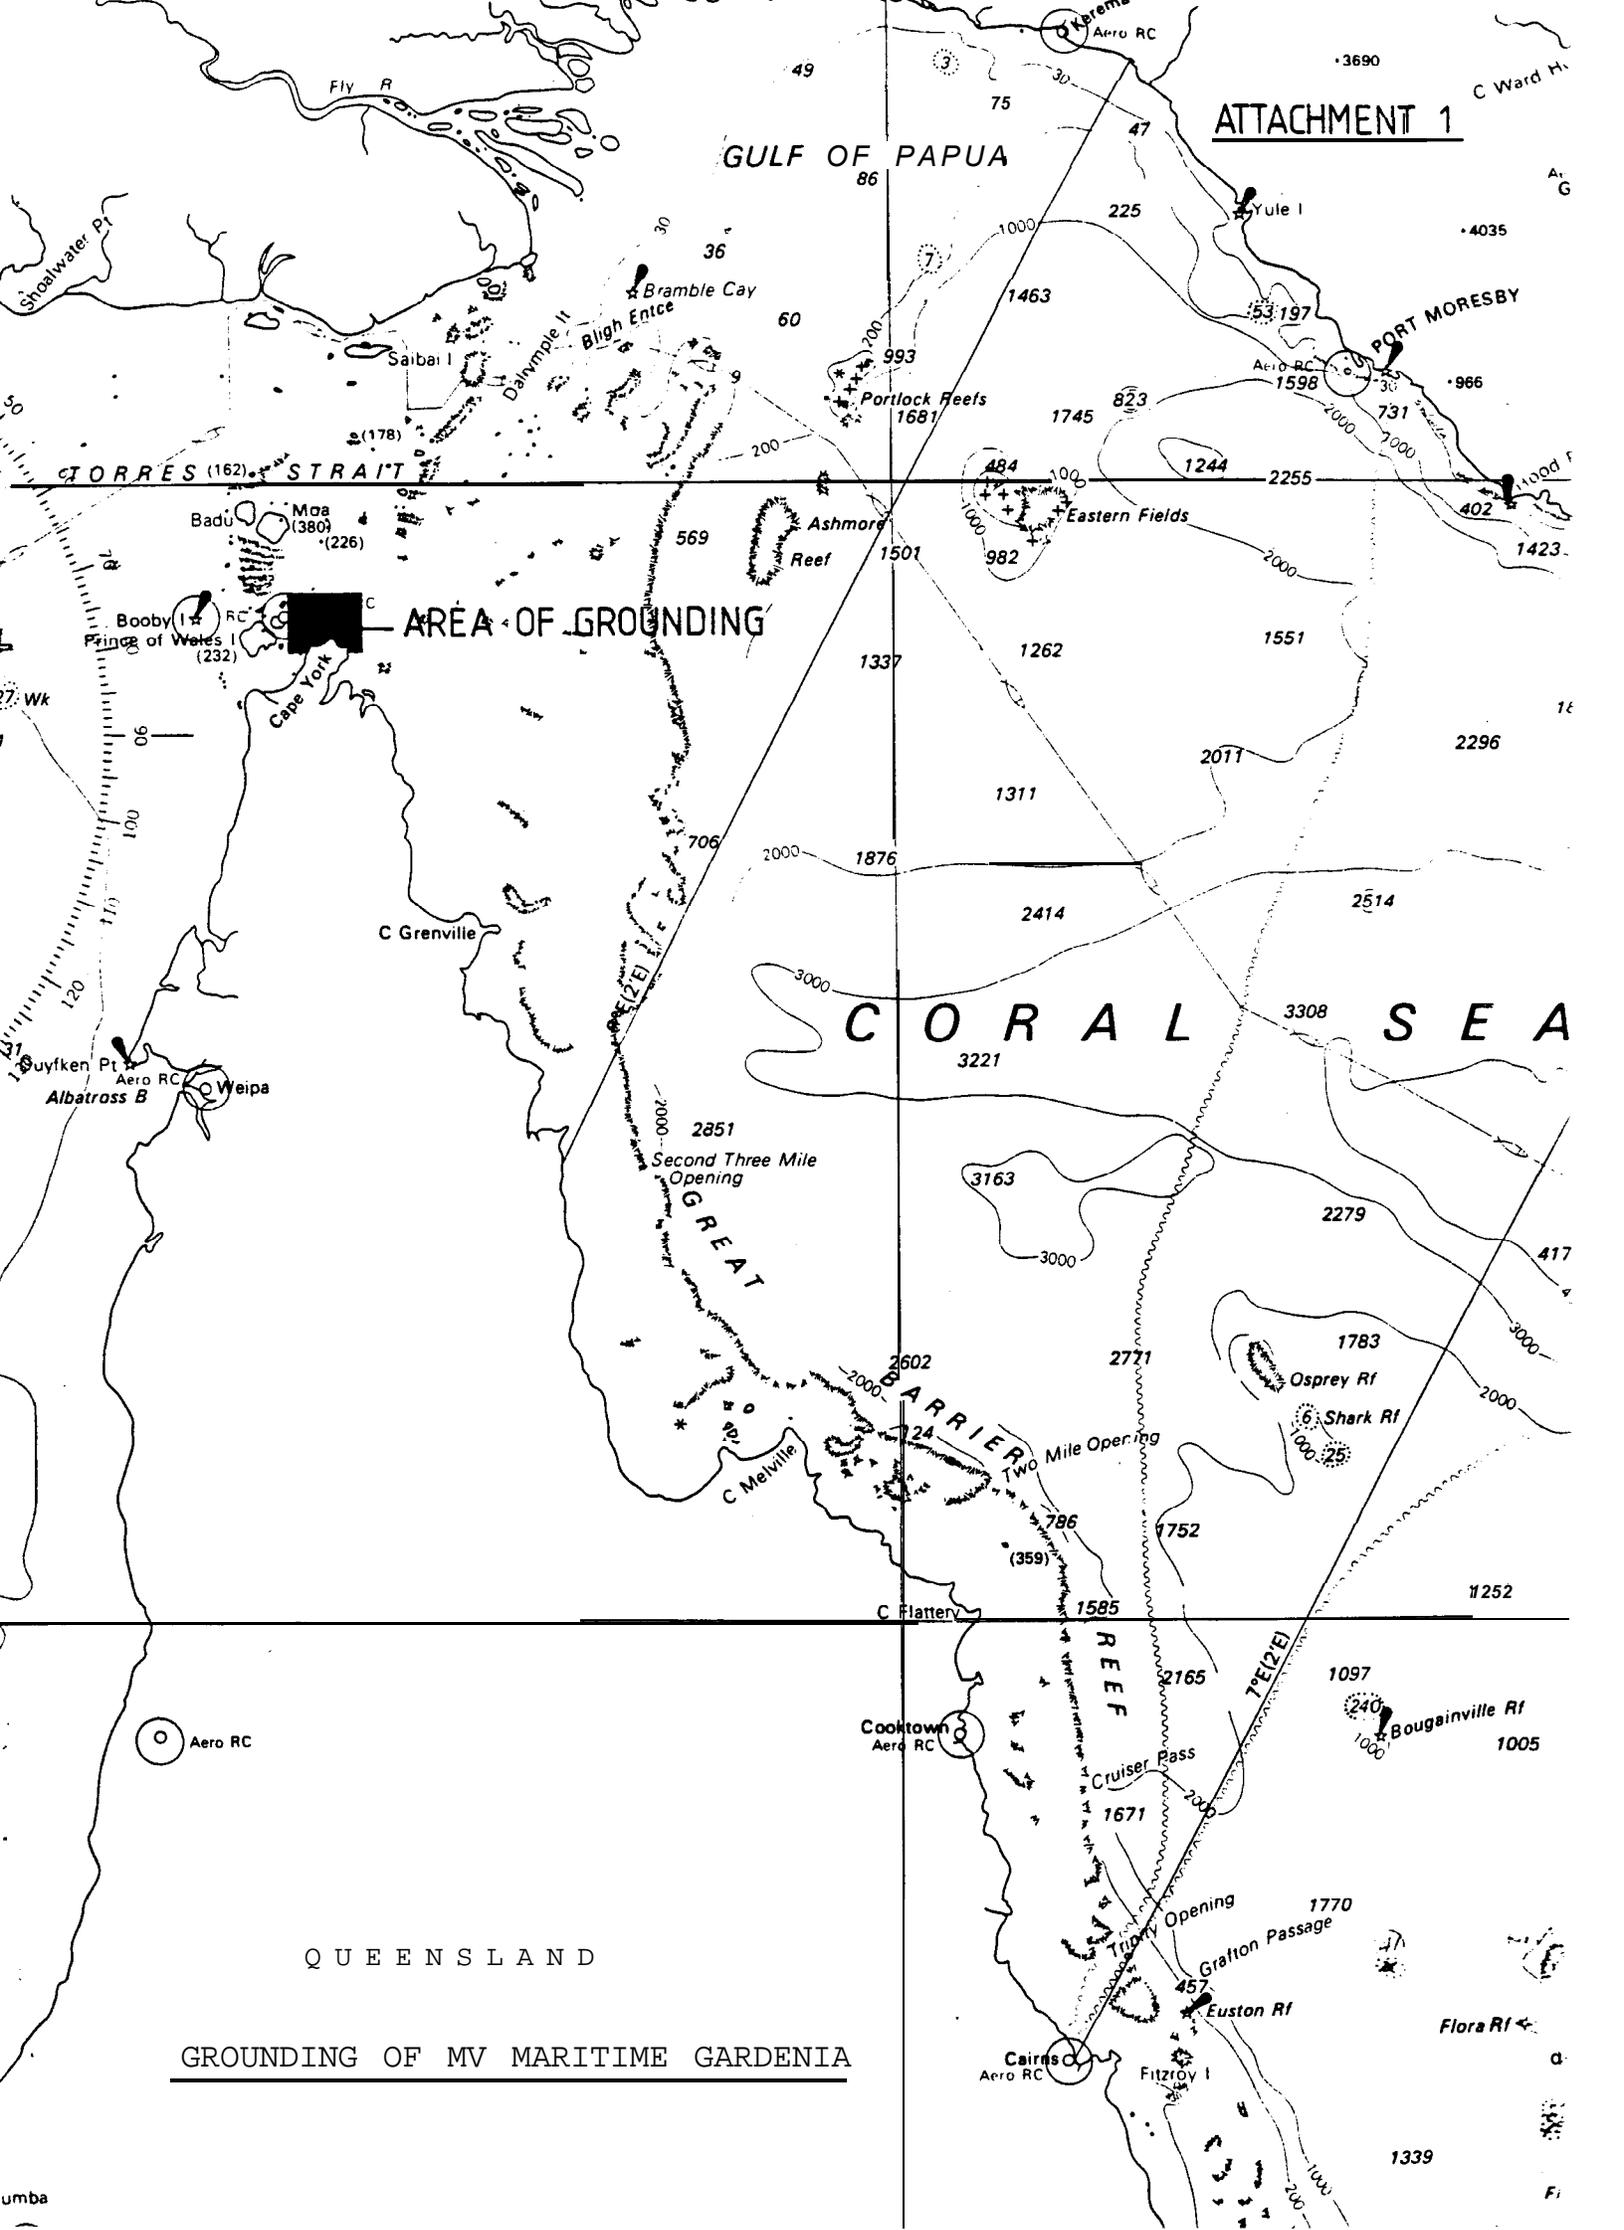
**ATTACHMENT 2**

9. The charted positions at 2005, 2010, 2015 and 2022 are reasonably consistent, in terms of speed, with the Chief Officer's 1950 and 2000 positions i.e. about 11.3 knots.

10. If the 2022 position is correct and the vessel grounded at 2025 the speed would have been 29.6 knots which is clearly an impossibility.

12. The course recorder shows (converted to ship's time) that from 1909 when the log book records the alteration to 300° (T) the vessel was consistently steering higher than 300° (T). It also shows that an alteration to 290° (T) was made at 2020 which is consistent with the evidence given by the Quartermaster through the Chief Officer. Furthermore, it shows that an alteration to 270° (T) was made at 2028 with the ship grounding at 2029 - 2030.

5. no allowance appears to have been made for tidal influences and the following sea.
6. at 2020 when the Third Officer altered to 290° (T) the vessel was probably 0.4 miles east of the 2022 charted position and, at 2022, 0.2 miles north east of that charted position.

7. as late as 2025 the alteration to 270° (T) could have been made without causing the grounding which I conclude occurred about 2029-2030.
8. that the Master and crew took appropriate measures to preserve the integrity of the vessel once it had grounded.

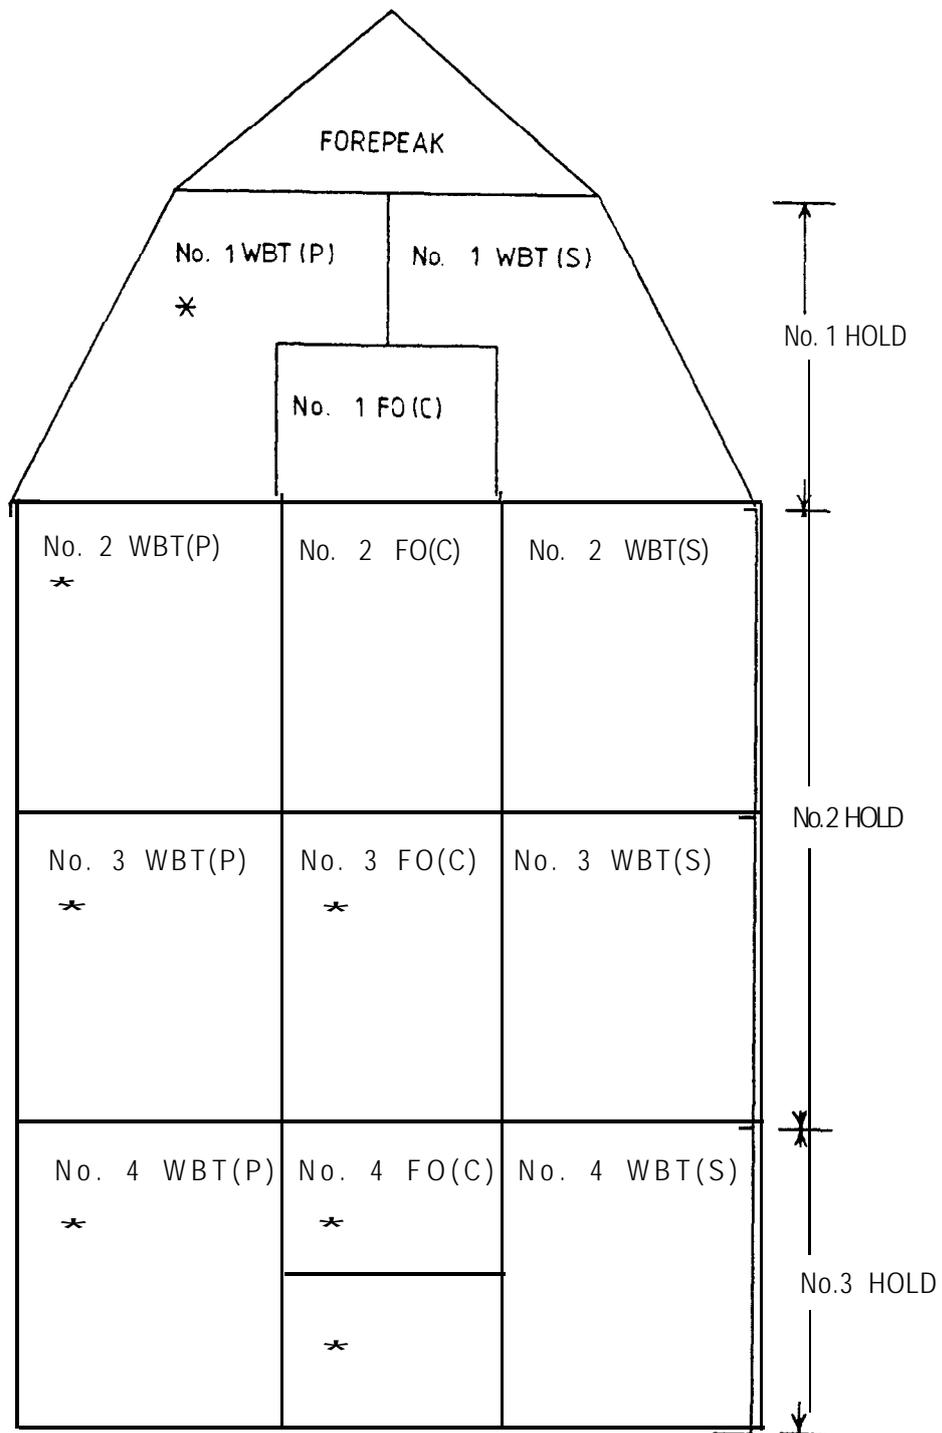
\* TANKS BREACHED DURING GROUNDING

The ship's bottom plating was extensively damaged between No. 1 Double Bottom water Ballast Tank Port and the engine room. Only the port side of the bottom and the keel were affected.

The plating was set up in many places-and the following tanks ruptured.

No.1 Water Ballast Tank Port  
No.2 Water Ballast Tank Port  
No.3 Water Ballast Tank Port  
No.4 Water Ballast Tank Port  
No.3 Fuel Oil Tank  
No.4 Fuel Oil Tank  
No.5 Fuel Oil Tank

A diagram showing the location of the double bottom tanks is at Attachment 3.

The bilge well to No.1 cargo hold was also breached allowing water to seep into the wheat filled hold. The rate of inflow was low and, by the time of the ship's departure on 8th September, the water had only risen to a depth of 1.2 metres on the port side and 0.3 metres on the starboard side of the hold.
