Report No 158

Navigation Act 1912  
Navigation (Marine Casualty) Regulations  
report of the investigation into  
the grounding of the Kuwaiti flag product tanker  
*Al Deerah*  
at Garden Island in the Tamar River, Tasmania  
on 30 April 2000

Issued by the  
Australian Transport Safety Bureau  
September 2001

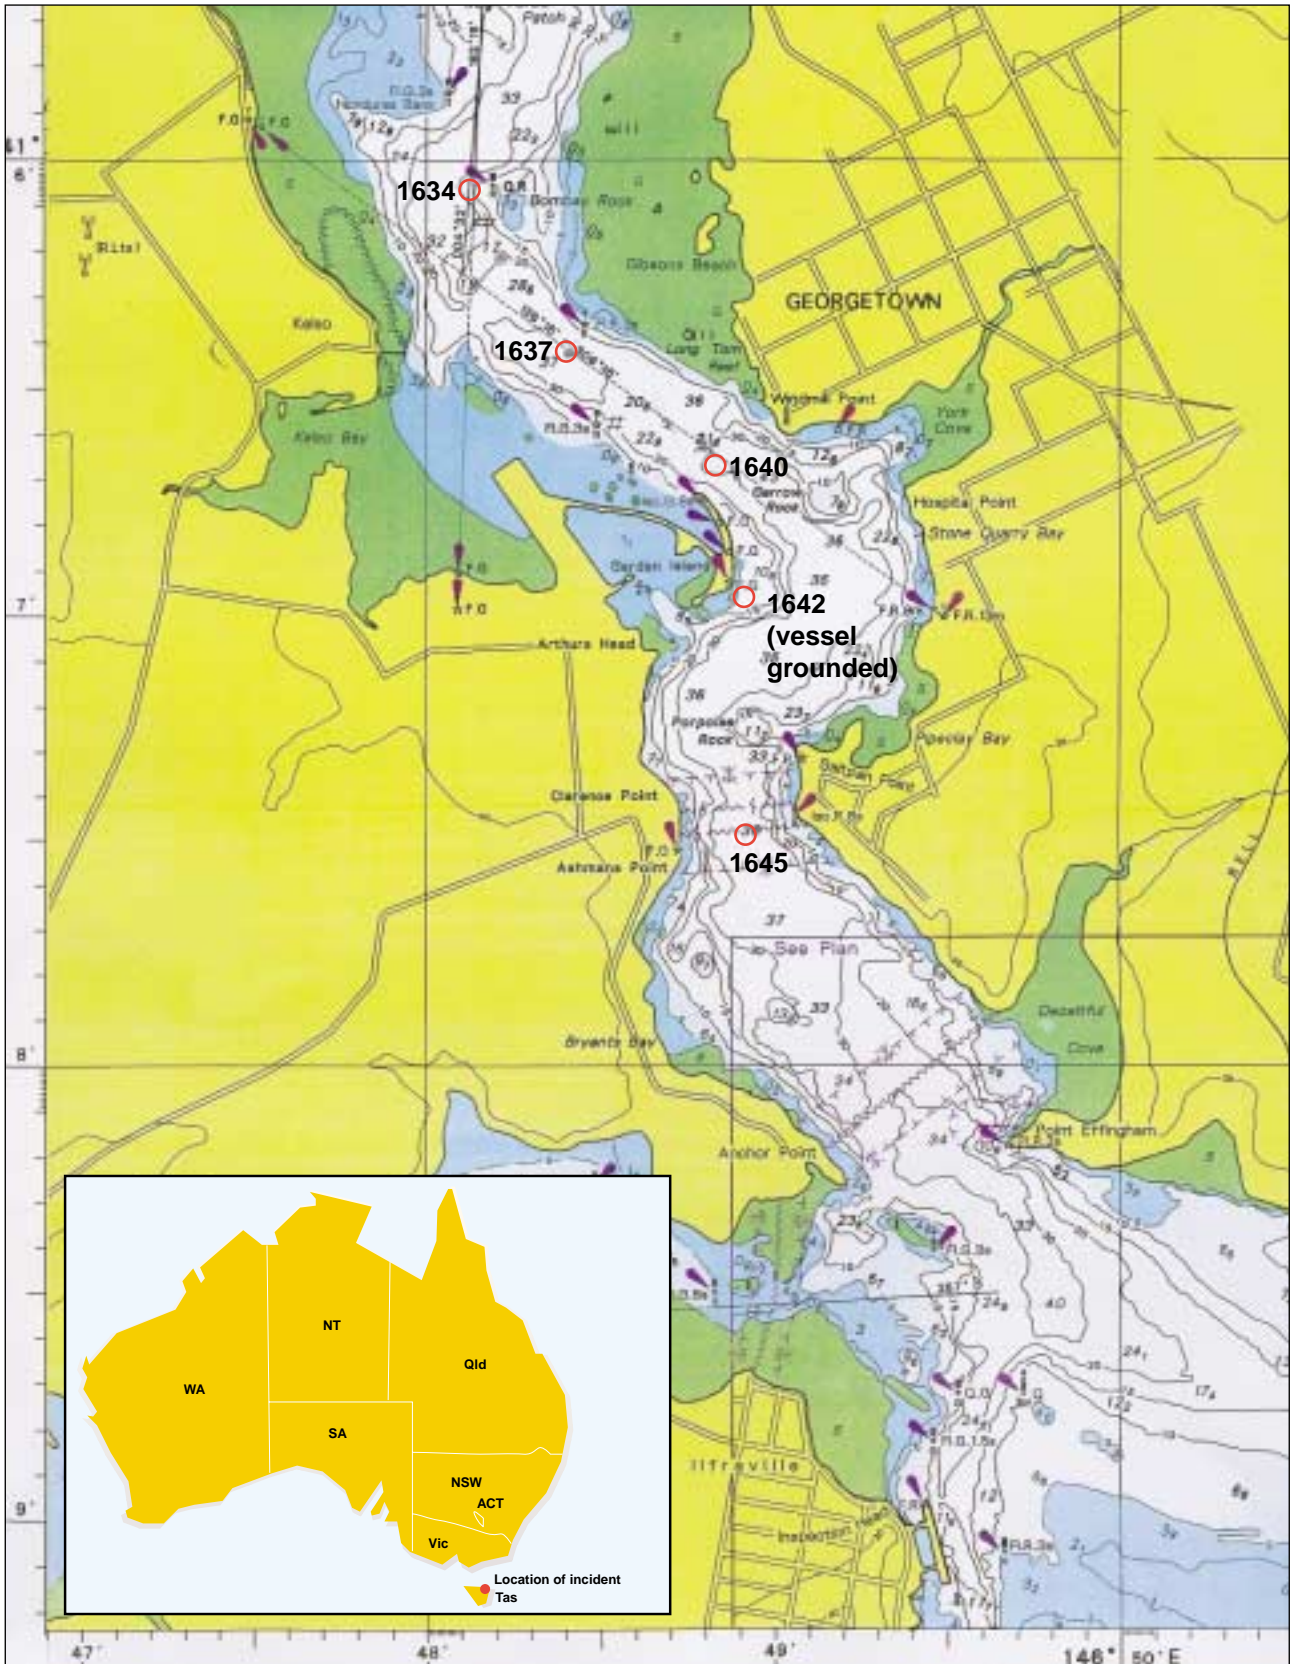
Figure 2:  
Portion of chart Aus167 showing positions of *Al Deerah*

At 1640 the mate plotted a position indicating that the vessel was south west of Windmill Point, just south of the Stone Quarry leads.

The mate plotted a position off Garden Island on the ship's chart at this time. The distance off the island, measured from the side of the ship, was about 60 metres.

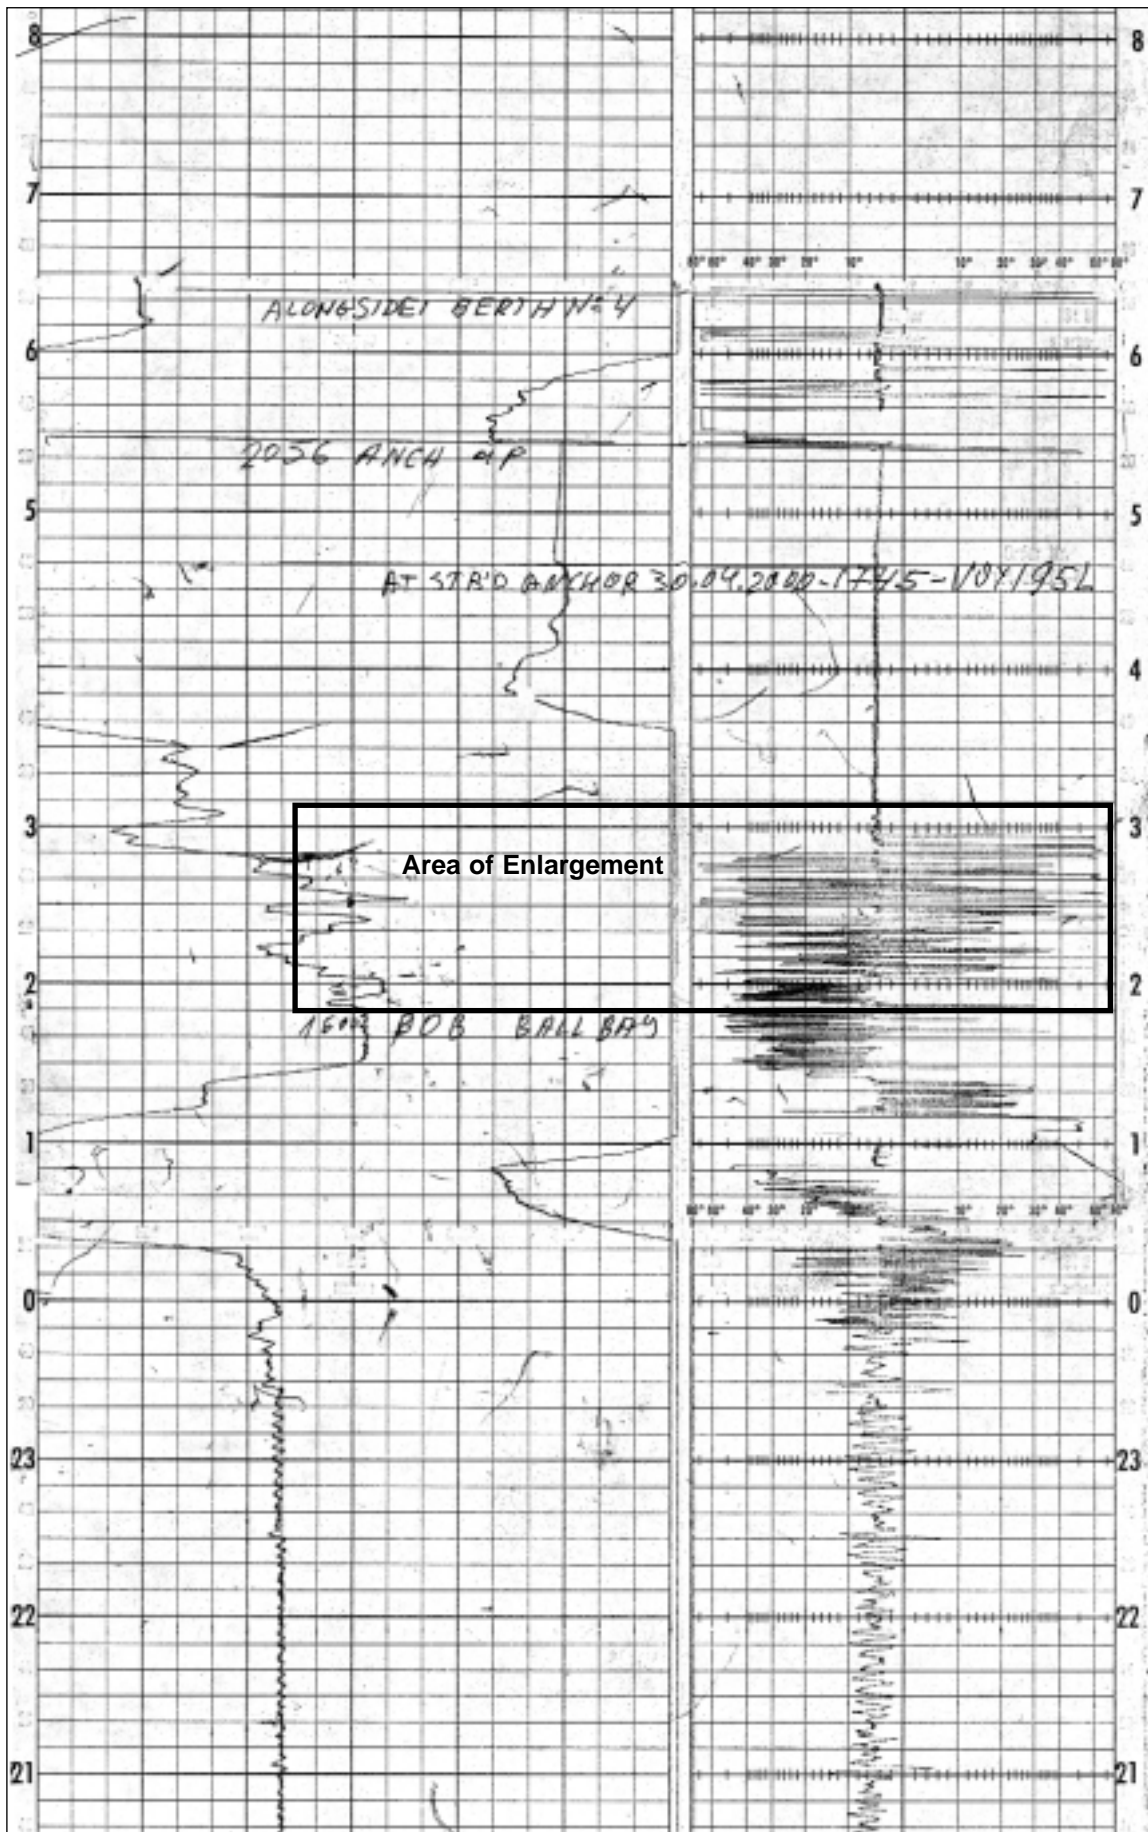
Figure 3:  
Course and rudder angle traces of *Al Deerah*

It is possible that both the course and rudder angle traces were out of calibration. The course recorder showed a course of  $130^\circ$  instead of  $126^\circ$  while the vessel was on the Stone Quarry leads, indicating a possible error of  $4^\circ$ .

The rudder angle trace showed  $2\frac{1}{2}^\circ$  to port when the rudder was amidships, indicating an offset of  $2\frac{1}{2}^\circ$ . In addition, during the river passage, when the rudder was moved in a direction from port to starboard, the stylus produced a trace which sloped slightly backward in relation to the time base, indicating some distortion in the instrument.

The course recorder chart shows that the ship was steady on the Stone Quarry leads on a heading of just over  $130^\circ$  from shortly after 1637 until shortly after 1639  $\frac{1}{2}$ . To start the vessel turning to starboard off Garden Island, the pilot recalled that he ordered starboard  $20^\circ$  for about 20 seconds.

The rudder angle recorder shows that the rudder was put over to about  $22^\circ$  to starboard.

The course recorder shows that the change of course as a result of this helm movement started at 1639  $\frac{1}{2}$ . The course changed from about  $130^\circ$  to  $160^\circ$  in about a minute. In the meantime, the pilot had ordered port  $20^\circ$  and then full port rudder to slow the turn.

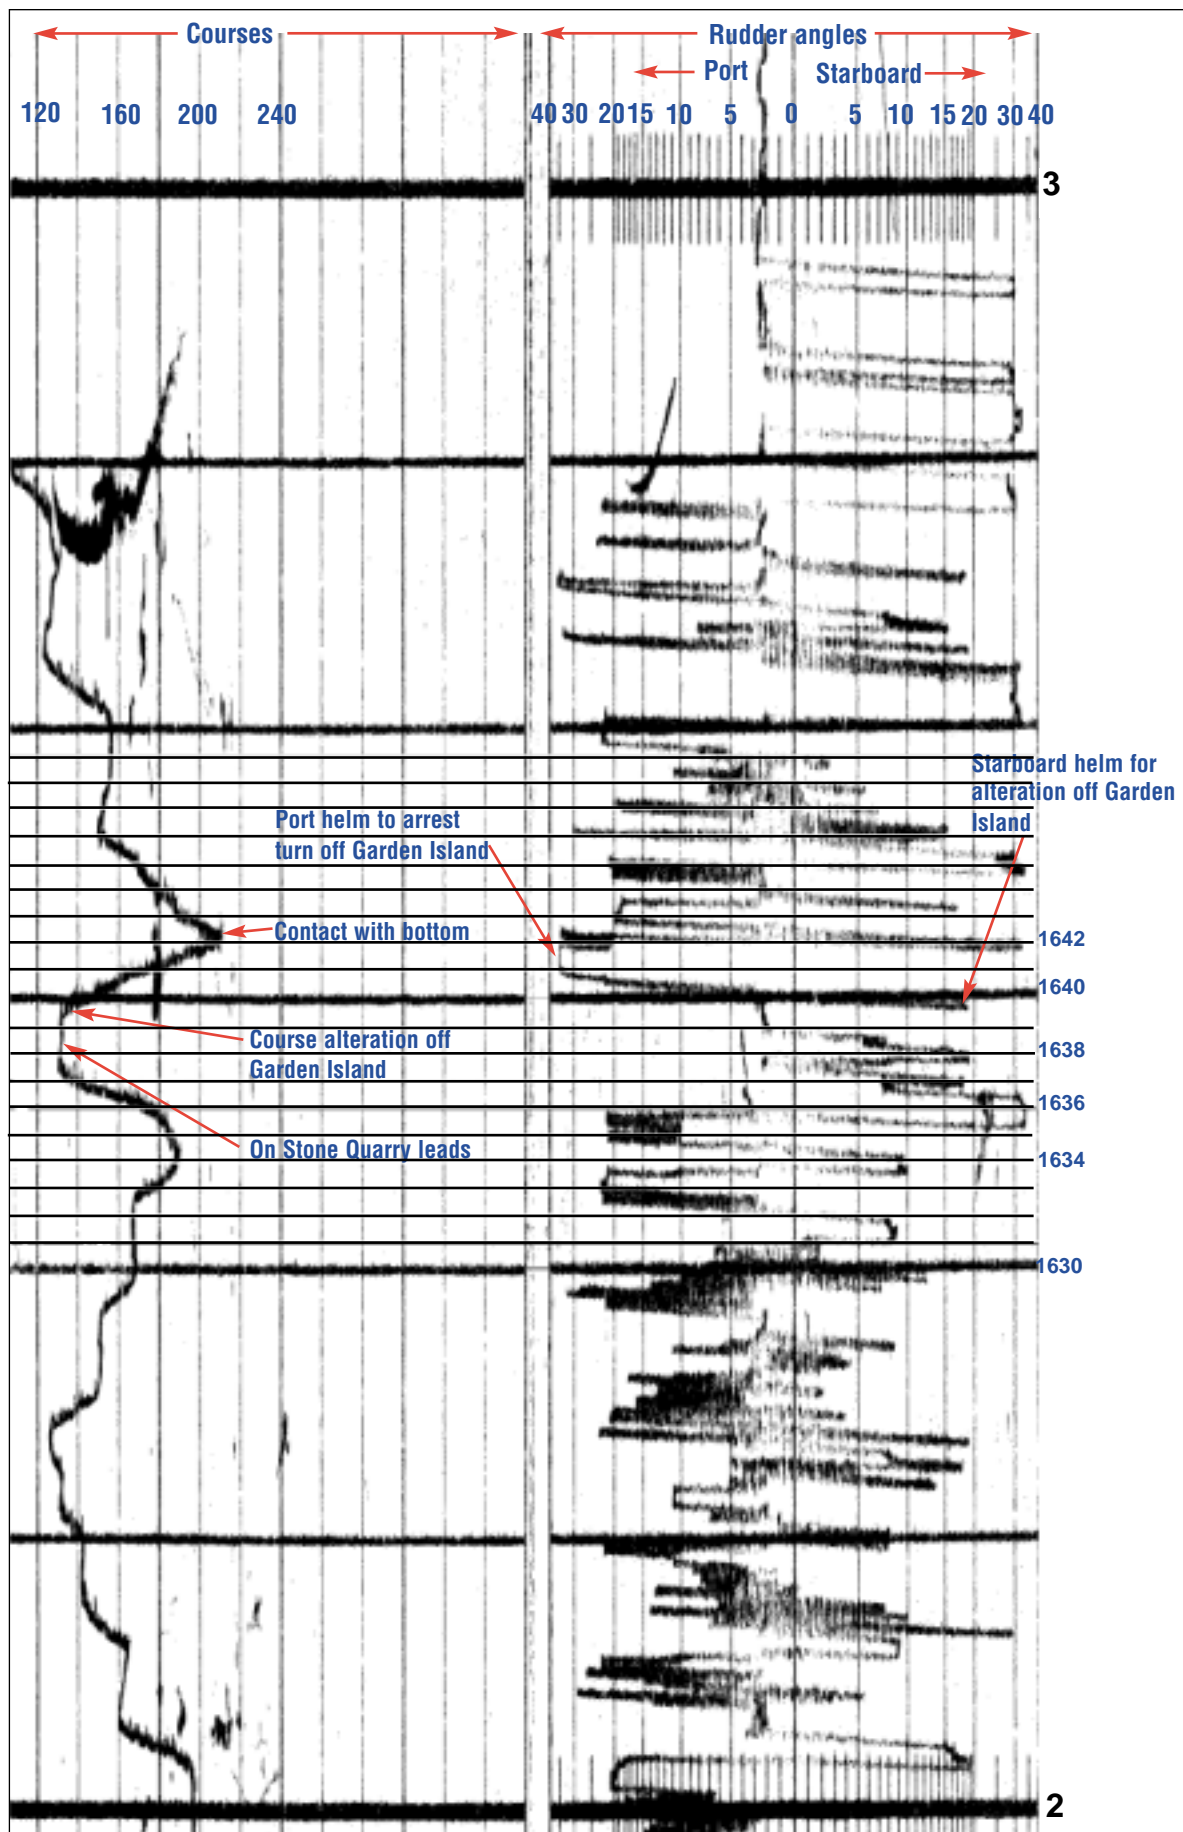
**Figure 4:**  
**Enlargement of course and rudder angle traces (in ship's time)**

The rudder angle recorder appears to indicate that it took almost a minute for the rudder to move from amidships to hard over to port. However, given the distortion in the trace together with any cumulative delays in issuing and responding to helm orders, first to port 20°, then hard over to port, the time taken is not considered significant.

Despite the rudder being put over to port, the course recorder shows that the ship's head went to about 170° at 1641, from which time, after the rate of turn appeared to have slowed momentarily, the course increased to a maximum of 210° at 1642. Contact with the bottom off Garden Island is considered to have occurred at this time.

The vessel then came around to port from 210° to 150° as the pilot conned the vessel off Garden Island and round Saltpan Point.

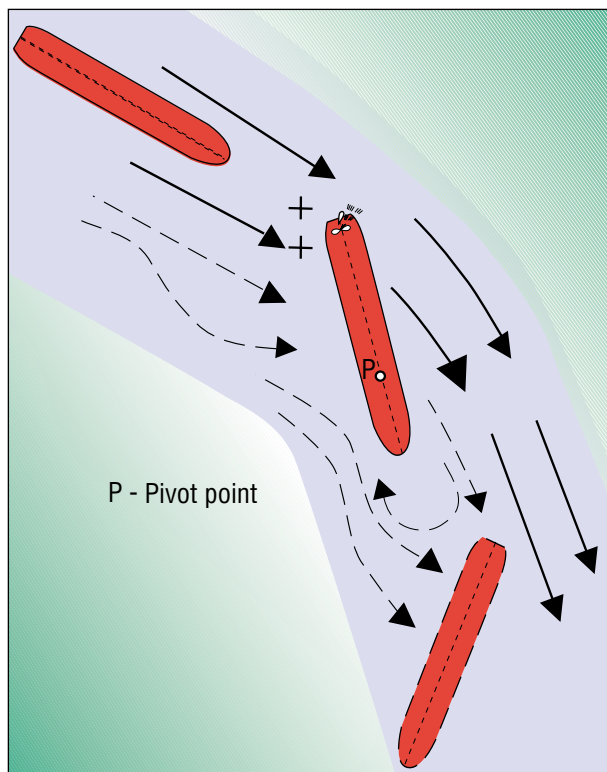
**Figure 5:**  
**Possible effect of tide**

With a following tide: If a relatively large ship is rounding a bend in a channel, with a strong following tide, it is possible for the ship to be positioned so that the strong tide is working on the after body of the ship, whilst only the weaker tide is influencing the fore body. With the pivot point forward the strongest tide is thus working on a good turning lever and a turning force of considerable magnitude is created (see diagram, below).

A ship can react both violently and rapidly to this force and it should never be underestimated.

Whilst it may be anticipated and corrected with a kick ahead of full power, sometimes this will not be sufficient to counteract the large force involved and the ship will continue to swing around, with the serious possibility of subsequently going aground.

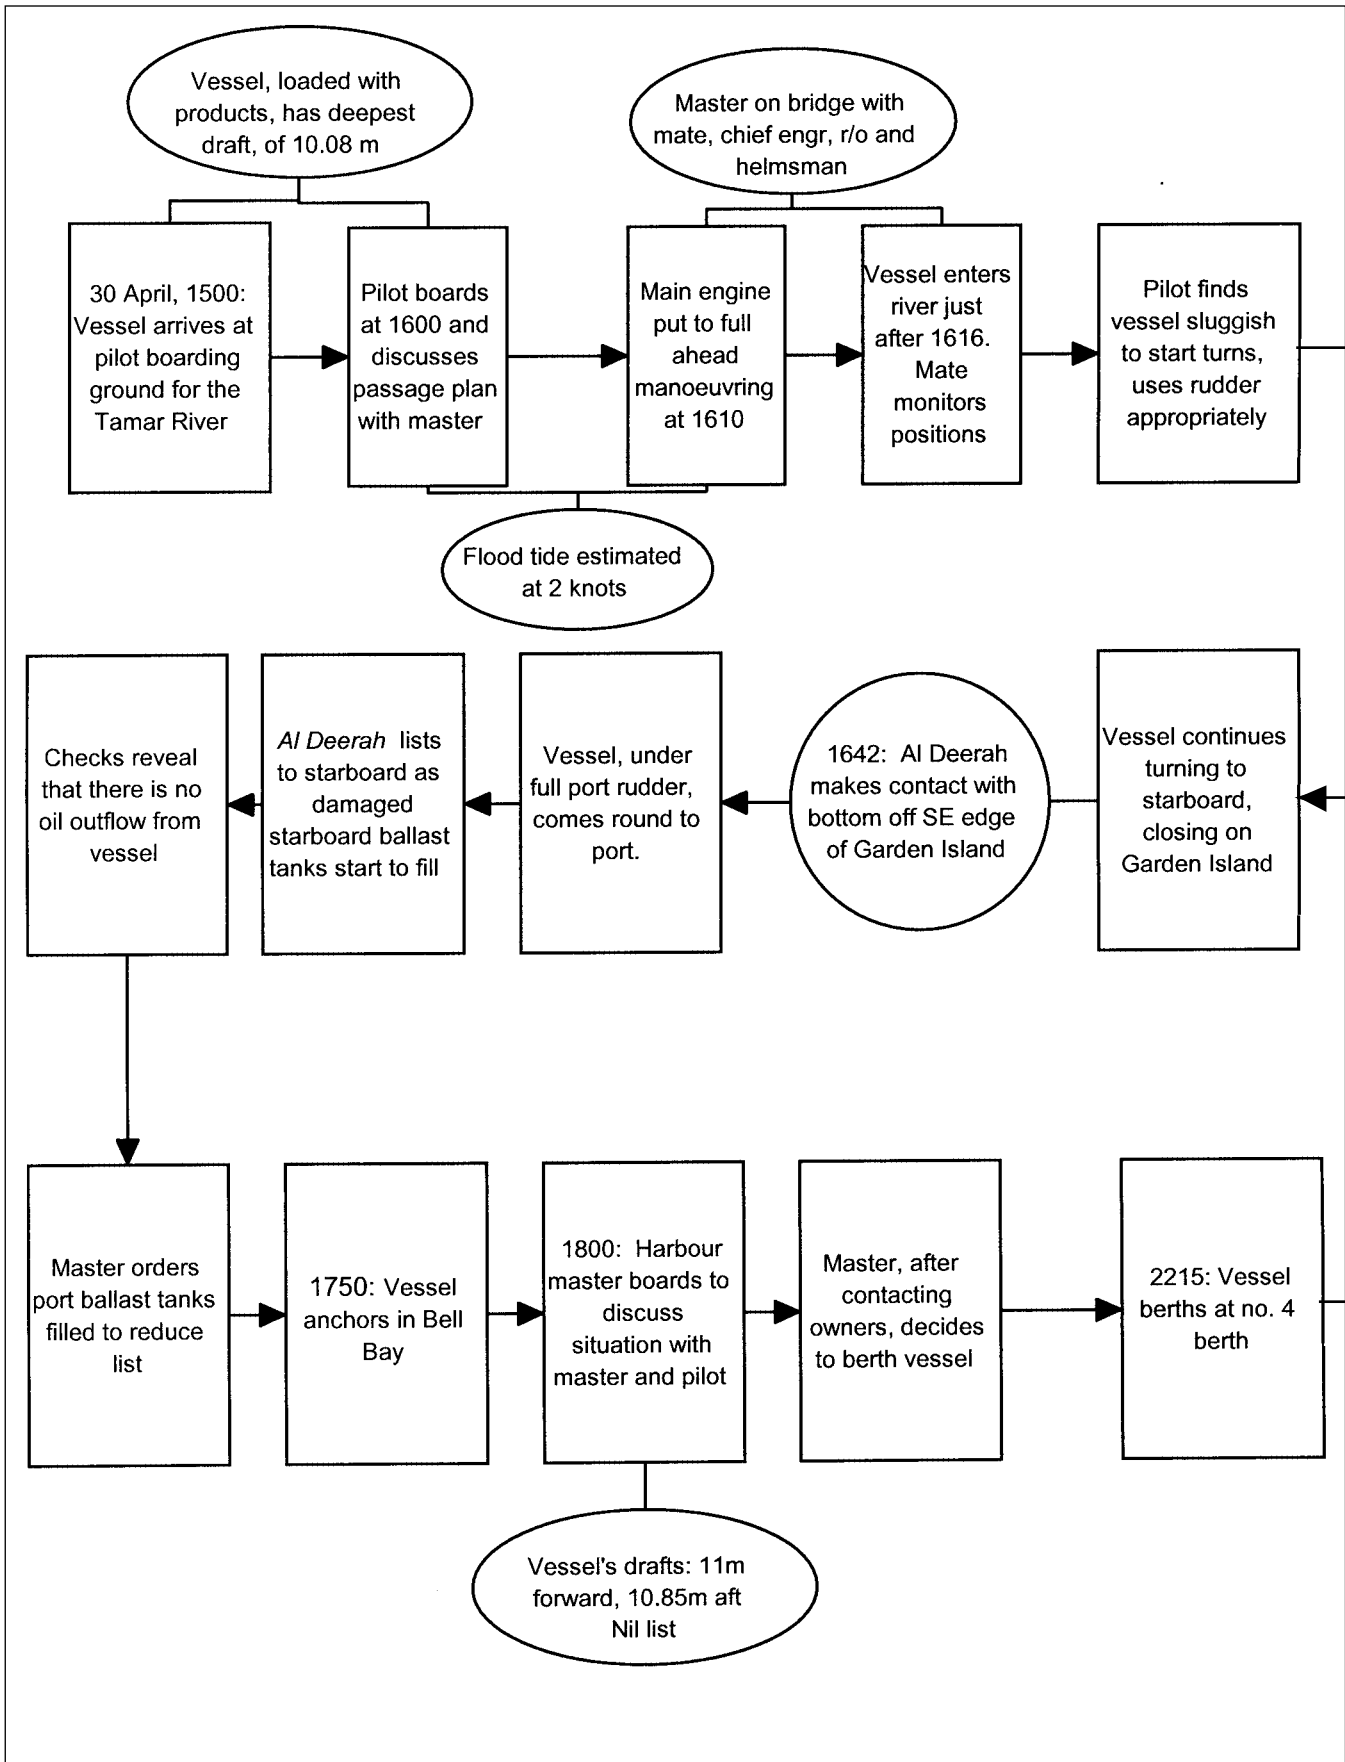
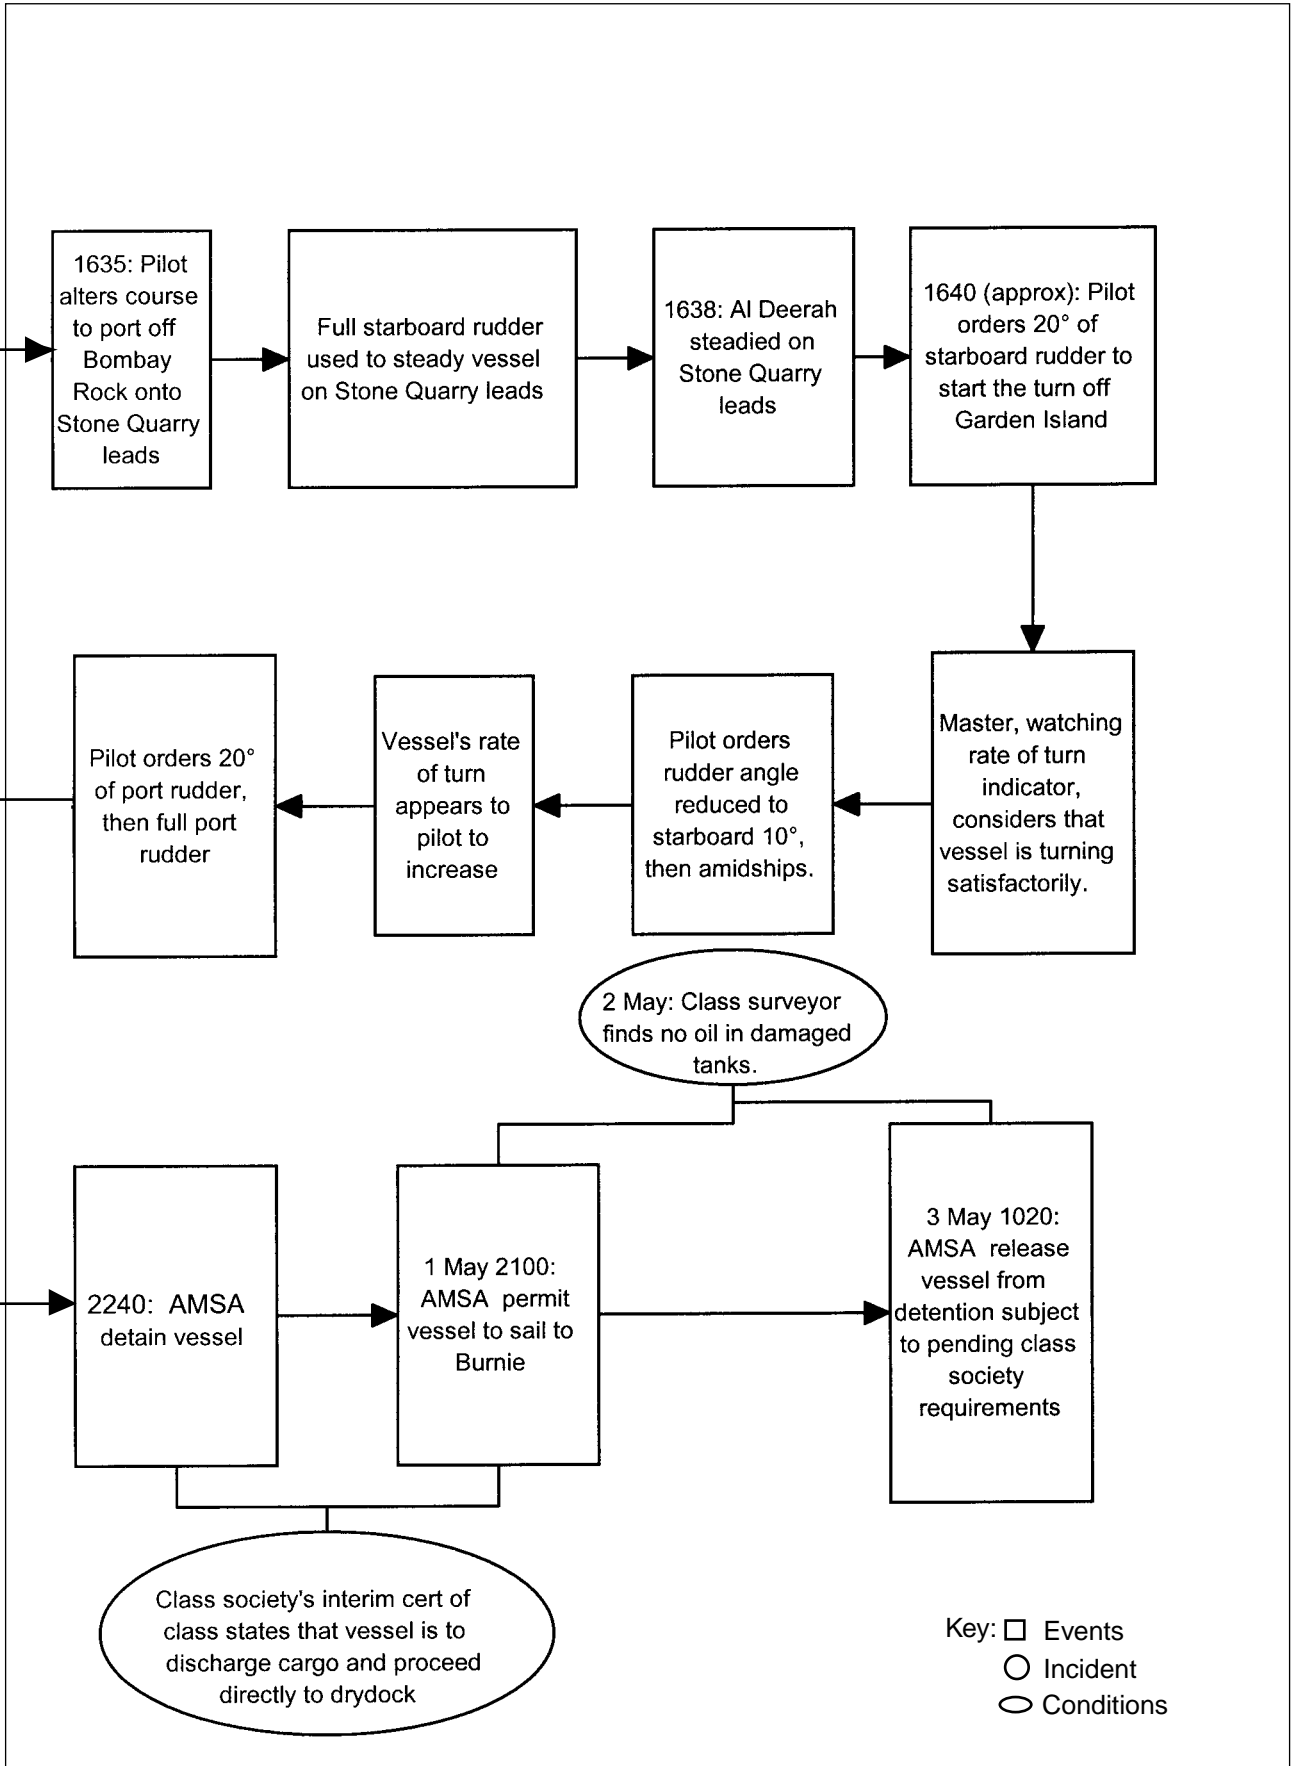
**Figure 6:**  
***Al Deerah* grounding off Garden Island: Events and causal factors chart**

5. The vessel was at full ahead manoeuvring speed and it is probable that any attempt to increase the propeller revolutions, after it became apparent that counter rudder was not affecting the rate of turn, would not have prevented the grounding.

The Inspector recommends that the Port of Launceston Authority review the conditions, including tidal conditions, under which vessels enter and depart the port, consulting as appropriate with the owners and managers of such vessels.
