MARINE SAFETY INVESTIGATION
No. 171

Independent investigation into the equipment failure
aboard the Hong Kong flag container vessel

Maersk Tacoma

in Bass Strait
8 August 2001

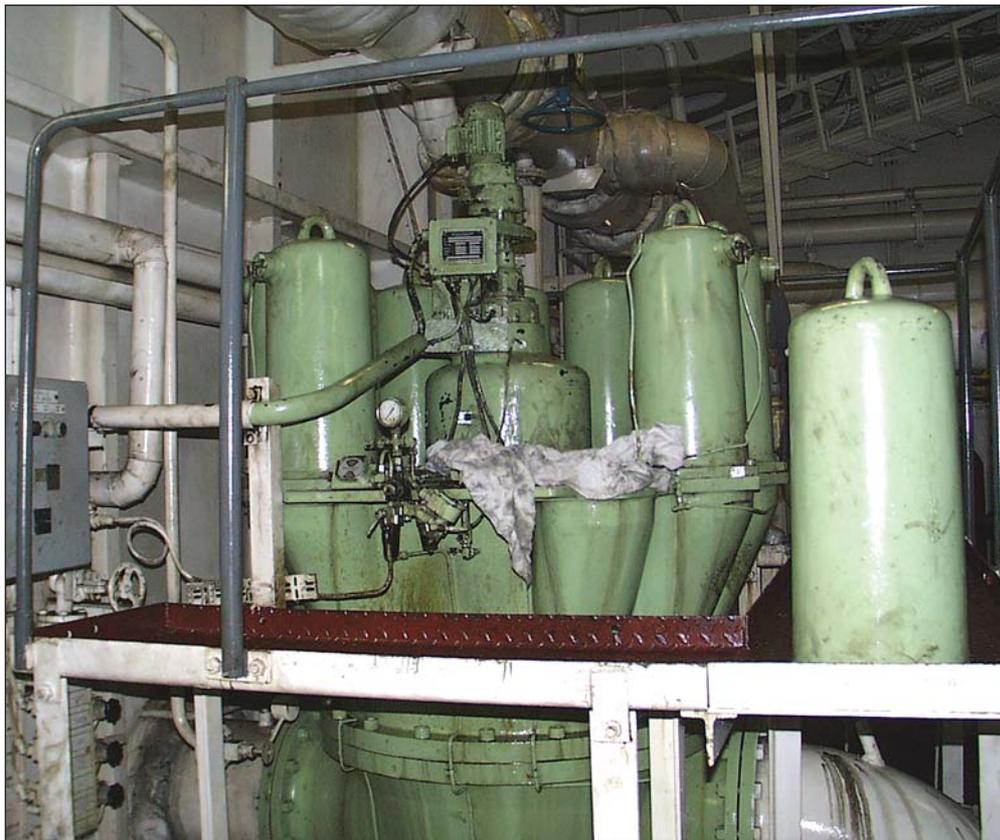
FIGURE 2: Lube oil Boll and Kirch automatic filter

For some period before the incident, *Maersk Tacoma's* Boll and Kirch filter had not been automatically flushing due to a problem with a differential pressure switch. The engineers had been in the practice of manually initiating a cleaning cycle each four hour watch or when they noticed that the differential pressure on the filter was increasing.

In June, the engineers had found that the nut holding the automatic filter's sludge valve on its spindle had sheared. A spare had been ordered but had not arrived on

There was a number of issues with the main engine's L.O. system which may have led to the initial high differential pressures across the automatic filter and the consequent decreased L.O. supply flow to the main engine. These included the failure of the filter's automated flushing system, the filter's sludge valve being detached from its spindle and the addition of the purified stuffing box L.O. to the main engine sump in Melbourne.

It is likely that in combination, the addition of the purified stuffing box oil to the main engine sump, the failure of the automatic filter's differential pressure switch and sludge valve all contributed to the failure of number twelve bottom end bearing.

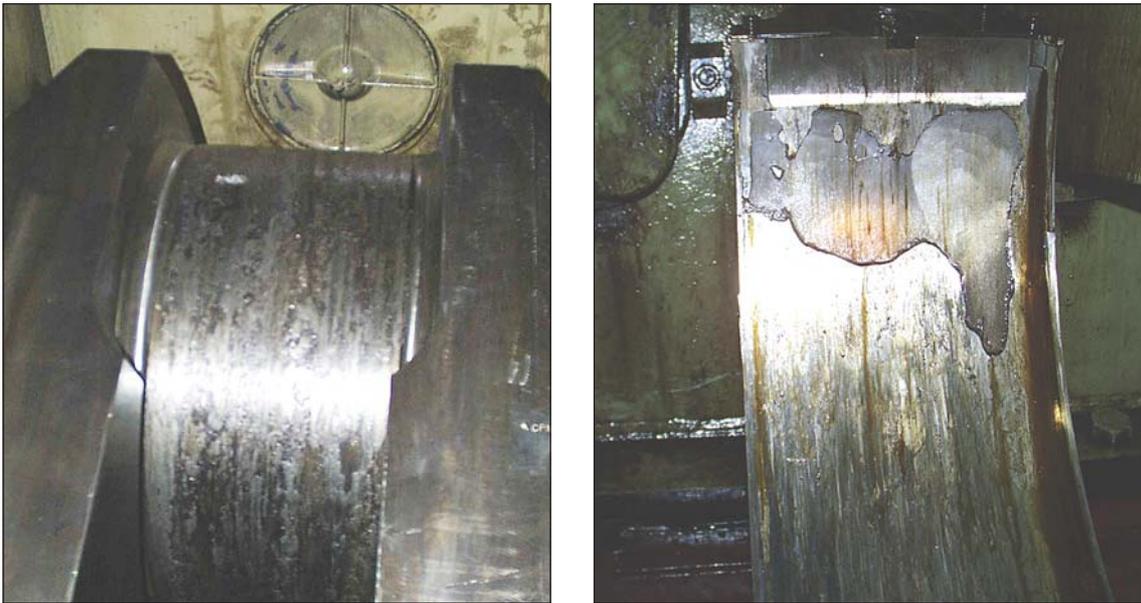
FIGURES 4 & 5: Number twelve bottom end bearing journal and bearing

With regard to number twelve bottom end bearing failure, the report from B&W states:

1. A foreign object has enter (sic) the lub. oil system and damaged the bearing and journal.
2. The bearing has deteriorate (sic) as seen on crankpin bearing no.11, 10, 6 and 3.

While the cause of the bearing failure is not conclusive, the report does suggest several mechanisms based on the condition of number twelve bearing surface and the type of breakdown it exhibited (figures 4 & 5).

The chief engineer stated that the engineers had stopped the main engine each time they had received a low L.O. pressure alarm in the afternoon and evening of 7 August and the during the following day, 8 August. After the stoppages at 1608, 2016, 2115 and 2200 on 7 August, the engineers found that the L.O. pressure was low due to a high differential pressure across the automatic filter. The L.O. pressure alarm setting was 1.3 bar, which is between 0.5 and 0.7 bar lower than the normal system operating pressure of 1.8-2.0 bar. In most circumstances a L.O. pressure low enough to trip the alarm would not result in damage to the engine. However the lower than normal flow of oil almost certainly contributed to the eventual failure of number twelve bearing probably in combination with a pre-existing fatigue crack or the poor condition of the white metal bearing surface.

The intervals of running time between the main engine stoppages due to low L.O. pressure rapidly decreased between 1608 and 2200. The probability is that the bearing had started to fail some time before 2016 and its condition continued to deteriorate each time the engine was subsequently run. The failing bearing had led

The chief engineer finally realised that there was a bearing problem when he opened the automatic filter's drain filter at 2200 and found white metal debris. This discovery led to the crank case inspection and the discovery of number twelve bottom end bearing's condition.

Maersk Tacoma's main engine bottom end bearings are normally only opened and inspected during class surveys every five years. Number twelve bottom end bearing had not been surveyed in the previous twelve months, although the bearing clearance on the journal had been checked in December 2000 and found to be within normal tolerance.

The B&W service report notes that all of the other bottom end bearings exhibited unusual longitudinal fatigue cracks in the white metal bearing material. As part of their investigation, the engine manufacturer conducted several tests on bearings throughout the engine to determine the type of bearing material (white metal) and whether or not it conformed to their standard. Their analyses revealed that the bearing material was type HMO2 with the report stating:
