Summary

The German flag, 35,303 gross tonnes container ship Berlin Express, while proceeding through the dredged cut, in the South Channel, Port Phillip Bay, en route to Melbourne, took a rapid sheer to starboard, as a result of which the

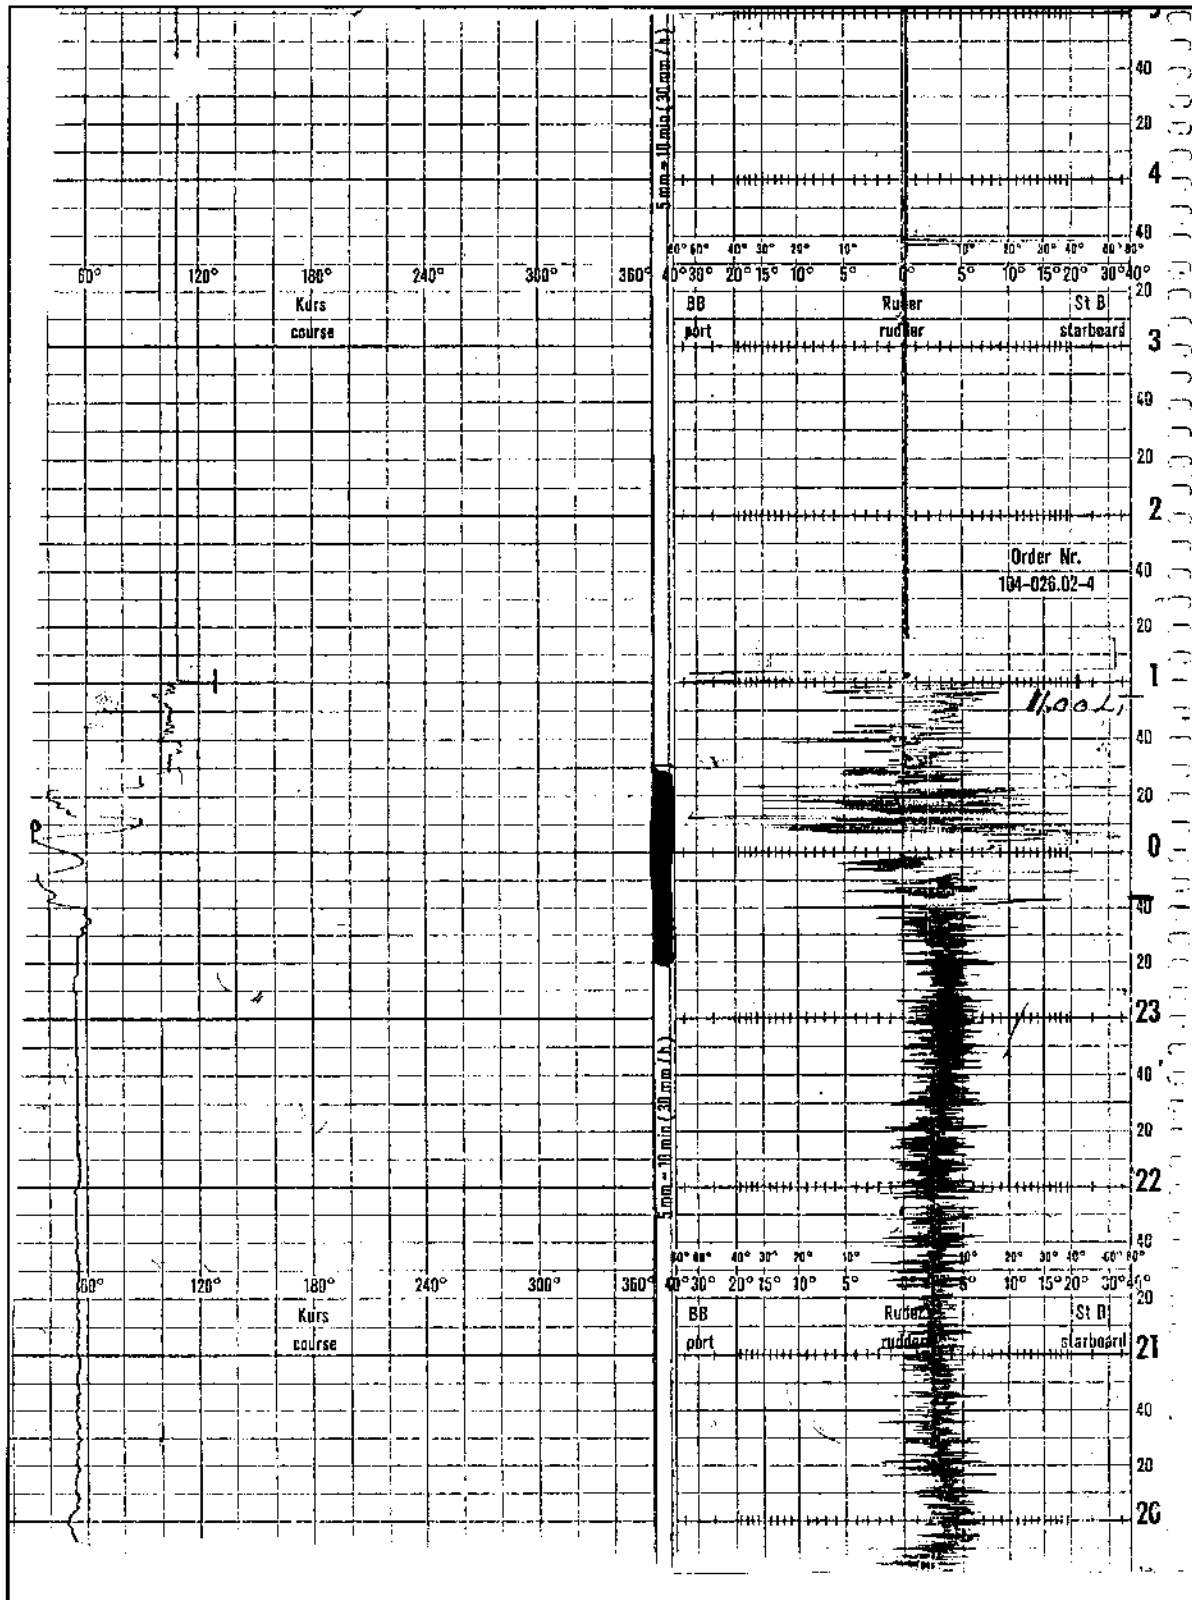
Section of Berlin Express course recorder chart

Examination of the course and rudder angle recorder chart shows that the rudder moved to 20 degrees starboard at 1100, at the time of the rapid swing to starboard. It is, therefore, necessary to investigate possible causes for this to occur.

What is readily apparent is that from the time of the approach to the pilot boarding area, Berlin Express was carrying starboard helm of between 2.5 and 3.5 degrees. Also the zero, or midships, helm setting is slightly off to the right, or to starboard. There would also appear to be a time-setting error of between one and 1.5 minutes - according to the course recorder the ship steadied on a heading of 109 degrees at about 1101, whereas from the data logger, the time of ordering stop engine, shortly before the actual grounding, was 1102.

The movement of the rudder to starboard 20 degrees between 1058.5 and 1100, which created the rapid swing to starboard, appears to be in a continuous flow from a port five degrees position. The autopilot had applied port five degrees to bring the ship back to the correct heading from a heading of 108 degrees, following which the ship swung to port to a heading of 104 degrees.
