RAIL SAFETY INVESTIGATION

2002/001

# Collision Between Suburban Electric Passenger Train 1648 and Suburban Electric Empty Train 1025

Epping, Victoria, 18 June 2002

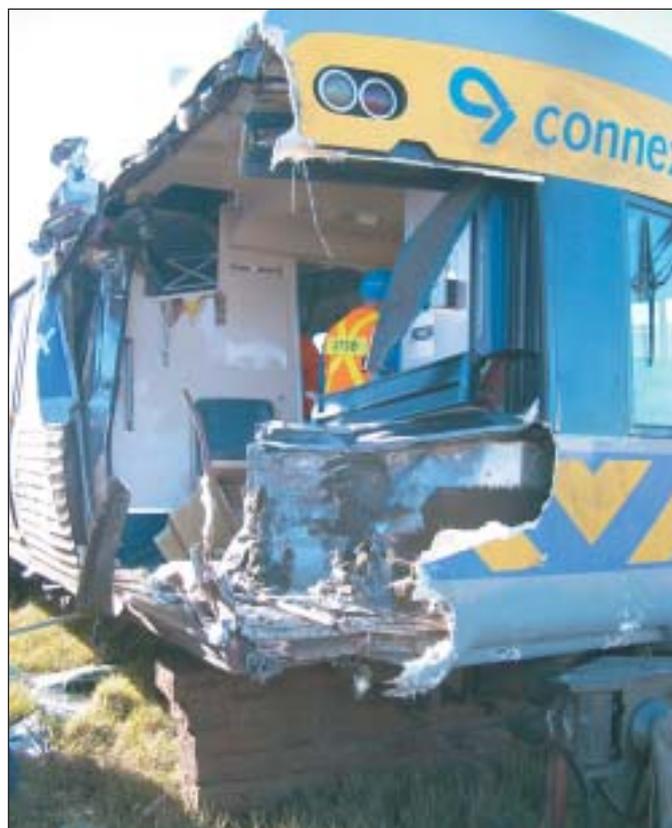
**FIGURE 4:**  
**Damaged carriage 634M**

Leading car 634M sustained major undercarriage and bulkhead damage as a result of the collision. The driver's control area was relatively intact with shards of shattered glass scattered throughout the cabin, the offside of the cabin was severely damaged. The outer steel skin was peeled back from the bulkhead and pushed back past the crew compartment door. Internal fittings and fixtures were smashed and dislodged. Inside the passenger compartment there was evidence of panel buckling on the offside behind the crew access door.

Undercarriage damage sustained by car 634M included major leading bogie damage, compressor, main reservoir, and supplementary reservoir, including other miscellaneous under body equipment.

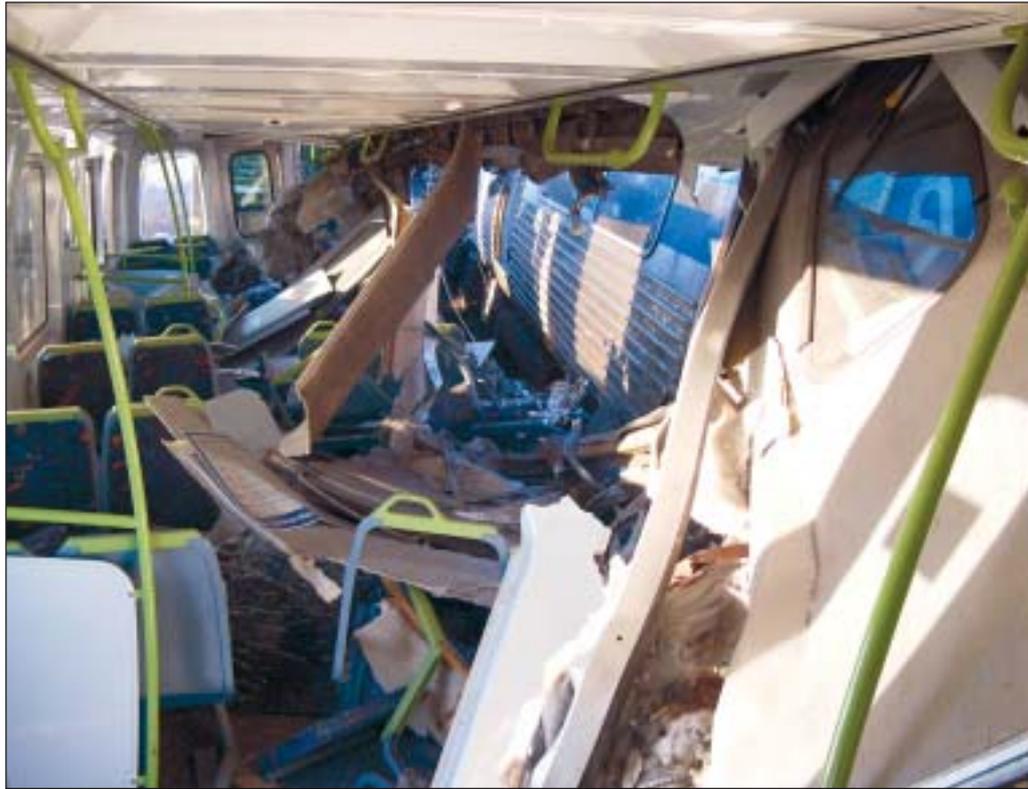
**FIGURE 6:**  
Internal damage to carriage 1109T

The outer skin of leading car 698M was severely scored. The second car (1109T) sustained major damage to its saloon area. The damage extended from the leading bulkhead through to the central doors of the carriage. The passenger seats on the right hand side of the carriage in way of the impact were torn from their floor mountings and thrown across the carriage, internal panelling was fragmented throughout the carriage. Undercarriage damage included serious impact damage to the leading bogie and other secondary equipment. Additionally, the Scharfenburg coupler between cars 698M and 1109T was bent as a result of the leading bogie on car 1109T derailing.

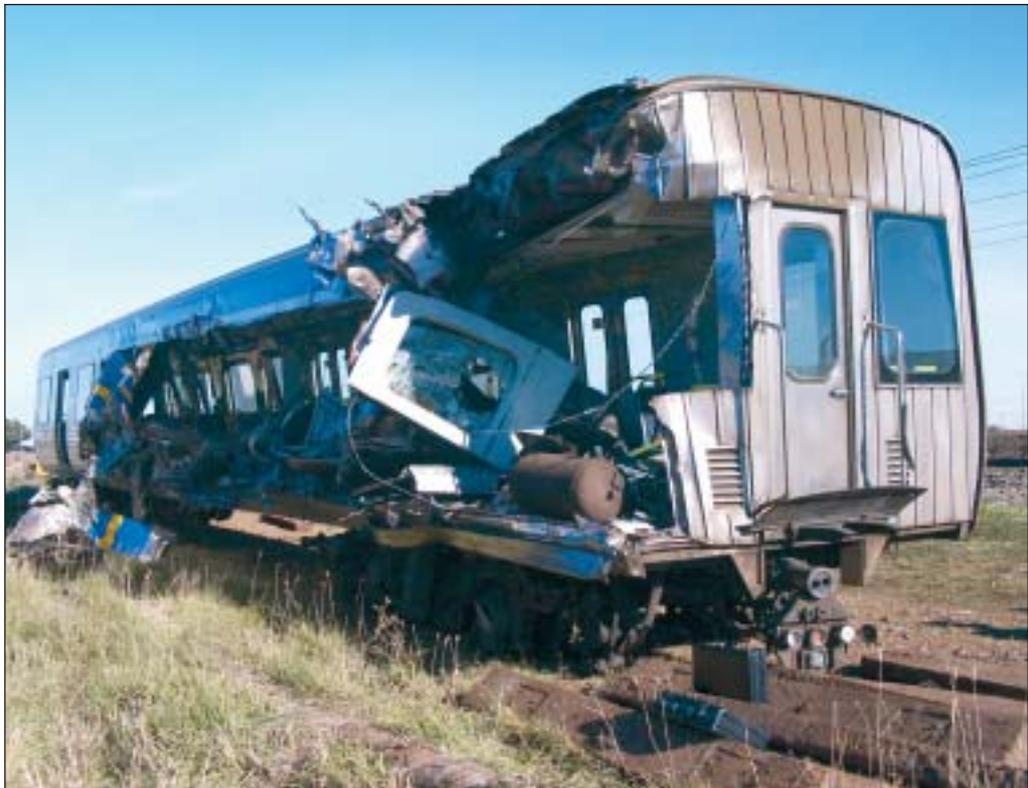
**FIGURE 7:**  
External damage to carriage 1109T

The collision caused the leading bogie of car 1109T (train 1025) to derail. The bogie was struck and forced over the field side rail into ballast, coming to a stand clear of the sleepers. The force applied to the field side rail caused the rail to roll outwards lifting securing spikes, pandrol clips, and sleeper plates from the timber sleepers, over a distance of about two metres. The timber sleepers showed superficial damage consistent with wheel flange impacts. All track fastenings were replaced following the accident but no sleepers were replaced. Both the turnout and main lines had wheel impact marks on the gauge faces as a result of the hard contact with the wheel flanges.

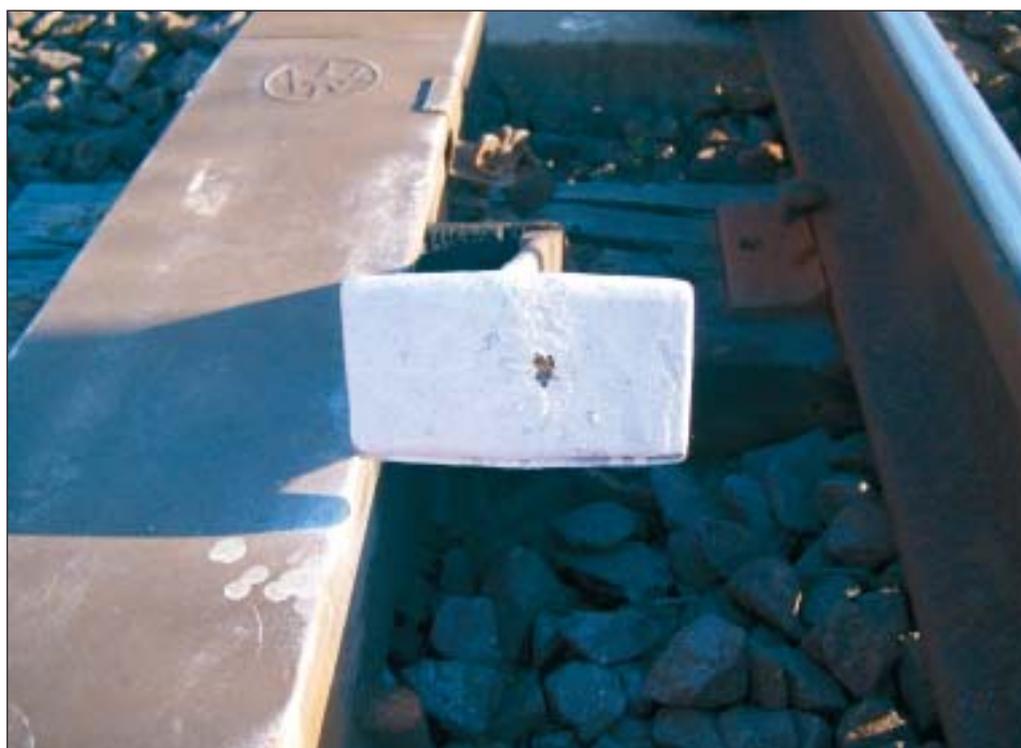
The train-stop arm at signal EPP121 was gauged in the stop position and found to be operating to specification.

**FIGURE 9:**  
**Signal EPP121 train stop showing an impact mark**

The signal circuitry, aspects, and the train-stop arm were determined to have been working as designed at the time of the train collision.

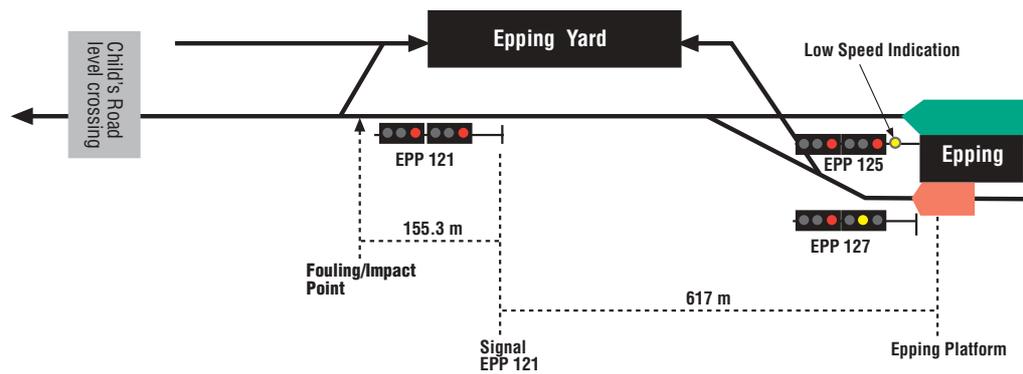
**FIGURE 13:**  
**Signalling layout at Epping**

The distance from signal EPP121 to the fouling point between the main line and number 22 points was 155.3 metres. A train travelling in excess of 55 km/h would not stop within the safety margin.

The design distance of the overlap was insufficient for the train stop to bring the train to a halt from the speed the train was travelling at the time of the accident.
