Australian Transport Safety Bureau

# Fatality off the Queensland port of Hay Point – 11 March 2004

## Yu Long Shan: Fatality during cargo hold repairs

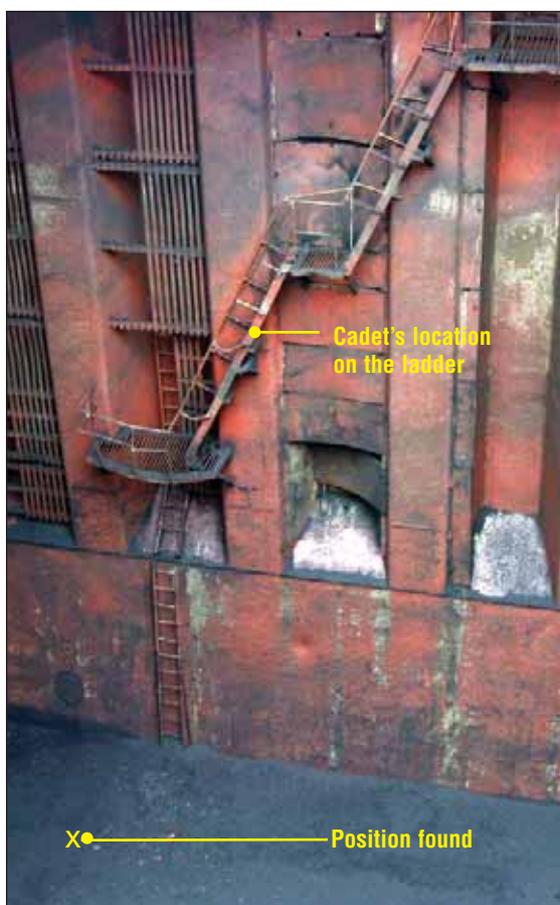
**FIGURE 4:**  
**Ladder arrangement**

The forward ladder arrangement in number six hold consists of three horizontal platforms linked by two angled ladders (at an angle of 65° from the horizontal plane of the lower two platforms). The lower angled ladder is 3.9 m in length and the upper, 3.6 m. There is a vertical ladder leading from the bottom platform to the tank top (approximately 6.1 m below the platform) and another vertical ladder leading from the top platform to the deck (approximately 4.1 m above the platform).

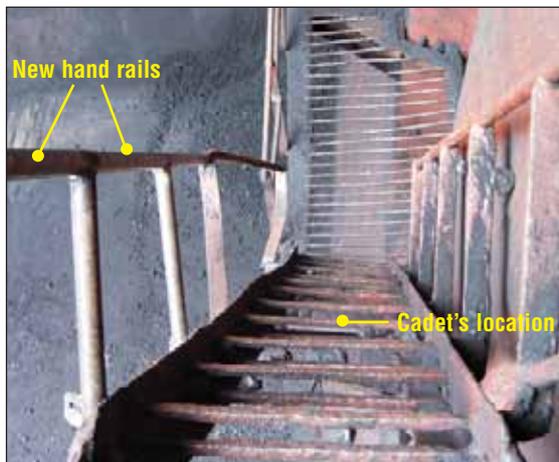
**FIGURE 2:**  
Cadet's position on ladder

Prior to the incident, the cadet had descended the ladder and passed some material to the chief engineer. He was making his way back to the middle platform when he turned, about 1.8 m from the top of the ladder. He apparently stood with the heels of his boots on the rungs of the ladder, possibly to look down the ladder at the repair operations on the bottom platform. Because he was in the process of returning to the middle platform, he had not attached his safety rope to a strongpoint on the ladder.

The chief engineer was working on the stanchions on the open side of the platform. His body could have blocked the cadet's view of the work from the cadet's vantage point on the ladder. The cadet would have had to lean out over the hand rails on the ladder to see any of the work being done.

The section of railing where the cadet was standing had just been replaced with new galvanised pipe and as such, was smooth to the touch and did not offer a great deal of grip. At the time of the accident he was wearing woven cotton gloves of the type frequently used by Asian crews. These gloves afford a small degree of protection from dirt but do not have very good gripping ability.

The available evidence supports the theory that the cadet overbalanced while leaning out over the hand rail of the ladder. The position of

his body on the tank top was not directly underneath but forward and out from the vertical below his last known position.

Shipping companies, managers and ships' masters should review ISM documentation to ensure that procedures for working in hazardous locations are adequately and unambiguously covered. These include:

- The wearing of appropriate foot coverings and gloves;
- Safety belts or harnesses being secured to a strong point; and
- The importance of concentrating on the task at hand.

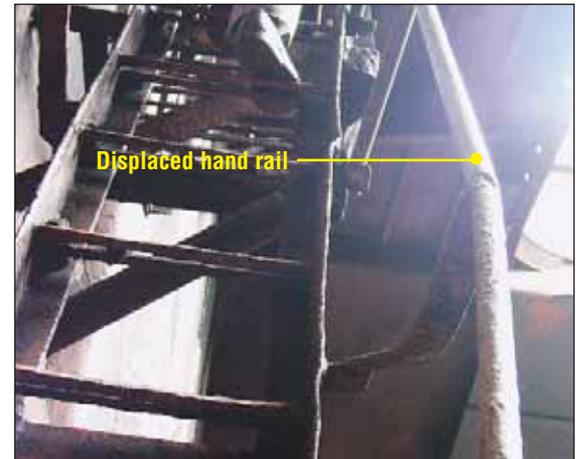
**FIGURE 3:**  
Displaced hand rail

The cadet was 180 cm in height and of slim build, giving him a relatively high centre of gravity. The hand rails on the ladder measured 350 mm from the perpendicular of the ladder, so his centre of gravity would have been considerably higher than the hand rails. The hand rails had also been displaced from the perpendicular by grab damage.
