# Collision with terrain, VH-ZRR

## 21 km SE of Kojonup ALA, Western Australia

### 17 November 2009

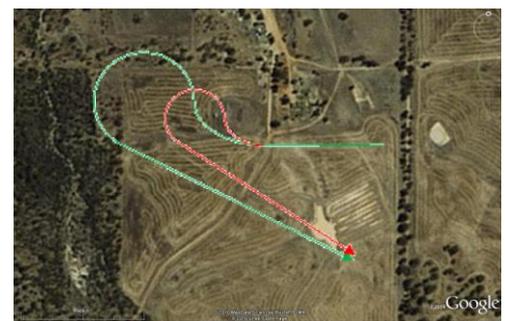
**Figure 1: Probable flight path based on witness description**

A representation of the aircraft's probable final flight path is at Figure 1. Reversal turns using 60° angle of bank (AOB) (annotated in red) and 45° AOB (annotated in green) at 85 kts are depicted before a period of straight and level flight directly to the accident site. The estimated heading during the period of straight and level flight derived from these projections approximates a final flight direction of about 130°, and is consistent with the direction of the ground impact and wreckage trail. The position of the wreckage indicates that the turn may have been initiated to position the aircraft on a cleanup run along the eastern boundary of the field.

preference of the pilot to 'rush and pull hard turns', and the Satloc evidence of the use by the pilot of high AOB turns to position the aircraft; support and are consistent with the pilot entering a steep, level, left turn after transiting from the north-west corner to the south-east corner of the field. The Satloc data also indicated that this turn was likely to have been conducted at a speed at or below 90 kts.

The high vertical velocity and low forward speed on impact with terrain, as well as the witness's report that the nose of the aircraft suddenly dropped and the aircraft dove towards the ground almost immediately after commencing the turn, is consistent with an aerodynamic stall. Any mishandled 60° angle of bank turn at the probable aircraft weight of 1,678 kg at speeds below 90 kts would increase the risk of the aircraft stalling. The application of rapidly increasing g in such a turn would deepen the stall before any reaction by the pilot. The low-level nature of aerial application minimises the height available for any recovery.
