Safeworking irregularity involving passenger train SN57 and train D231 at Moss Vale, New South Wales 17 June 2010

Abstract

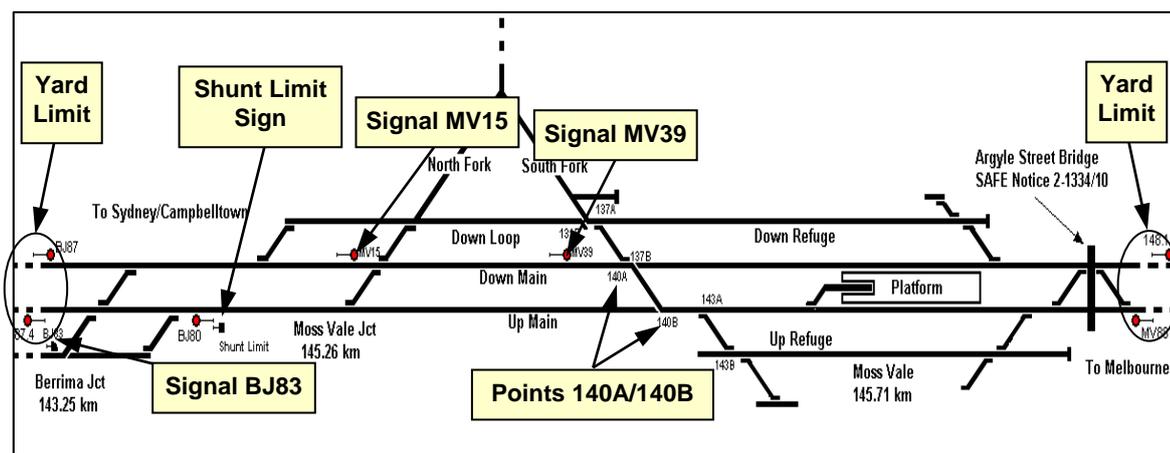
Figure 3: Schematic - Berrima Junction to Moss Vale

Almost immediately, the network controller realised that he had simultaneously authorised passenger train SN57 into the Up Platform Road and train D231 into the Up Refuge Siding. This meant that both trains were to traverse a common set of points (140) which would bring the two trains into direct conflict.

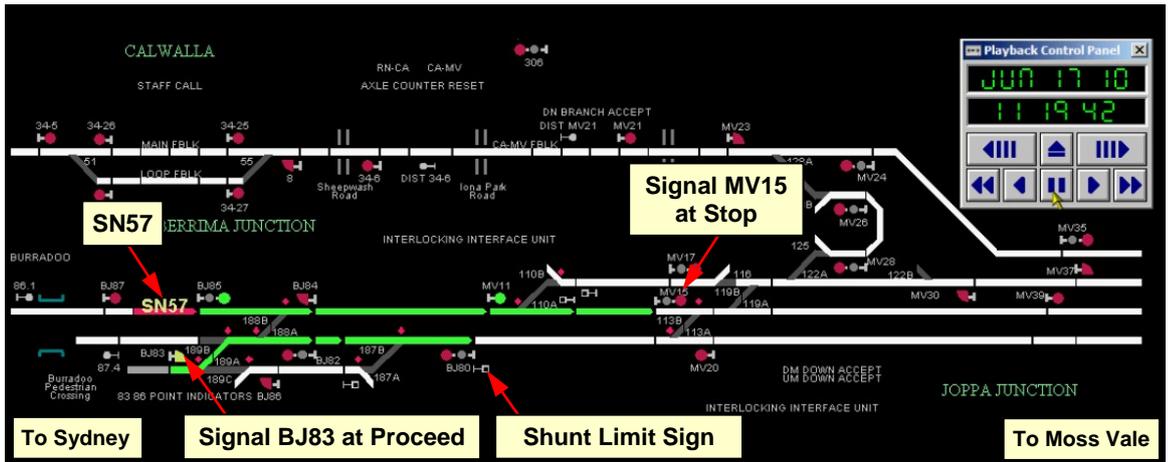
Figure 4: Berrima Junction, Phoenix replay 1119:42

At the same time passenger train SN57, travelling at a speed of about 80 km/h, was on the adjacent Down Main line and trailing train D231 (Figure 4). Passenger service SN57 continued towards signal MV15. It then commenced slowing down and came to a stand in front of signal MV15, at about 1123 (Figure 5).

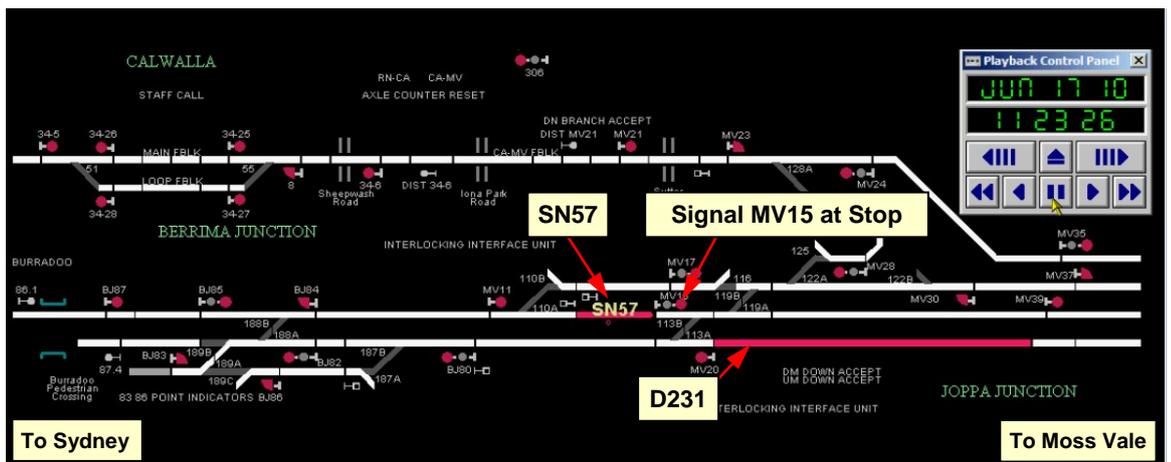
Figure 5: Berrima Junction, Phoenix replay 1123:26

The driver of passenger train SN57 spoke to the controller and shortly thereafter (1123:26) received verbal authority to pass signal MV15 and MV39 displaying a Stop indication and to proceed down to 140 points where the road would be set for his movement into the Up Platform Road.

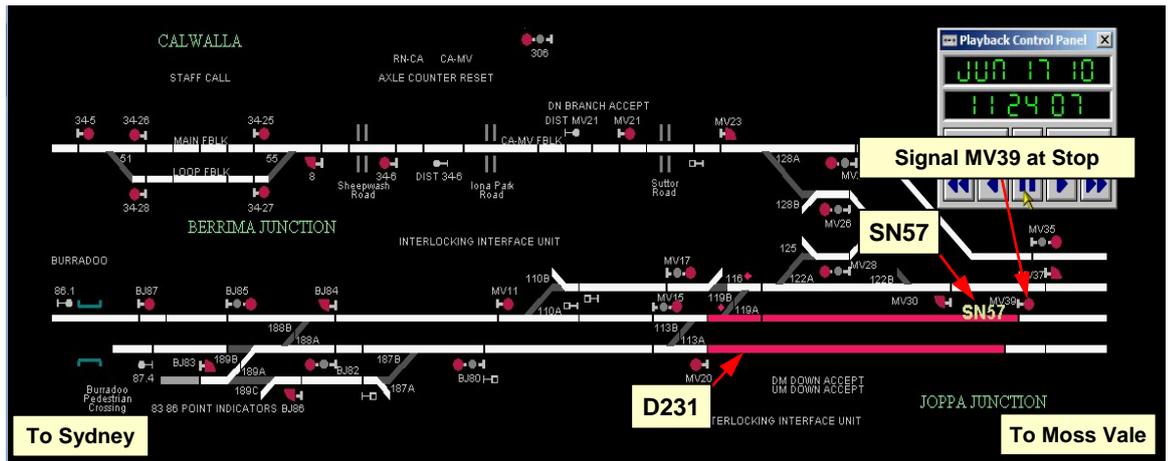
Figure 6: Berrima Junction, Phoenix replay 1124:07

Train D231 had now just caught up to passenger service SN57 as it began to accelerate slowly and proceed past signal MV15 on its way to Moss Vale. Having now authorised both train D231 and passenger train SN57 through the Moss Vale Yard over 140 points the two trains would come into direct conflict if the conflicting movement was unchecked or undetected.

Fortunately, the network controller recognised that he had made a mistake and immediately called the driver of train D231 (1124:07 Figure 6 and Figure 7) to request that the driver bring the train to a stop.
