**ATSB TRANSPORT SAFETY REPORT**  
Aviation Occurrence Investigation – AO-2009-007  
Final

**Collision on ground**  
**Townsville Aerodrome, Queensland**  
**11 February 2009**  
**VH-SBW**  
**Bombardier DHC-8-315**

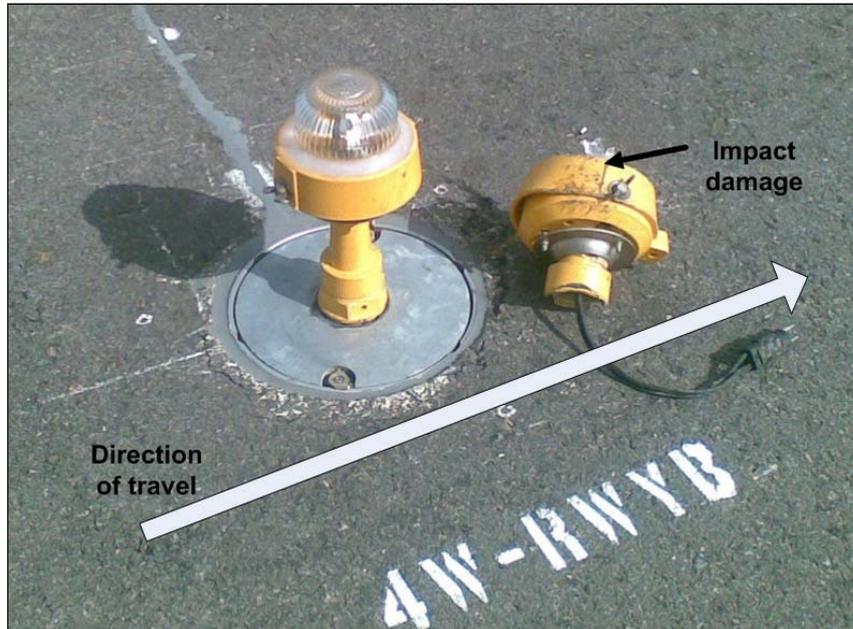
The damaged runway light was the first elevated light on the left of runway 01. Damage to the light consisted of a broken lens and a crushed upper casing. Witness marks on one side of the casing consisted of scrapings and, on the other side of the casing, tyre markings. The damage to the light was such that if the light was in its

correct position, the damage was parallel to and on the left runway edge side of the light fitting.

**Figure 1: Damaged runway light with replacement (scrape marks indicated on the damaged light)**

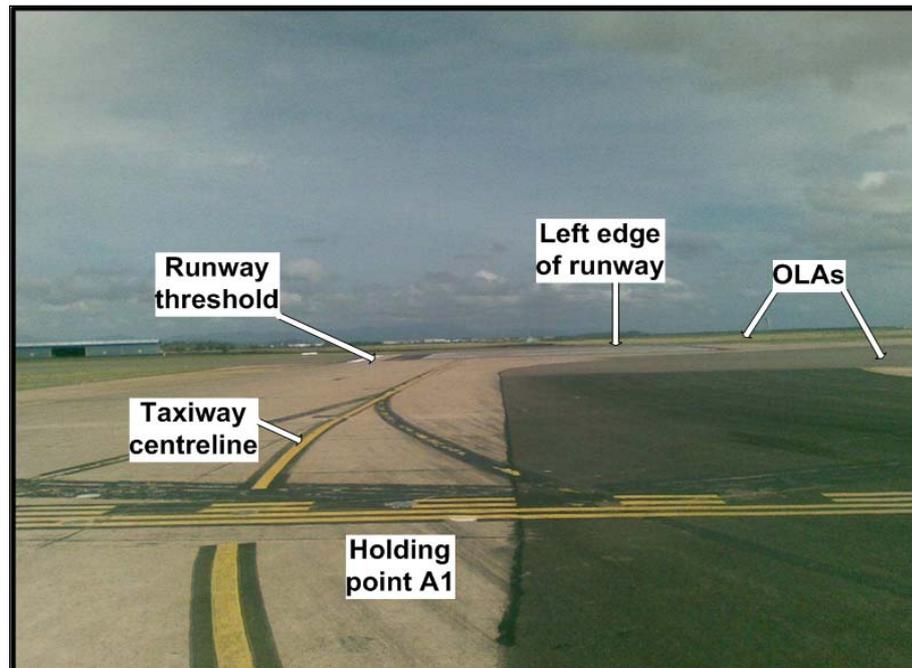
Entry to runway 01 from taxiway A1 was marked by black and yellow lines that lead onto the runway (Figure 3). At the beginning of the runway, there was a series of black and white lines that formed the threshold marking. Those lines were spaced parallel to, and at equidistant intervals from the centre of the runway. That left a relatively larger black section in the centre of the runway threshold markings.

Figure 3: Taxiway A1 holding point and runway 01 entrance markings

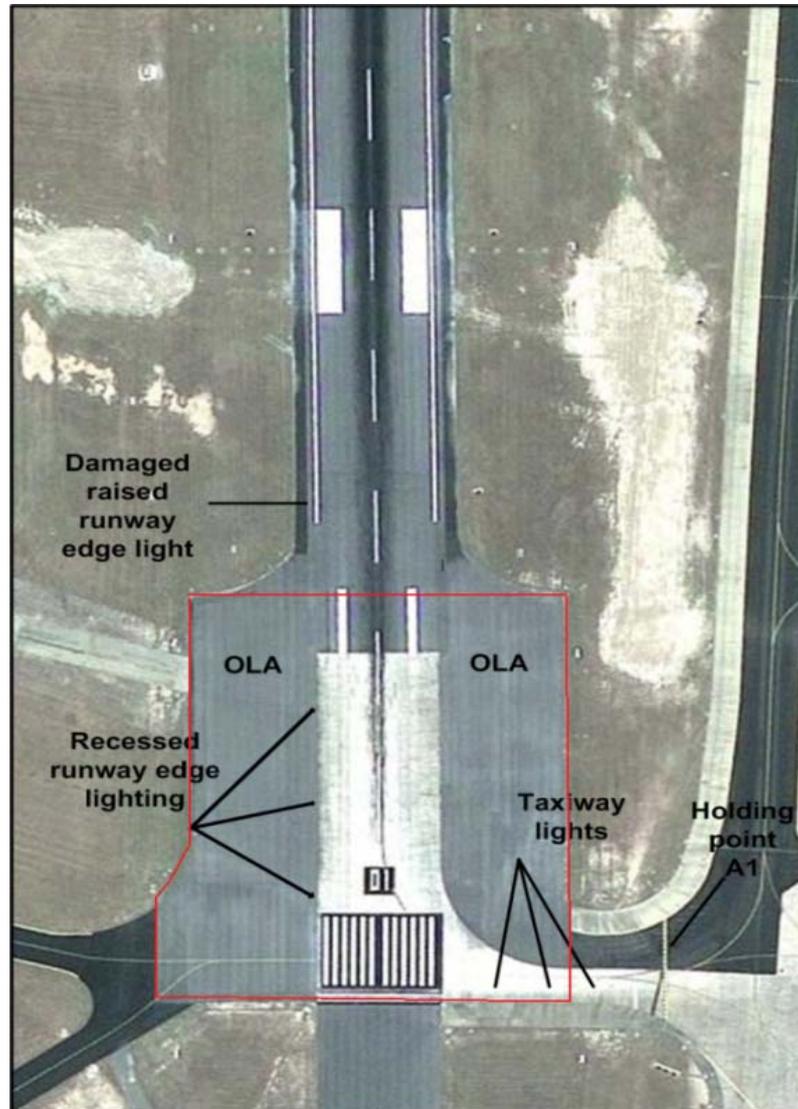
about 60 m from the runway threshold and comprised a series of dashed lines that continued the full length of the runway (Figure 4).

**Figure 4: Aerial view of Townsville runway 01 (position of taxiway and runway edge lighting shown)**

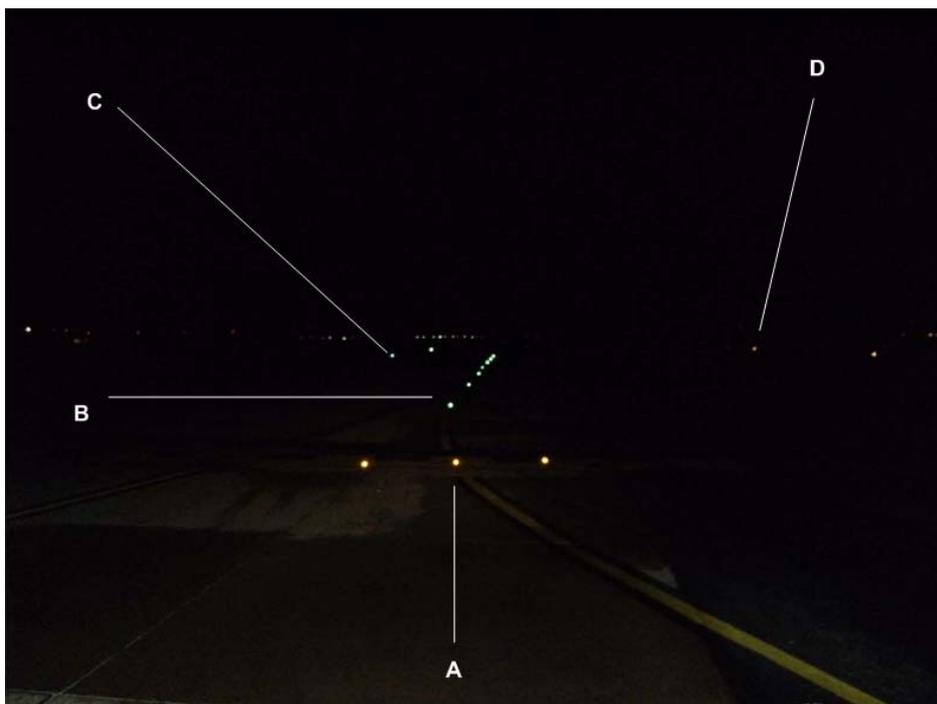
The runway edge lighting was spaced at 60 m intervals and the first three runway edge lights were recessed into the pavement, as both sides of the runway had OLAs that could be used by aircraft to access the runway. At the sides of these movement areas were a series of blue lights that signified the outer edges of the OLAs. The images in Figures 3 and 6 were taken from the holding point at taxiway A1 and show the view from that point during daylight and darkness.

**Figure 6: Taxiway A1 holding point at night**

A shows the Holding point lights, B taxiway centre line lights, C threshold lights, D runway edge lights

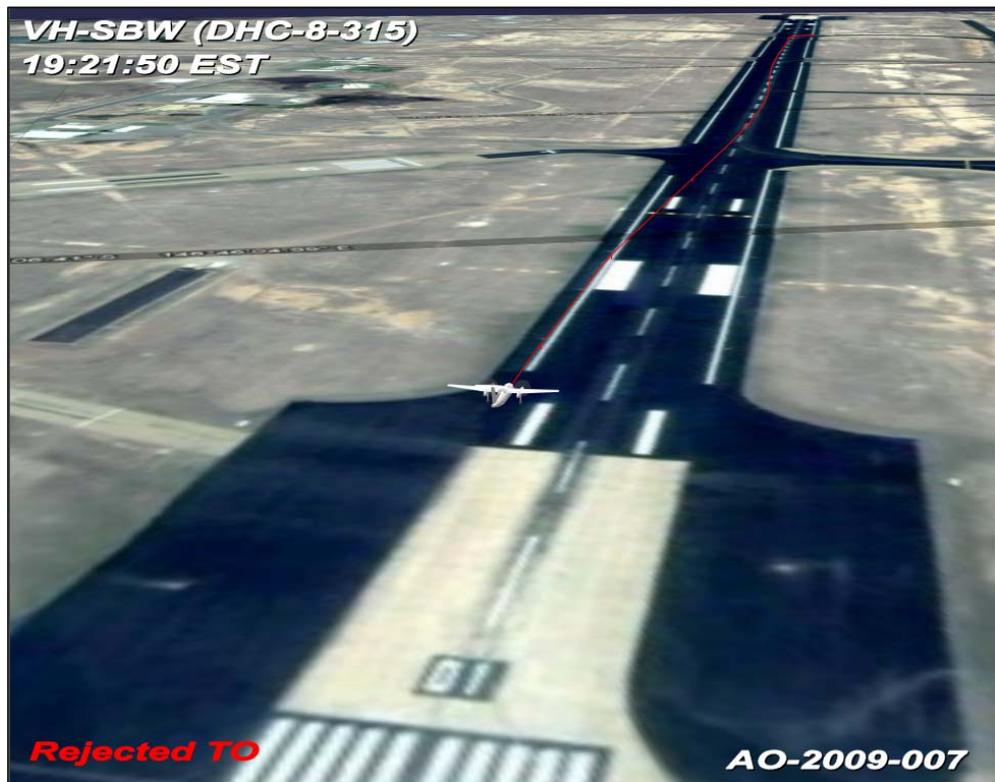
A representation of the aircraft's track during the rejected takeoff was derived from the FDR data and is shown in Figure 7 and 8.

Figure 7: Aircraft's track during the rejected takeoff

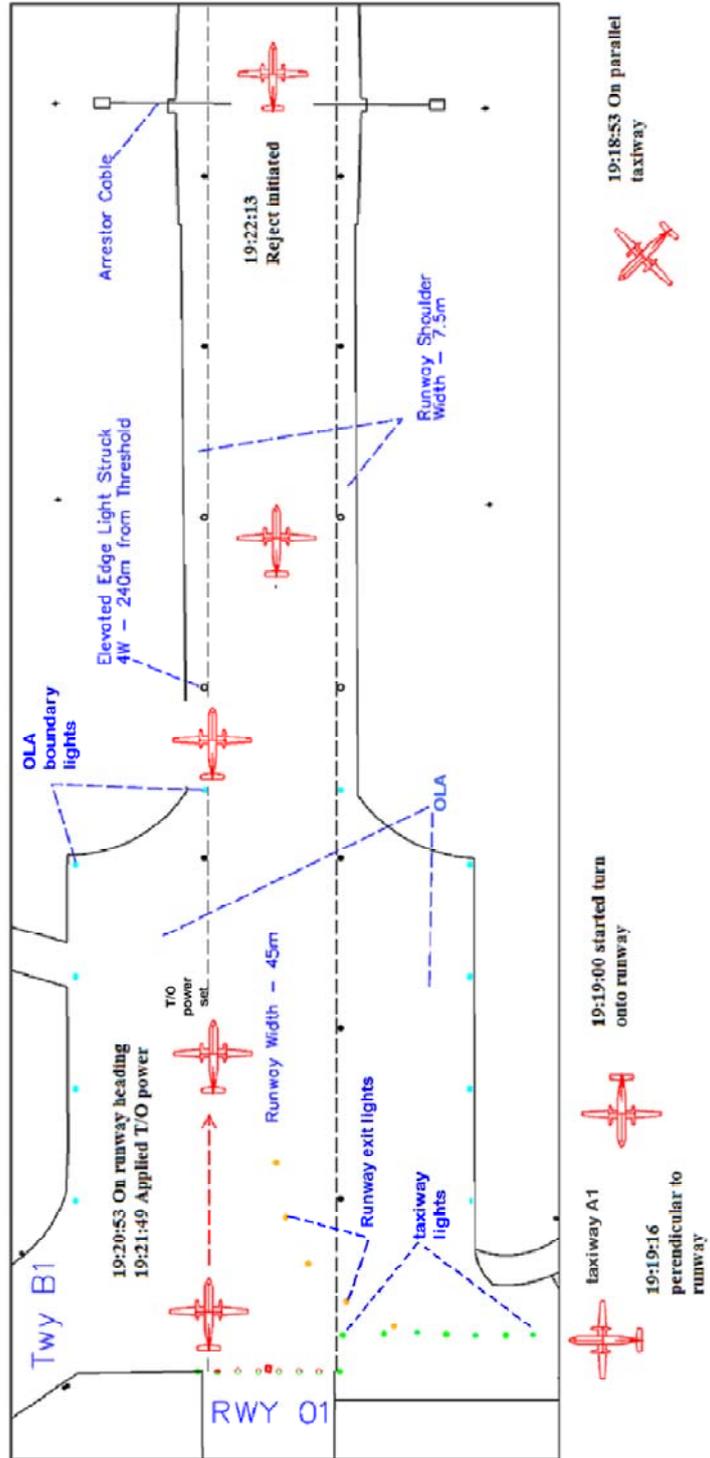
Figure 8: Take-off sequence until the flight crew rejected the takeoff
