Collision with terrain, VH-ODP

5 km north-east of Wickepin, Western Australia

3 October 2009

Abstract

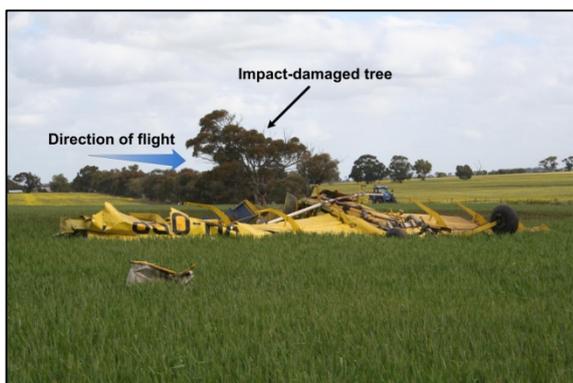
Figure 1: Main wreckage (looking approximately south)

Debris from the aircraft's spray boom, and a substantial number of tree branches of between 50 and 150 mm in diameter, were found at the base of a 23 m high tree that was located at the north-western corner of one of the canola crops that was to be sprayed. That tree was significantly taller than the other trees that ran along the western boundary of the crop (Figure 1).

The aircraft impacted the ground about 150 m north of the 23 m high tree and about 10° to the right of the direction of the spray run in an inverted, 40° nose-down attitude. The aircraft slid

inverted for about 50 m, before coming to rest, with numerous items of aircraft wreckage distributed along the wreckage trail. Damage to the aircraft was consistent with a high-energy impact.

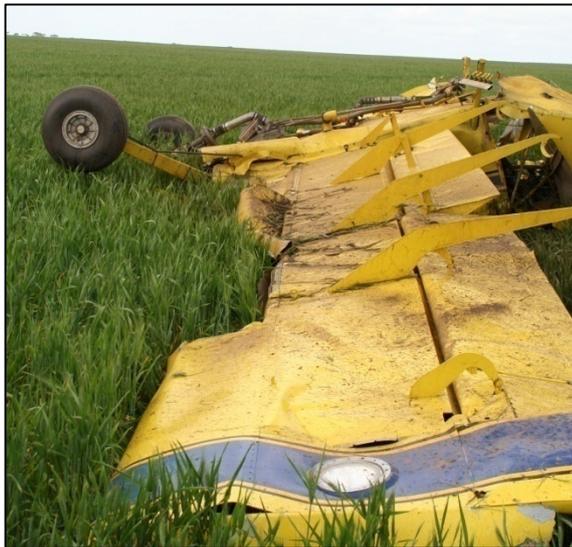
When examined, none of the fallen branches exhibited signs of cutting that would be expected if they had come into contact with the aircraft's propeller. There was damage to the leading edges of the aircraft's wings, consistent with the damage observed to the tree's canopy. The most extensive tree impact damage was on the right wing (Figure 2), where 50% of the leading edge was disrupted. There was a lesser amount of tree impact damage to the left wing.

Figure 2: Damage to the leading edge of the aircraft's right wing

The amount of aerodynamic lift generated by an aircraft's wing is, amongst other factors, dependent on the smooth flow of air over the wing. The type of leading edge damage observed on ODP would not only disrupt the smooth flow of air over that section of the wing, it would also increase drag and reduce the total effective wing area, resulting in a reduction in the lift generated. As a consequence, the uneven lift produced between the left and right wings could induce a rolling motion exceeding the control authority of the aircraft's flight controls at a given airspeed, and result in a loss of aircraft lateral control.

The aircraft's impact with the ground in an inverted, steep nose-down attitude was most likely a result of loss of control due to extensive damage to the aircraft's wings; in particular, to the leading edge of the right wing. That damage produced an asymmetry of lift between the left and right wings, and a consequential roll from which the pilot was unable to recover before colliding with the ground. The nature of the damage to the leading edge of the wings was consistent with damage observed

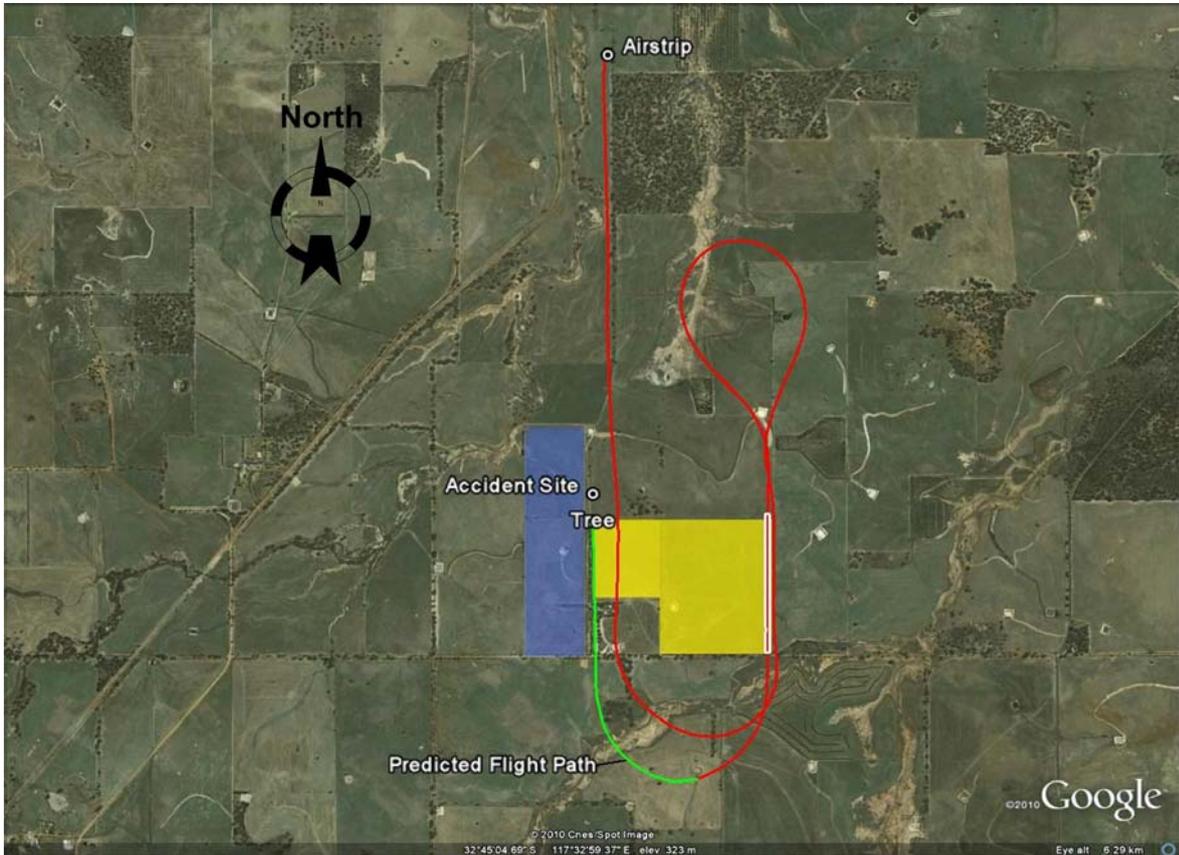
APPENDIX A: DEPICTION OF RECORDED
DATA

Recorded information from the memory card showed that the aircraft became airborne on a southerly heading and continued in that direction flying parallel and close to a farm track that separated two adjacent fields of canola that the pilot intended spraying. The fields were approximately rectangular in shape and the boundaries were aligned north-south/east-west. The recorded data is depicted in Appendix A.

The pilot carried out the first spray run on a southerly heading, along the eastern boundary of the first field. That run was followed by a right turn, consistent with the pilot positioning the aircraft to spray the western boundary of that field. The last recorded data from the Satloc was midway during that turn, at 1157:06.
