## FACTUAL INFORMATION

On 7 May 2005, a Fairchild Metroliner SA227-DC, registered VH-TFU, with two pilots and 13 passengers, was being operated under instrument flight rules (IFR) on a scheduled passenger service from Bamaga to Cairns via Lockhart River, Qld.

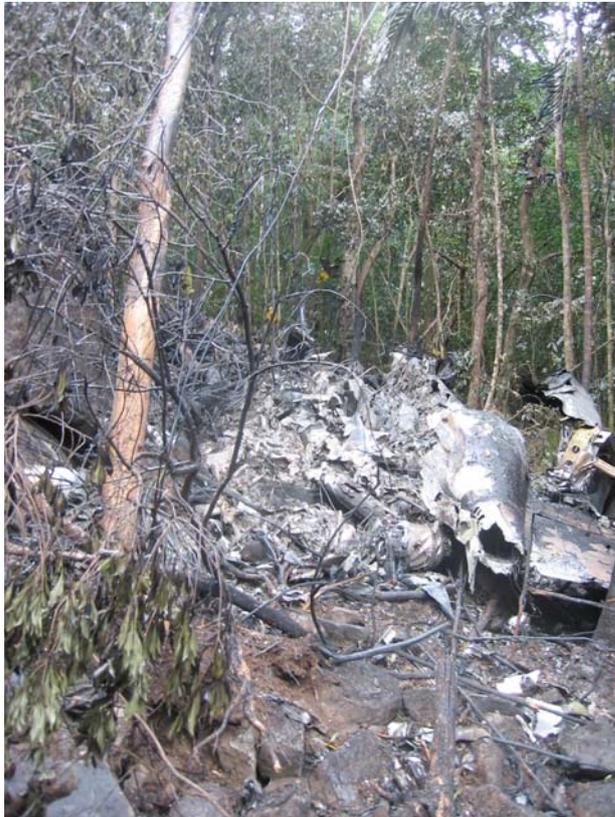
The aircraft had cut a swath of less than 100 m through heavy timber on the steep slope and came to rest at an elevation of 1,210 ft above mean sea level (amsl) about 90 ft below the top of the ridge.

The aircraft entered the forest canopy at a descent angle of between 3 and 5 degrees. Damage to the propellers and engines was consistent with both engines producing power at impact. An intense, fuel-fed, post-impact fire destroyed most of the aircraft fuselage, including much of the instrument panel and avionics. The accident site is located on the published Lockhart River 12 RNAV final approach track. At that point in the approach, the minimum obstacle clearance altitude was 2,060 ft amsl.
