ATSB TRANSPORT SAFETY REPORT
Rail Occurrence Investigation RO-2010-015
Preliminary

Derailment of train 1MP5 at Goddards Siding, Western Australia

28 December 2010

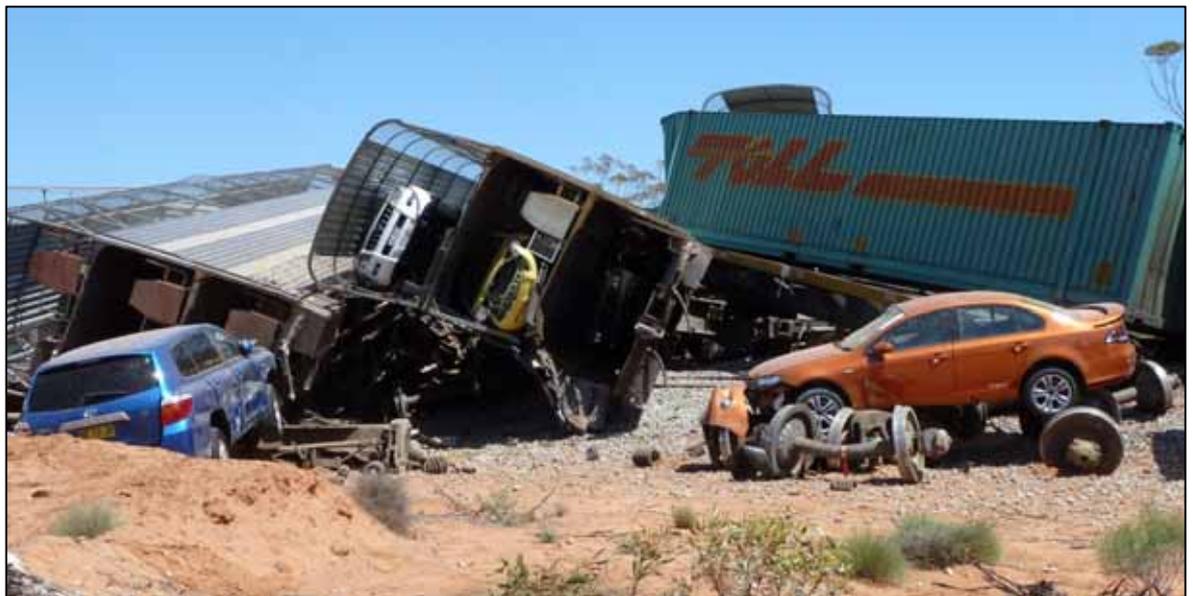
Figure 1: Train 1MP5 – Central section of the derailment site

A total of 23 freight wagons were derailed with 14 sustaining significant damage. Six double deck and four triple deck loaded car carrier wagons and four container flat wagons sustained the majority of vehicle damage. About 550 m of mainline and 200 m of the crossing loop track was damaged in the derailment.

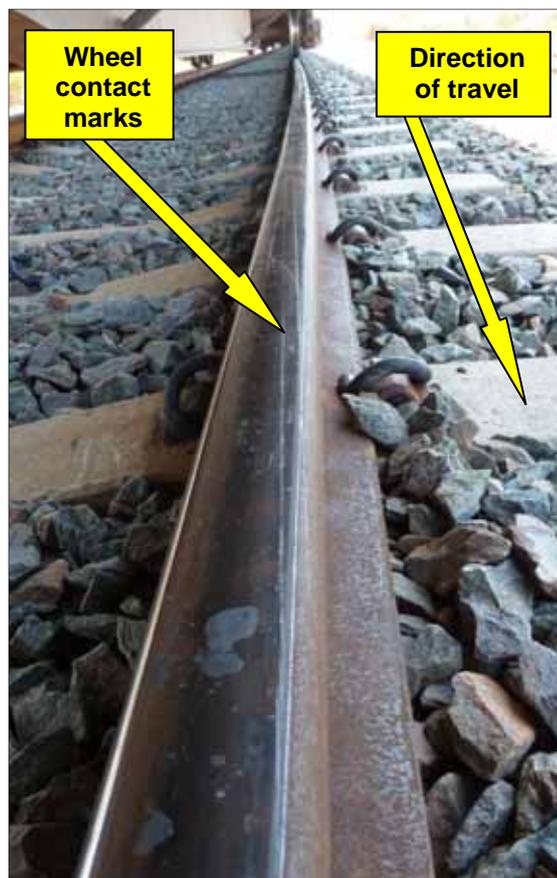
Figure 2: Wheel contact marks across the southern rail head near the point of derailment

- A single diagonal wheel contact mark, about 5 m in length, (Figure 2) was found on the head of the southern rail about 410 m west of the 1544 km post⁴ and the Goddards Siding east end.

- The mark extended from the inside to the outside of the rail head and indicated that a wheel had ridden up and over the rail at this point. It then dropped off towards the field side of the southern rail with wheel contact marks visible on resilient rail fasteners and on the top surface of the concrete sleepers.

- The wheels of trailing wagons had impacted and disengaged resilient clips, breaking sleeper ends that released the southern rail from the sleeper, causing a loss of correct track gauge.
