**Aviation Safety Investigation Report  
200401353**

**British Aerospace PLC 3201  
16 April 2004**

**Occurrence Number:** 200401353

**Aircraft Details:** British Aerospace PLC 3201

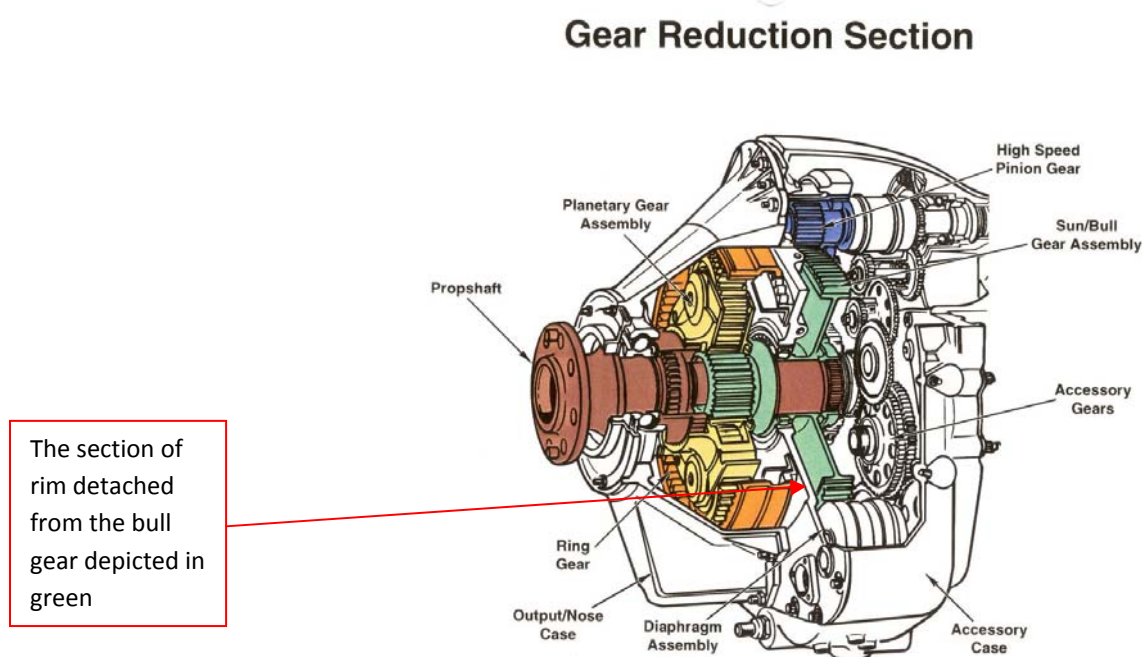
**Figure 1: Cutaway diagram of TPE 331 reduction gearbox**

An examination of the engine, supervised by the Australian Transport Safety Bureau (ATSB), found that a section of the spur gear teeth from the outer rim of the reduction gearbox bull gear, had detached during engine operation (See Figure 1). Spur gear teeth are radial, uniformly spaced around the gear's outer periphery and parallel to the shaft axis<sup>1</sup>. The detached section of gear had penetrated the diaphragm housing (intermediate gearbox housing) and the gearbox accessory case, before exiting the engine through the compressor air intake.

An ATSB Technical Analysis report (Appendix A), on the mode of failure of the bull gear, part number 3108295-1, found that the gear had failed as a result of a mechanism known to the manufacturer. The report indicated that the progressive propagation of high cycle fatigue cracking within the gear web and rim transition region, had caused a section of the gear rim to separate from the gear.

The investigation determined that the bull gear failed as a result of a previously known high cycle fatigue cracking mechanism.
