Collision with terrain, VH-NTV

145 km north of Marree, South Australia

18 August 2011

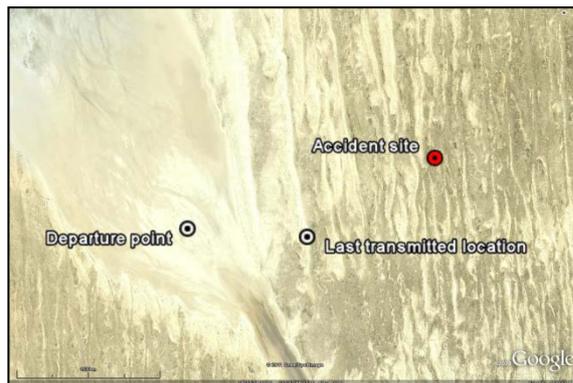
Figure 2: Back-to-base reporting points

After advising authorities of the situation, the tour group initiated a search, and later that night they located the wreckage of the helicopter about 3 km east-north-east of the departure point (Figure 2). The pilot and the two passengers were fatally injured. The helicopter was destroyed by impact forces and a fuel-fed fire.

For the accident flight, the data showed that the system was activated at 1856:40 and that the helicopter became airborne at 1859:40. The last recorded data point that was transmitted by the back-to-base system was at 1900:40. At that time, the helicopter was at 1,165 ft above mean sea level (AMSL) and on a heading of 045° with a speed of 66 kts (Figure 2).

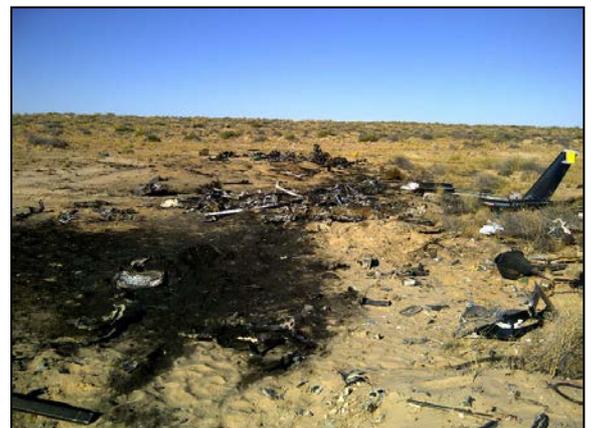
Figure 4: Helicopter wreckage

The wreckage was located on sandy, undulating terrain (Figure 4). All of the helicopter's major components and extremities were identified at the accident site.

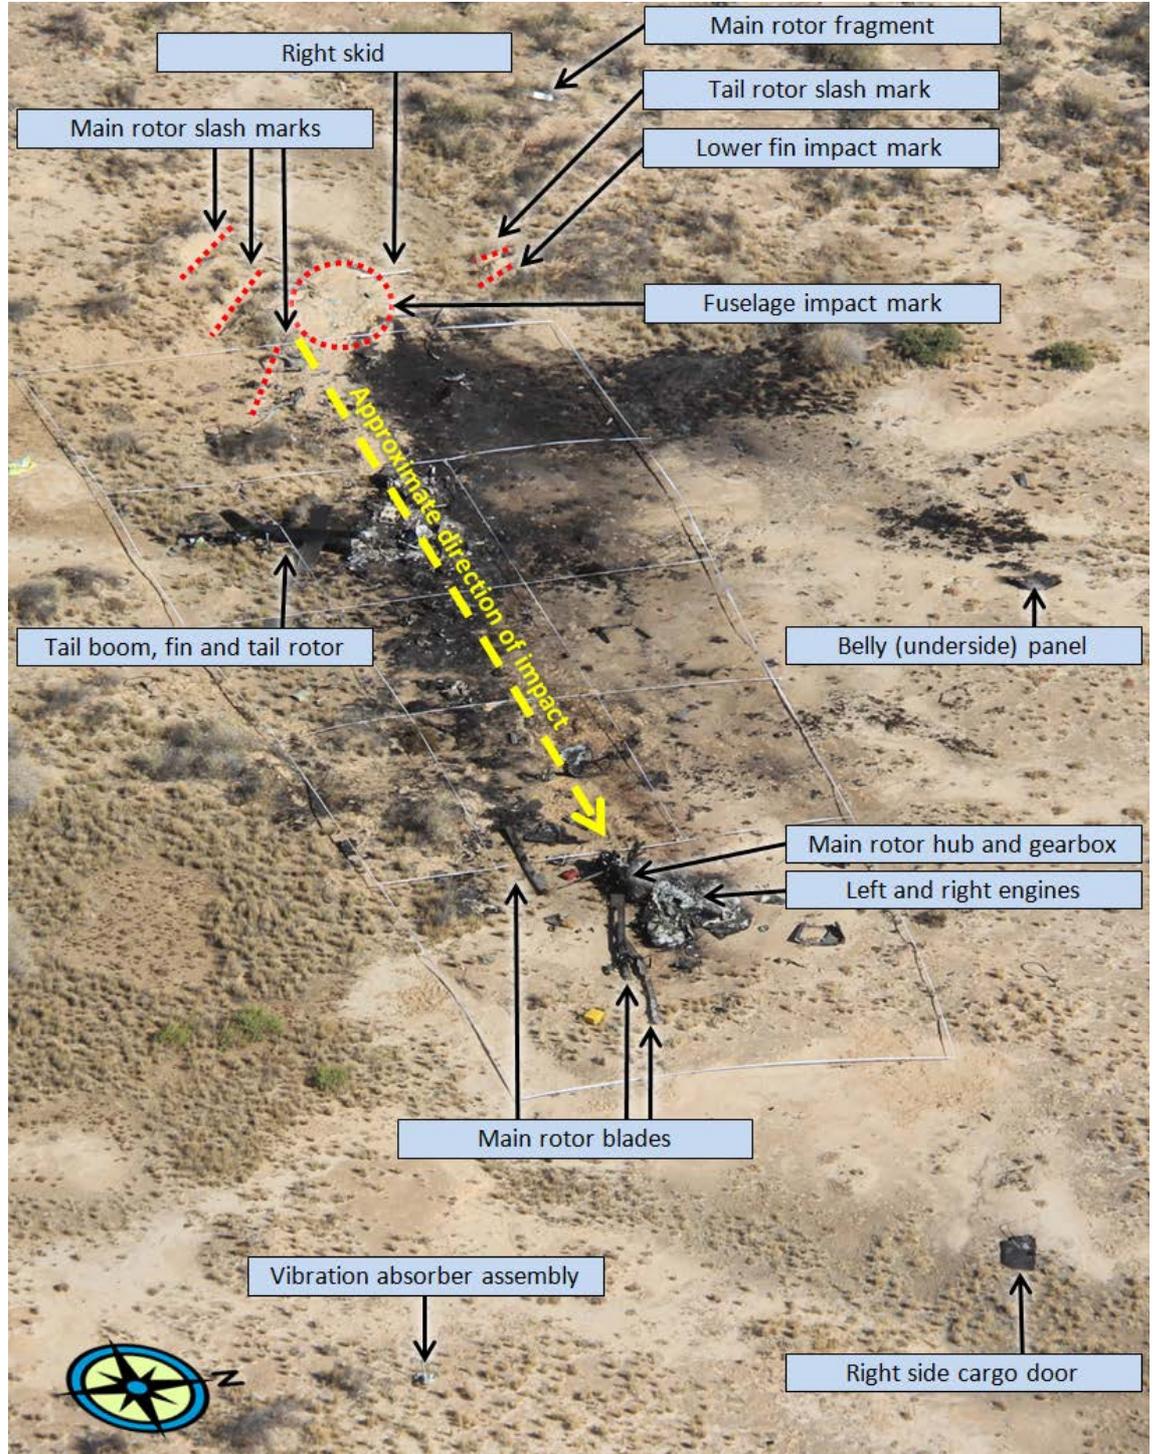
Figure 5: Wreckage trail

The wreckage trail was about 60 m long and indicated that the helicopter was travelling in an easterly direction at the time of impact (Figure 5).

Much of the wreckage was destroyed by a fuel-fed fire. There was no evidence of fire along the estimated flight path. The first evidence of fire was identified in the wreckage trail, after the initial impact marks, consistent with a post-impact fire.

Ground strike marks from the helicopter's three main rotor blades were identified at the beginning of the wreckage trail (Figure 5). The marks, and the orientation of two main rotor blade tips found embedded in these marks, indicated that the helicopter impacted the ground in about a 90°, right-side low attitude (Figure 6)

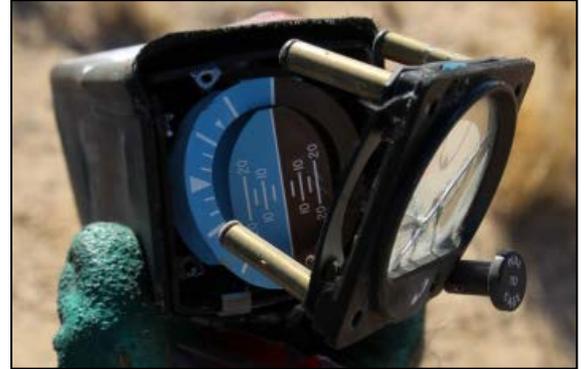
Figure 7: Standby artificial horizon

An examination of the standby artificial horizon confirmed that its internal gyro was rotating at the time of impact (Figure 7). The roll attitude indication on the instrument was captured at about 90° right-side low. The pitch attitude in the instrument had some movement, and therefore its relative position at the time of impact could not be determined.
