ACCIDENT INVESTIGATION COMMISSION

AIRCRAFT ACCIDENT INVESTIGATION PRELIMINARY REPORT AIC-11-1010

**Forced landing
P2-MCJ
Bombardier DHC- 8-103
33 km south east of Madang
13 October 2011**

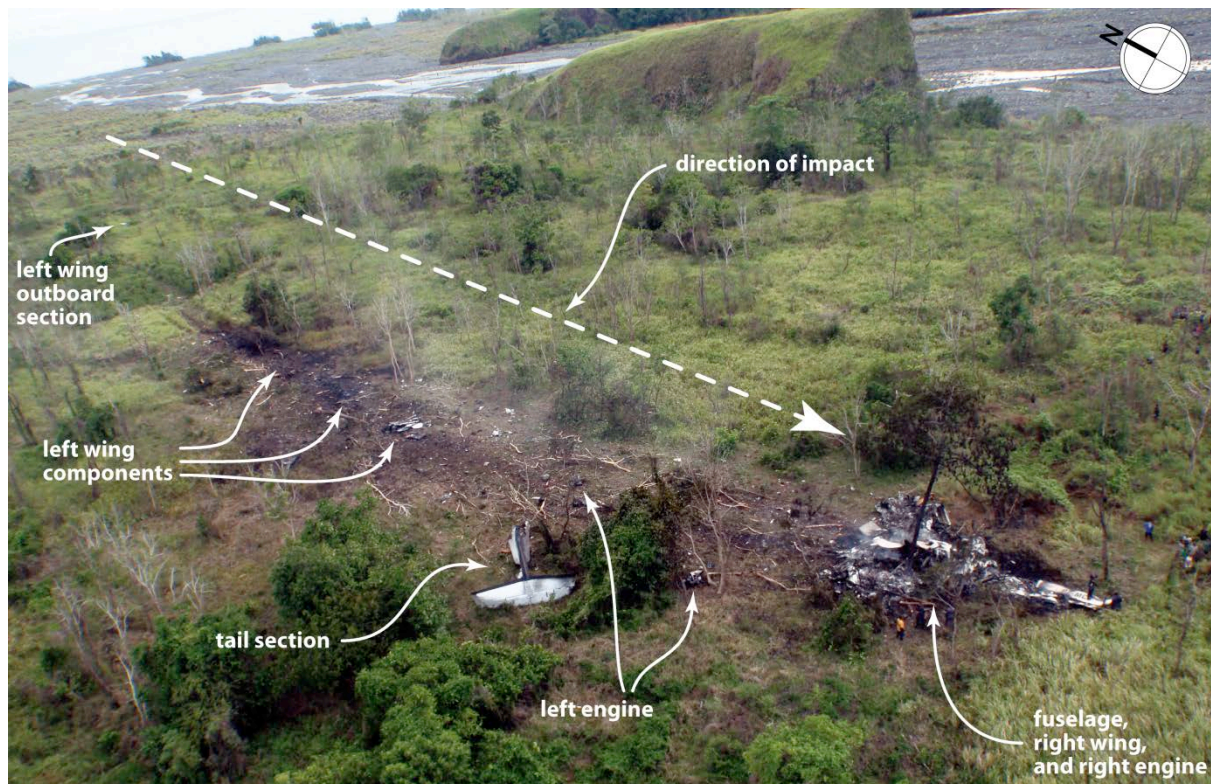
Figure 3: Aircraft wreckage overview

The outboard section of the left wing was located at the beginning of the wreckage trail, followed by numerous other elements of the left wing structure and its components. The left engine sustained a significant impact which separated it into two sections. The empennage (tail section) separated from the fuselage and was found adjacent to the main fuselage section. The remainder of the aircraft, which included the main fuselage, right wing, and right engine were situated at the end of the wreckage trail (Figure 3).

Thermal damage to aircraft parts and foliage indicated that a post-impact fuel-fed fire began when the aircraft was about halfway along the wreckage trail. When the aircraft finally came to rest, the fire intensified and totally consumed most of the aircraft.

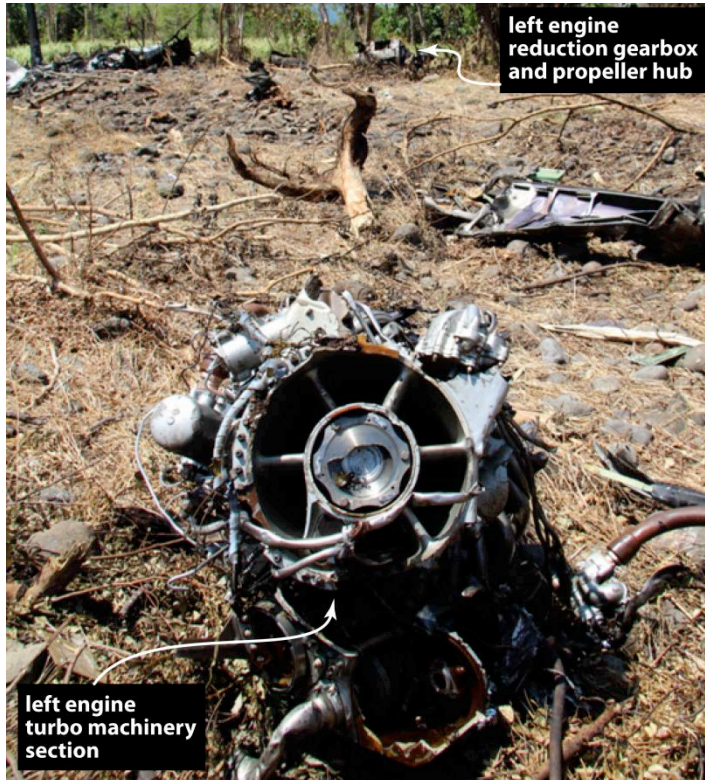
Figure 4: Left engine (after sectioning at the accident site)

externally on-site. The left engine had separated from the left wing and had broken into two sections (Figure 4). The left propeller hub was still attached to the reduction gearbox; however, three of the four propeller blades had separated from the hub during the impact sequence. The left propeller actuator was noted to be in the feathered position, indicated the propeller blade angles at the time of the accident.

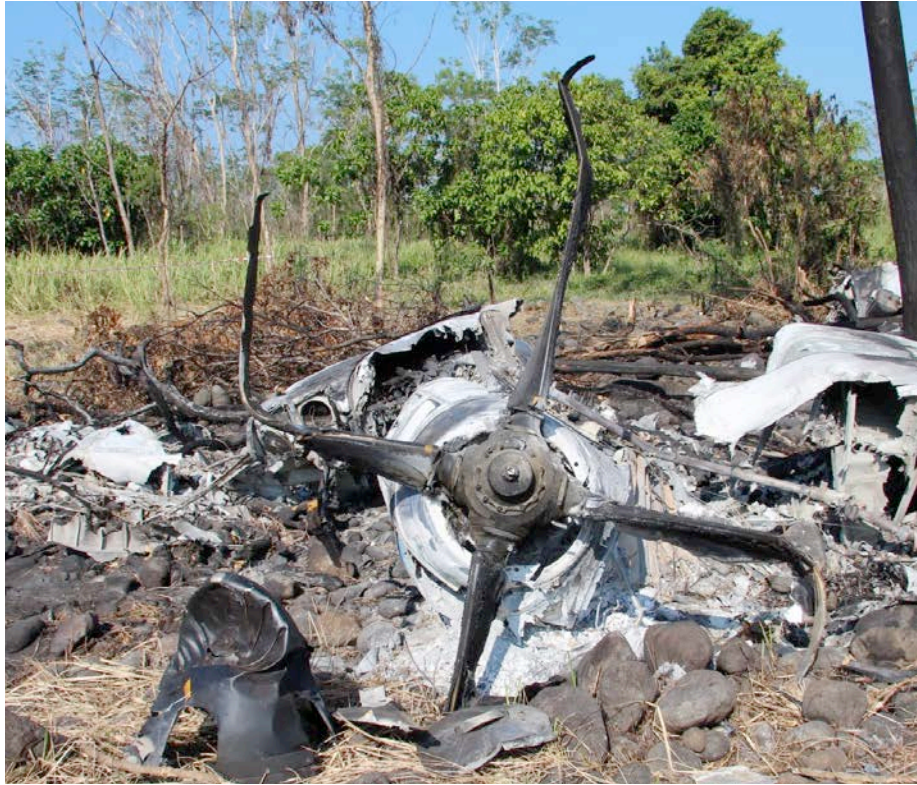
Figure 5: Right engine and propeller assembly

The right engine was still attached to the right wing. It had sustained considerable thermal damage in the post-impact fire. The reduction gearbox outer case had completely disintegrated. The right propeller blades were noted to be in the fully feathered position (Figure 5).
