Emergency landing, VH-OTZ

7 km east of Northam, Western Australia

2 April 2011

Abstract

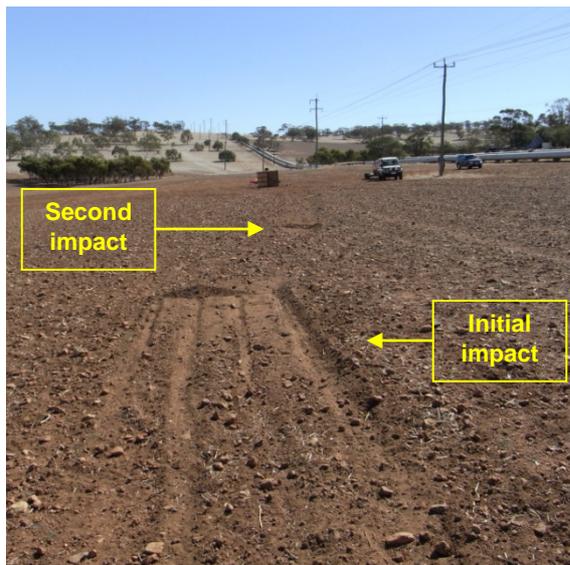
Figure 1: Accident site

The initial impact was located at the top of a rise in a bare paddock, 40 m from the projected point of intercept with the powerlines and 21 m laterally from the closest of three parallel powerlines (Figure 1). The closest powerline was about 8 m high and the adjacent powerline about 21 m high.

The ground marks indicated that the basket impacted the ground with the short side leading and while travelling in a westerly direction. The direction of travel subsequently changed by about 15°, taking the basket closer to the powerlines.

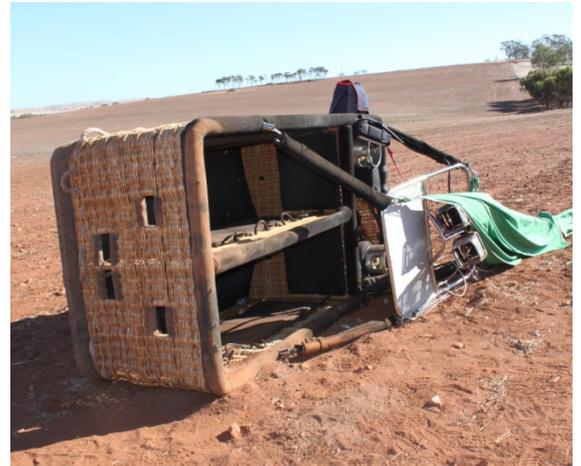
Figure 2: Basket assembly

The ground marks indicated that the basket maintained hard contact with the ground over a distance of 6 m and was then airborne for 7 m before again contacting, and then dragging along the ground for 48 m. The basket came to rest on its side (Figure 2), about 11 m from the closest powerline.

The basket sustained minor damage to the wicker cane. The burner mount frame was distorted with one upright strut detached from the basket.

One of the burners was damaged during the landing sequence. After some minor repairs, a functional test was carried out on both burners with no evidence of any defects or anomalies. There was LPG in each of the five on-board storage cylinders with a calculated total quantity of 215 L. Each burner was connected to a cylinder that was at least 60% full at impact.

The balloon envelope was holed at panel 15 (about 2/3 of envelope height) as a consequence of contacting one of the powerlines during the emergency landing sequence. All of the envelope rigging and control lines were intact.

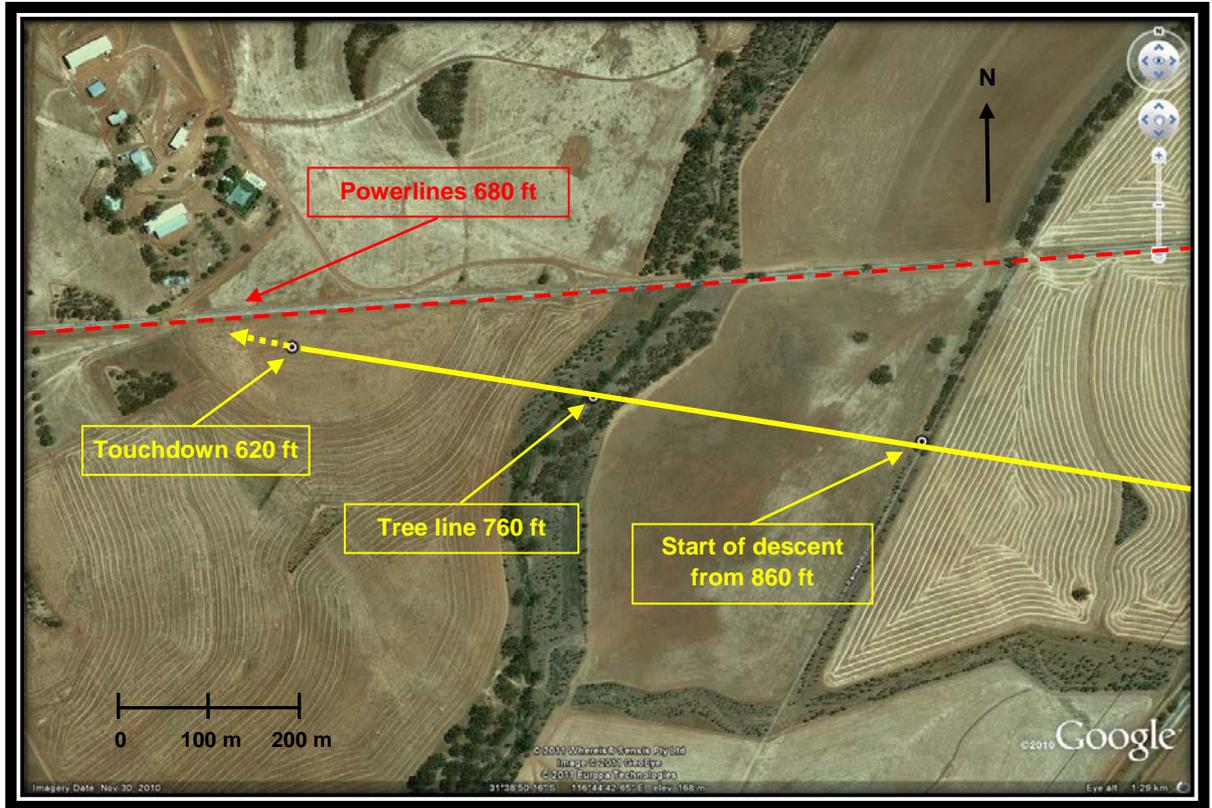
APPENDIX A: DEPICTION OF RECORDED DATA – BALLOON TRACK

From the recorded GPS elevation of the launch site of 650 ft, the balloon ascended to 750 ft. There was a period of level flight, then a series of climbs, descents and level periods. The average speed of the balloon in the early stages of the flight was 7 kts (13 km/h), which increased later in the flight to 24 kts (45 km/h). The maximum altitude reached was 1,447 ft.

At 0703:03, when the balloon was about 1,840 m from a projected intercept point with the powerlines, it levelled at 860 ft (about 180 ft above the highest powerlines) and maintained that altitude for 1.8 minutes at an average speed of 19 kts (35 km/h). The balloon's track throughout the last part of the flight was converging on the powerlines at an angle of 15°.

At 0704:52, when the balloon was about 790 m from the powerlines, it began a continuous descent at an average 162 ft/min and an average speed of 15 kts (29 km/h). During the early part of this descent, the terrain below the balloon was fairly level and up to 300 ft below the balloon.

At 0705:41, when the balloon was 370 m from the powerlines and passing over a tree line at 760 ft (about 100 ft above the highest powerlines), the terrain started to rise at an average 4% gradient.

Touchdown was at 0706:25 at an elevation of 620 ft. The GPS data was not precise enough to establish the rate of descent or speed at the point

of ground impact. A depiction of the balloon's track during the last 2 minutes of the flight is at Appendix A.
