Collision between freight train 3SP7 and road-rail vehicle near Menindee, New South Wales

13 July 2011

Abstract

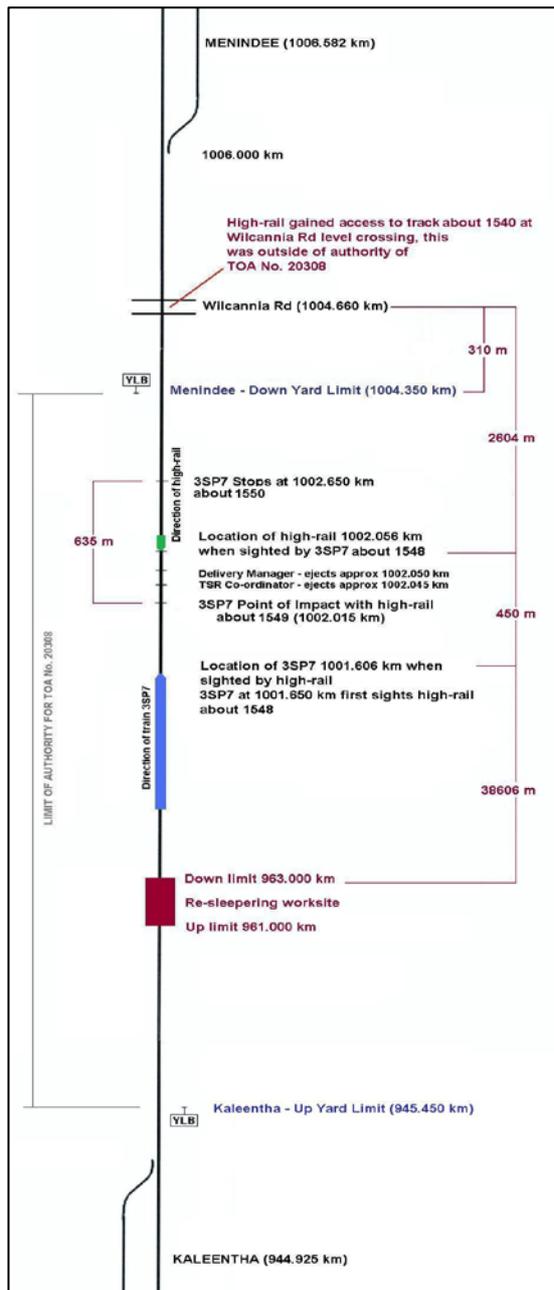
Figure 2: Incident site Kaleentha to Menindee

Yard Limit Boards⁴ within the Kaleentha to Menindee section are located at Kaleentha, 945.450 km (Figure 2 - Up Yard Limit) and Menindee 1004.350 km (Down Yard Limit) respectively.

There are several level crossings within Kaleentha to Menindee section of track including Wilcannia Road at 1004.660 km (Figure 2).

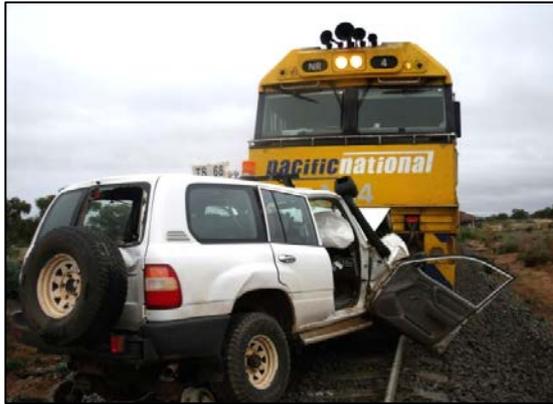
Figure 3: Road-rail vehicle at front of NR4

At about 1545¹, on Wednesday 13 July 2011, freight train 3SP7 collided with a road-rail² vehicle in the Kaleentha to Menindee section of track, located in western New South Wales (NSW). The road-rail vehicle, a Toyota Landcruiser station wagon, was extensively damaged. The lead locomotive of train 3SP7, NR4 incurred only minor damage and after effecting repairs at the incident site the train continued through to Port Augusta en route to Perth. There were no injuries and no damage to fixed infrastructure.

After hearing the impact, the train driver and co-driver returned to the locomotive cab and saw that the train was pushing the road-rail vehicle ahead of the train before finally coming to a stand (Figure 3) at the 1002.650 km mark, having travelled about 635 m from the initial point of impact.
