Collision with terrain, 24-7634

Old Bar Airstrip, New South Wales

1 October 2011

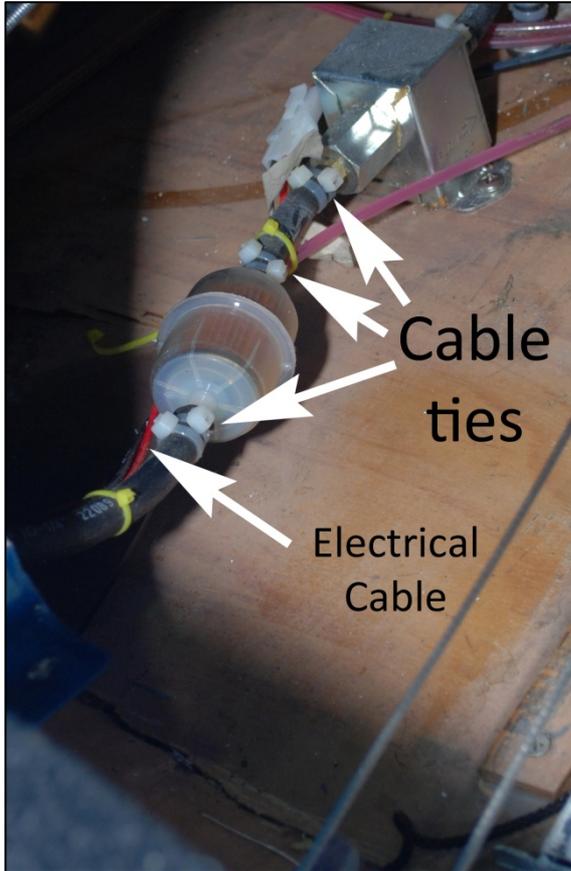
Figure 1: Use of cable ties to connect fuel lines

- The use of electrical cable ties to secure fuel lines and connectors within the aircraft (Figure 1). A post-impact fuel leak was identified that resulted from the disconnection of a fuel line at the main tank drain. Electrical cable was routed alongside and connected to a number of fuel lines.

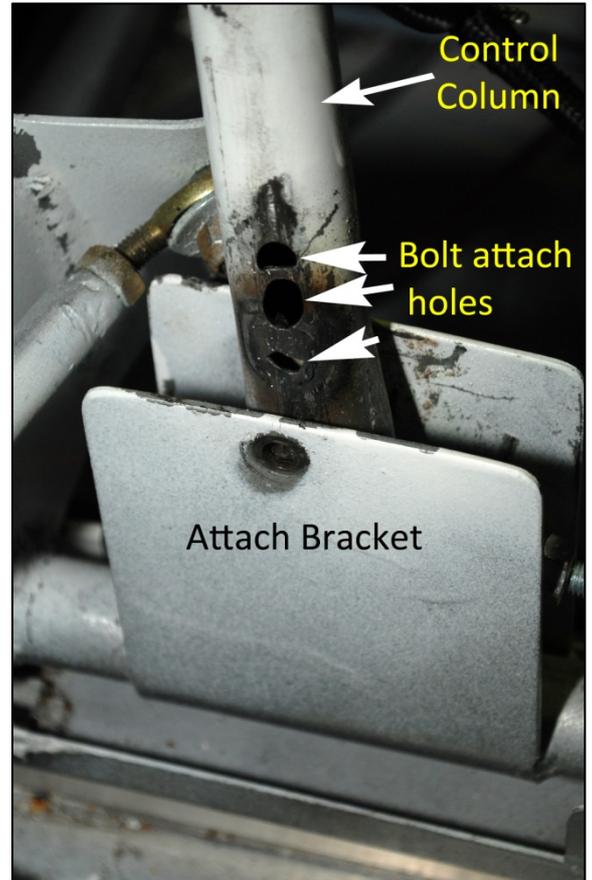
Figure 2: Control column attachment

- The single flight control column showed numerous holes and repairs at the single attachment point to the flight control attachment bracket (Figure 2). There was no evidence of a bushing around the attaching bolt.

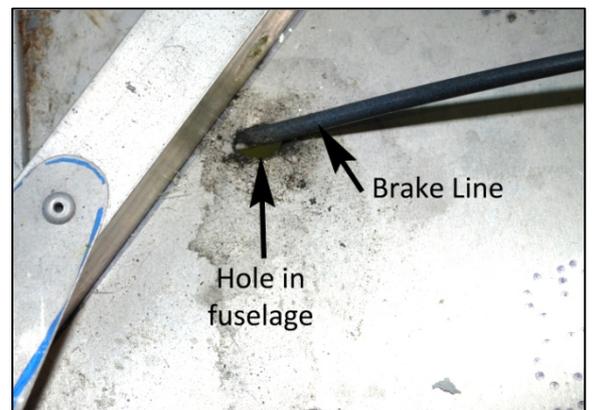
Figure 3: Hydraulic brake line routing through fuselage

- A number of hydraulic brake lines were routed through holes that were drilled in the bottom of the fuselage, with no evidence of grommets being employed to prevent chafing (Figure 3).

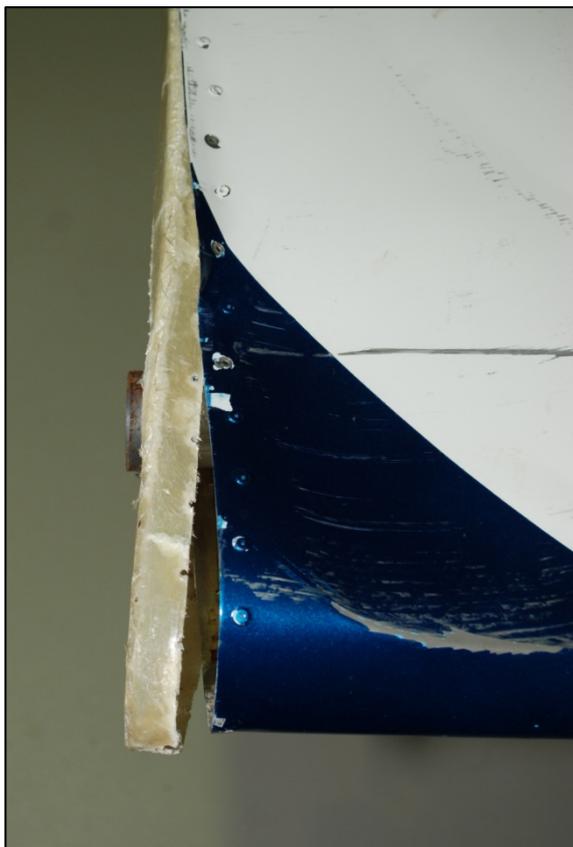
Figure 4: Tailplane rib construction

- A number of tailplane ribs were not aligned with rivet lines (Figure 4).

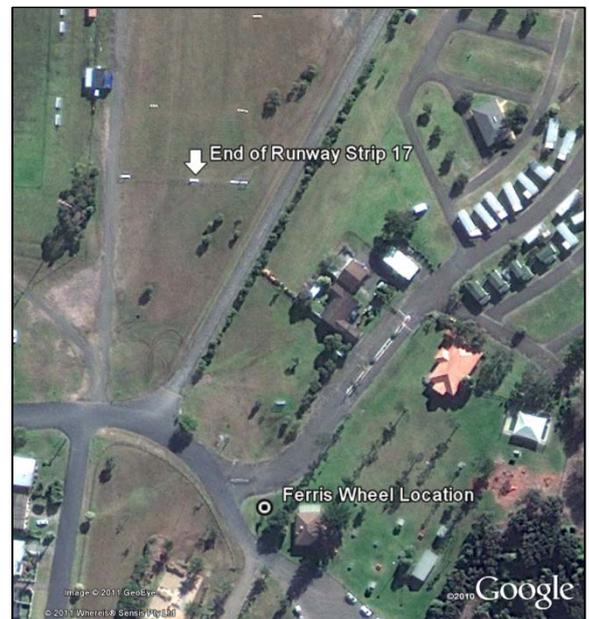
Figure 5: Location of the ferris wheel relative to the airstrip

The centre of the ferris wheel was located 34 m to the east of the runway centreline, 161 m from the end of the runway strip (Figure 5).

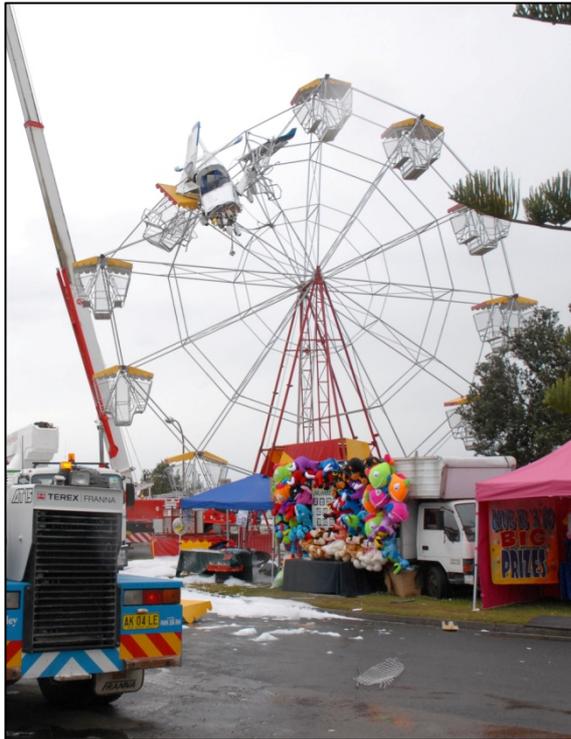
Figure 6: Aircraft wreckage and ferris wheel following the collision - looking toward aircraft's direction of travel

The ferris wheel remained upright following the collision. The aircraft impacted the upper right side of the wheel as viewed from the direction of flight (Figure 6). At the time of impact, the occupants in the ferris wheel were located in two carriages, one below and one to the left of the aircraft impact.

The impact moved the base of the ferris wheel about 75 cm. The operator of the wheel reported that nearly all of the wheel's structure was damaged or bent by the collision.
