Collision with terrain, VH-THI

170 km east of Katherine, Northern Territory

4 October 2010

Abstract

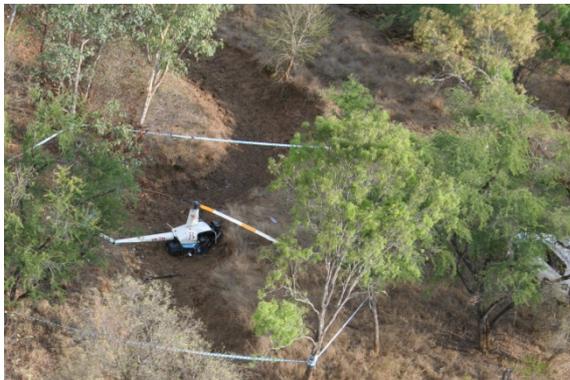
Figure 1: Aerial view of the accident site

Several minutes later, the station owner and first pilot sighted the wreckage of THI in a dry creek bed that was surrounded by trees (Figure 1). They landed in a nearby clearing and proceeded on foot to the accident site where they found that the pilot had sustained fatal injuries.

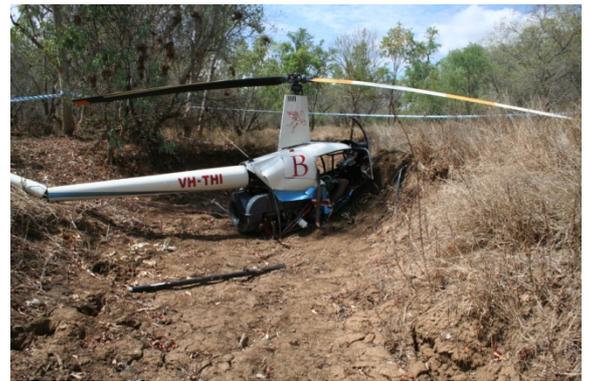
Figure 2: Helicopter main wreckage

The wreckage of the helicopter was located on a dry creek bed that was surrounded by numerous trees about 10 m in height (Figure 2). There was evidence of slight main and tailrotor contact with the surrounding trees during the final stages of the descent. The helicopter's angle of descent was estimated to be about 45°.

The helicopter collided heavily with the creek bank in an upright attitude with a high rate of descent that collapsed the skid-landing gear. There was evidence that, at the time of the collision with the terrain, the helicopter had low forward speed. That speed could not be quantified.

The 60° upwards slope of the creek bank brought the helicopter to an abrupt stop. The impact forces deformed the cabin and cabin floor, severely compromising the survival space.

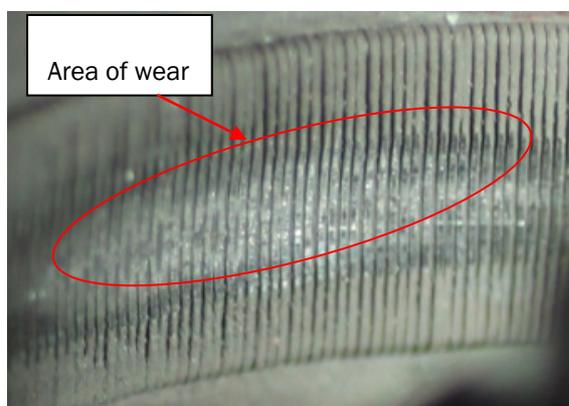
Figure 3: Main fuel tank sender unit wire-wound resistor

On examination, the sender unit exhibited intermittent resistance between a position that corresponded to about three quarters full, down to the empty position. The unit was dismantled and examined in an effort to understand that intermittent resistance.

Wear of the unit's wire-wound variable resistor⁹ was identified (Figure 3). The location of that wear was consistent with the helicopter having regularly operated with fuel quantities of less than half full tank capacity. That would have given intermittently erroneous fuel quantity indications and was consistent with a tendency for the gauge to over read, particularly between half and the lower end of the fuel gauge scale.
