**ATSB TRANSPORT SAFETY REPORT**  
Aviation Occurrence Investigation  
AO-2009-012  
Final

**Tailstrike and runway overrun  
Melbourne Airport, Victoria  
20 March 2009  
A6-ERG  
Airbus A340-541**

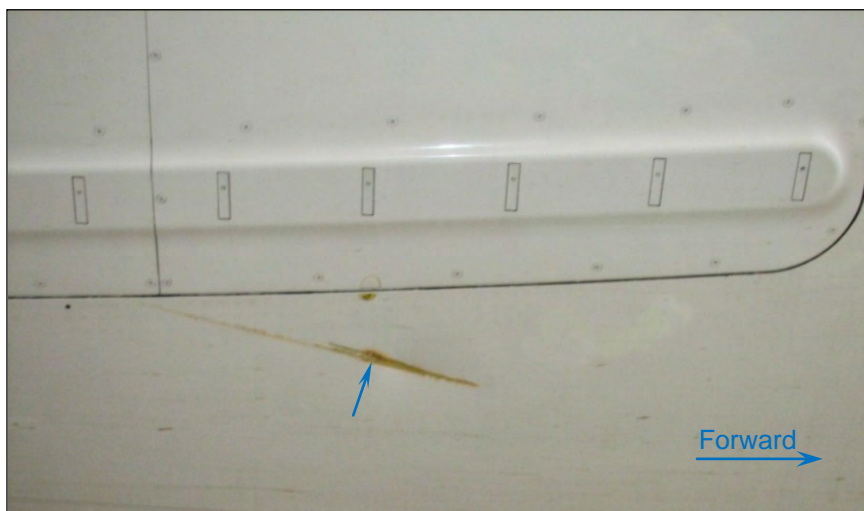
The right side rear fuselage contained several contact marks. One contact mark, forward of the abraded area and immediately below the rear cargo door (Figure 4), was orange in colour consistent with the orange paint on the localiser near-field monitor antenna. Another contact mark was located adjacent to the skin abrasion and consisted of several fine, divergent marks running rearwards and slightly upwards (Figure 5).

**Figure 4: Contact mark below rear cargo door**

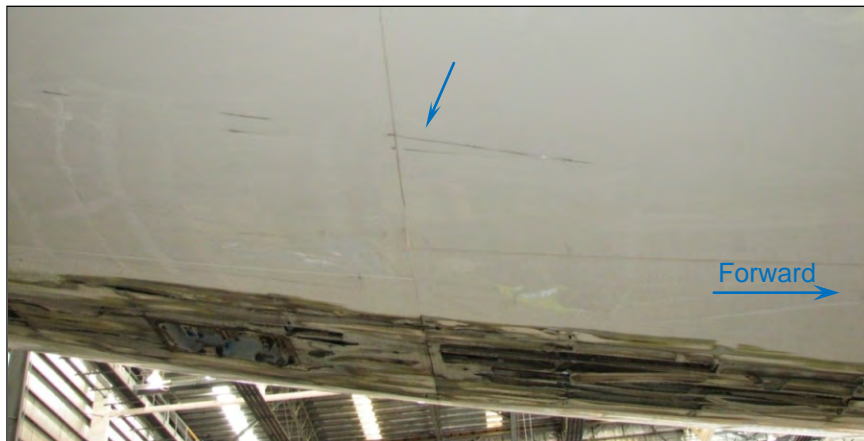
**Figure 5: Contact marks adjacent to the skin abrasion**

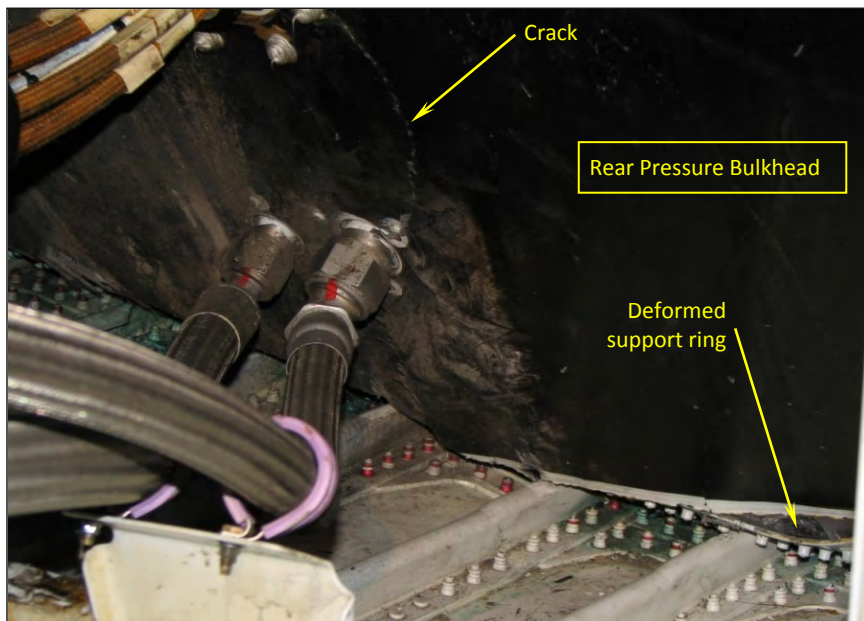
Numerous fuselage frames and stringers in the rear fuselage area were damaged by the abrasion and contact forces during the tailstrike. The damaged frames were deformed and several were cracked. The composite rear pressure bulkhead<sup>12</sup> had cracked, and the bulkhead diaphragm support ring was deformed (Figure 6).

**Figure 6: Example of rear pressure bulkhead damage**

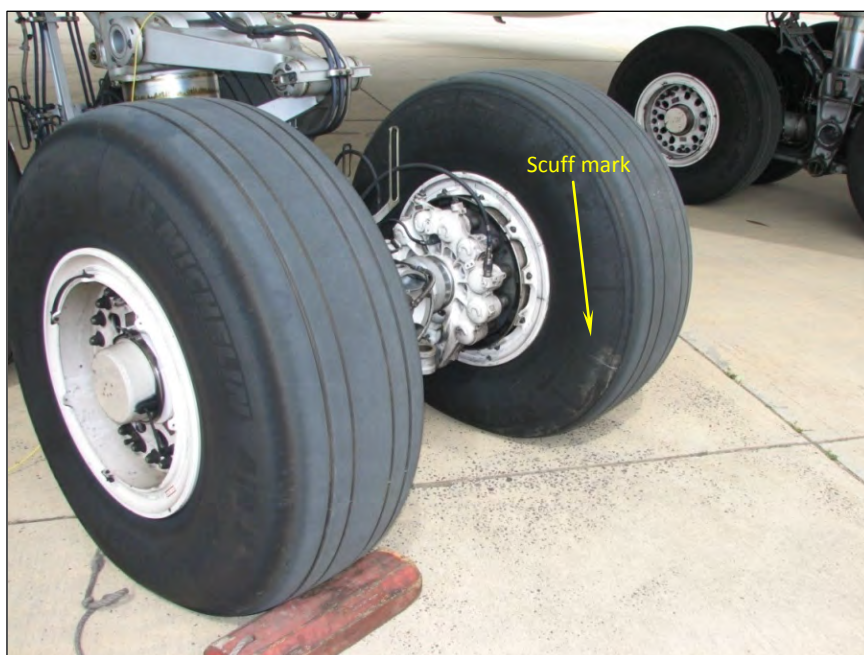
The inboard rear tyre on the left main landing gear had a scuff mark on its sidewall (Figure 7). The mark contained transferred material that was the same orange colour as the localiser antenna system.

**Figure 7: Contact mark on the left main landing gear, inboard rear tyre**

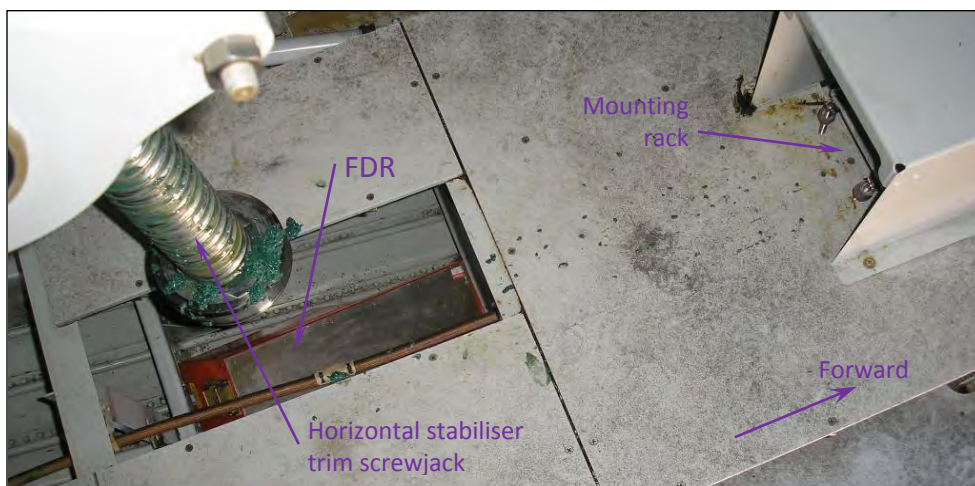
The flight data recorder (FDR) was dislodged from its mounting rack immediately behind the rear pressure bulkhead and was found lying on the lower fuselage skin below and slightly to the rear of the mounting rack (Figure 8). The FDR was undamaged and contained recorded data from the commencement of the take-off roll until the dislodgement at 2232:05. The results of an examination of the FDR rack are at Appendix A.

**Figure 8: Location of the dislodged FDR and its mounting rack**

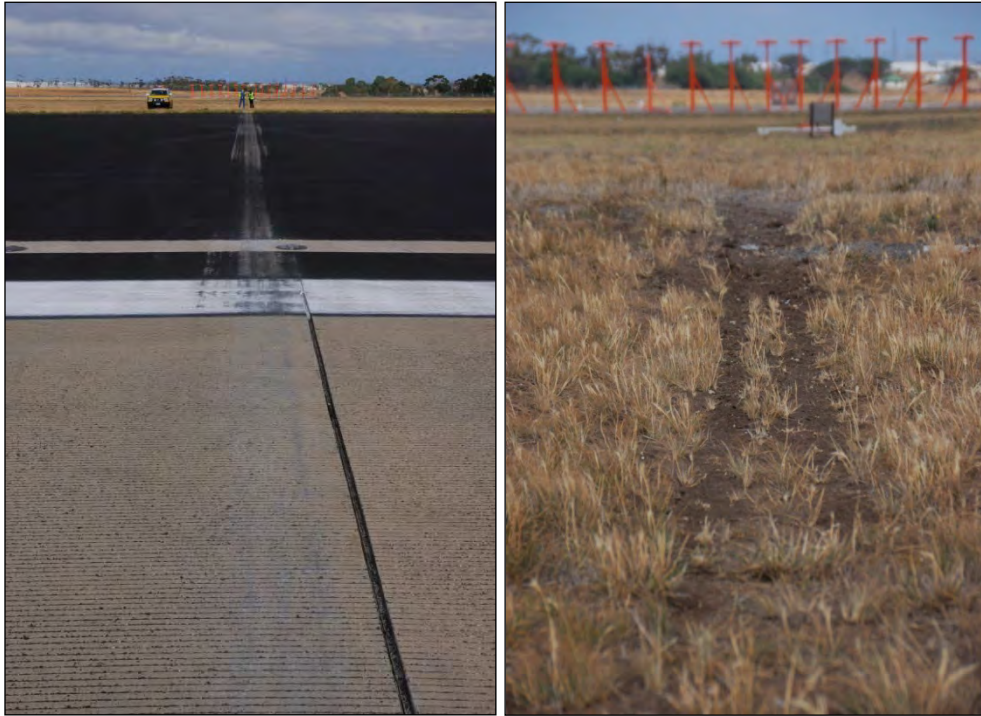
An inspection of the runway, stopway, clearway, and overrun areas identified multiple contact marks, consistent with the tailstrike and overrun (Figure 9). The aircraft's tail contacted the runway at three locations, starting at 265 m, 173 m, and 110 m from the end of the runway, respectively (indicated by ①, ②, and ③ in

**Figure 10: Typical contact marks on runway, stopway and grassed areas**

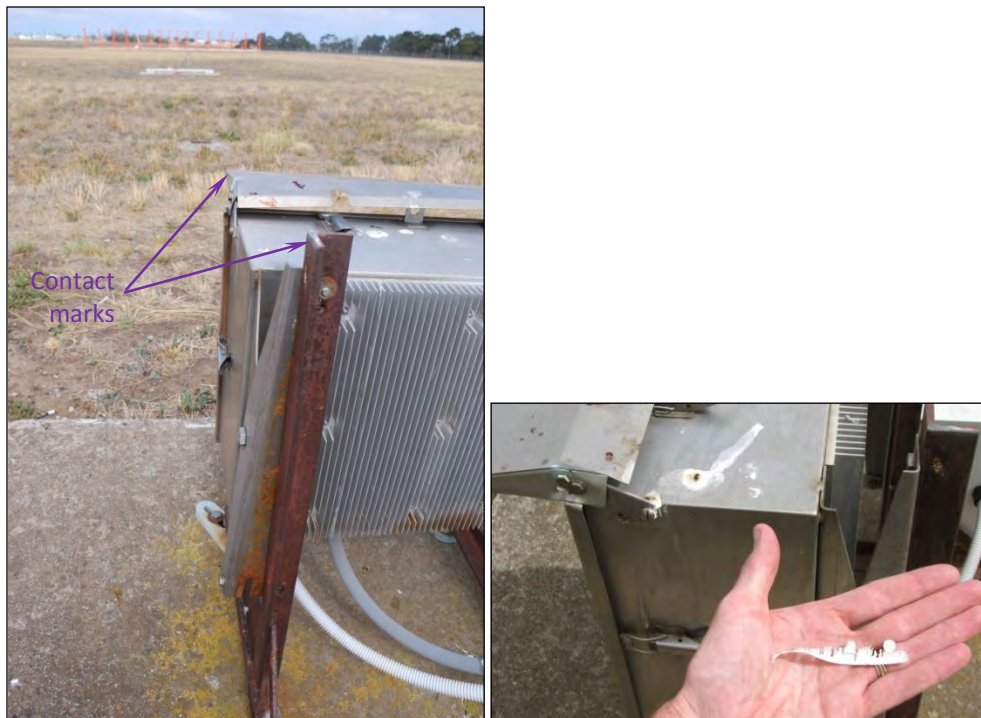
**Figure 11: Lead-in strobe light**

To the south of the last ground contact mark, the fuselage contacted the runway 34 lead-in strobe light that was closest to the runway 16 end (Figure 11). That contact was slight and resulted in scrape marks on the support post and slight deformation of the lens shield. A small strip of white paint was located adjacent to the strobe light (Figure 11).

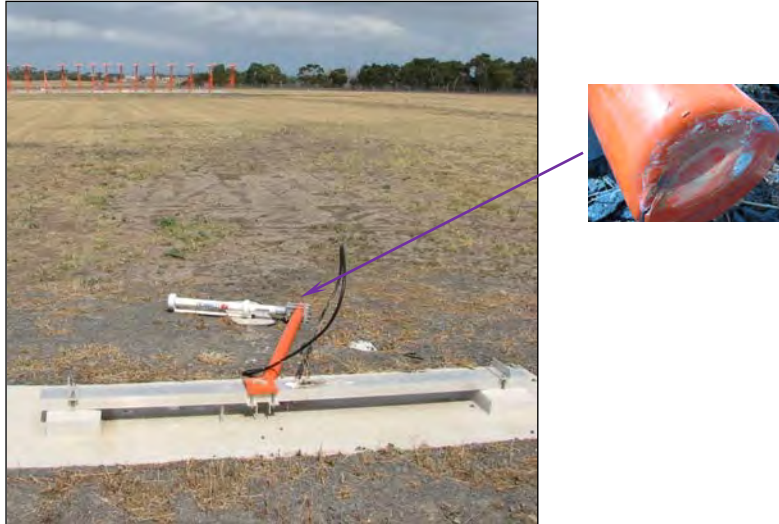
**Figure 12: Localiser near-field monitor antenna**

The aircraft struck the runway 16 localiser near-field monitor antenna and the main localiser antenna array. The localiser near-field monitor antenna support post was fractured at the base and fell in the approximate direction of takeoff (Figure 12). The antenna was damaged and the top of the support post was indented and exhibited white paint transfer.

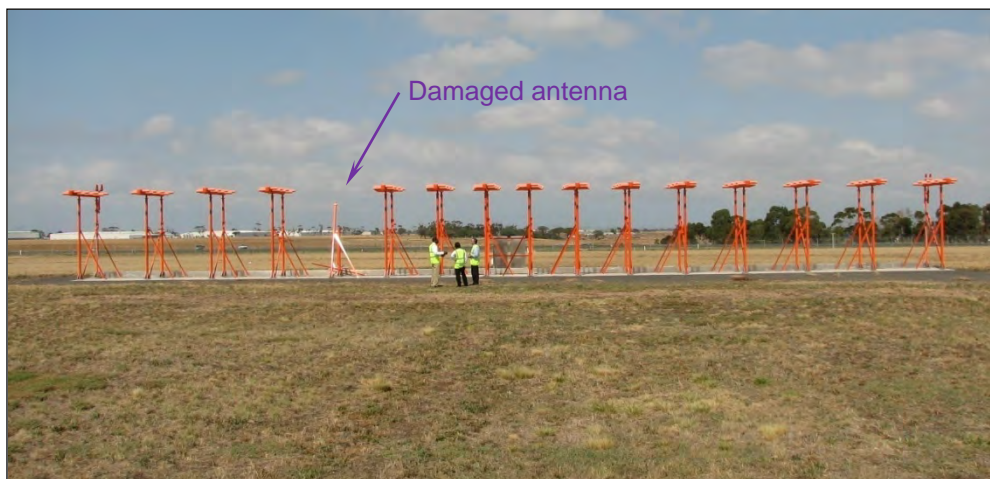
**Figure 13: Localiser antenna array**

Damage to the localiser antenna array was limited to one of the 16 antennae (Figure 13). The forward (runway) end of the damaged antenna was deformed and the composite cover was severely disrupted. The top of the forward end of the antenna had a black, rubber-like marking and the deformation of the antenna was consistent with an impact (Figure 14).

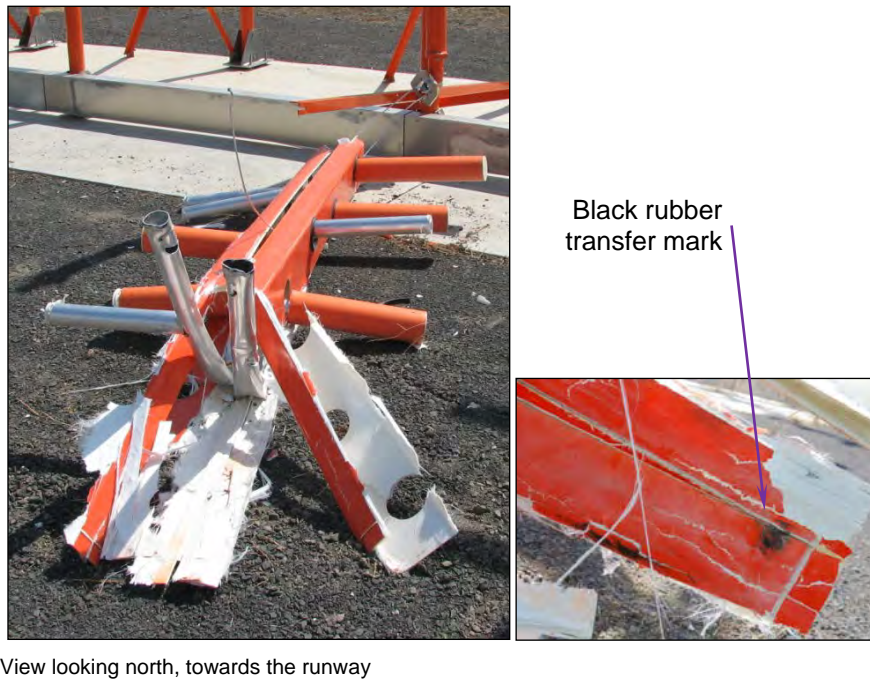
**Figure 14: Damaged localiser antennae**
