Breakdown of separation 22 km S Williamstown (Newcastle Airport), NSW 1 February 2011

Abstract

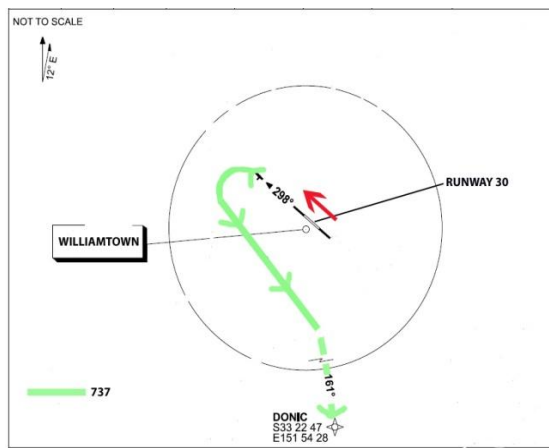
Figure 1: 737 flight-planned track

The 737 was flight planned to track from Williamstown to intercept its outbound route via DONIC, an instrument flight rules (IFR) reporting point positioned at 35 NM (64.8 km) on the

Williamstown 161 radial (Figure 1). At about 1300, the aircraft taxied for departure from runway 30, which was the duty runway.

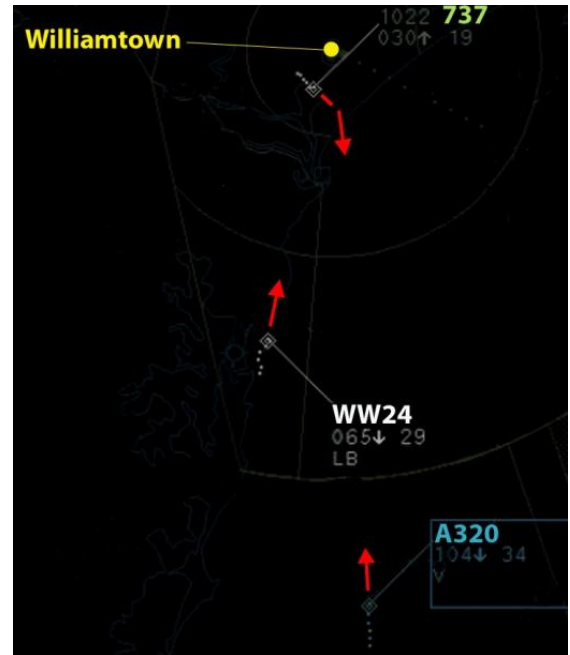
Figure 2: Proximity of aircraft at 1303:56

At 1303:56, after a frequency transfer by the ADC, the 737 flight crew called APP (H) on climb to 5,000 ft. The aircraft was about 1.8 NM (3.3 km) south of Williamtown in a left turn to intercept the 161 radial, and passing 3,100 ft with a groundspeed of 190 kts. After dealing with military jet formation traffic, the APP (H) controller acknowledged the call, radar identified the aircraft, and issued the crew with an instruction to turn right onto a heading of 200° to enable separation with inbound traffic. The controller also advised the crew to expect further climb shortly. At that time, the inbound WW24 was about 10.7 NM (19.8 km) south of Williamtown, passing 6,400 ft on descent, with a groundspeed of 290 kts (Figure 2).

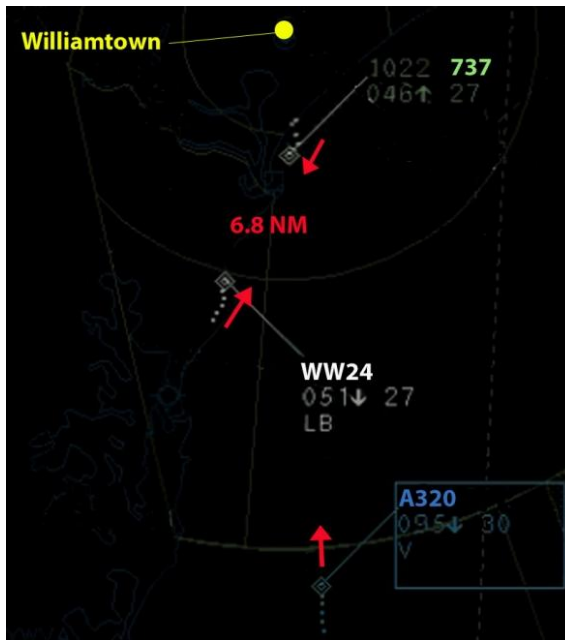
Figure 3: Proximity of aircraft at 1305:01

At the time the training officer made the instruction, the WW24 was descending from 5,100 ft to level off at 5,000 ft, in the 737's 12 o'clock position, at 6.8 NM (12.6 km), with a groundspeed of 270 kts (Figure 3). The 737 was passing through 4,600 ft on climb at the same speed. The A320 was about 27 NM (50 km) to the south of Williamtown, inbound on the 161 radial and passing 9,500 ft on descent. The A320's level assignment of 6,000 ft provided separation assurance with both the 737 and WW24 (both assigned 5,000 ft).

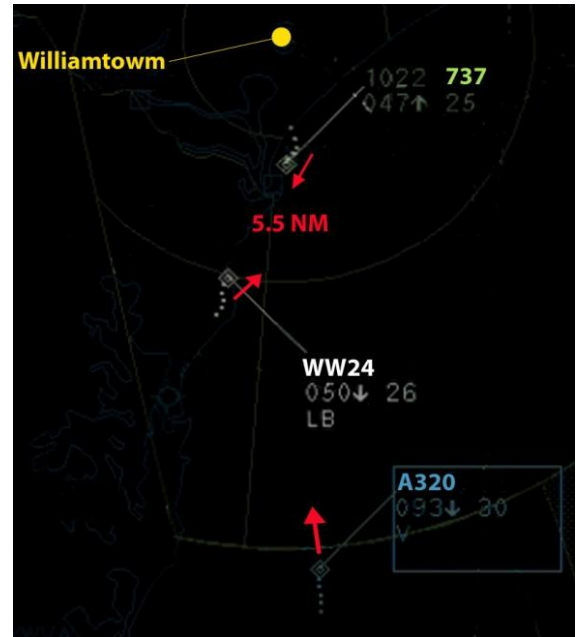
Figure 4: Proximity of aircraft at 1305:10

At this time, the WW24 was about to maintain 5,000 ft at 12 NM (22.2 km) from Williamtown, with a groundspeed of 260 kts, and the 737 was about 6.5 NM (12.0 km) from Williamtown,

passing 4,700 ft on climb with a groundspeed of 250 kts. There was 5.5 NM (10.2 km) between the aircraft (Figure 4).

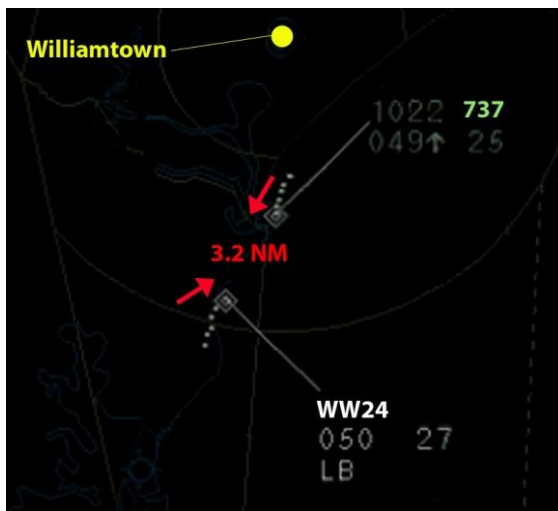
Figure 5: Proximity of aircraft at 1305:24

At 1305:24, there was 3.2 NM (5.9 km) between the aircraft, with the 737 at 5,000 ft with a groundspeed of 250 kts, and the WW24 maintaining 5,000 ft, with a groundspeed of 270 kts (Figure 5). The 3 NM (5.6 km) radar separation standard between the 737 and WW24 was infringed 1 second later, resulting in a breakdown of separation.⁵

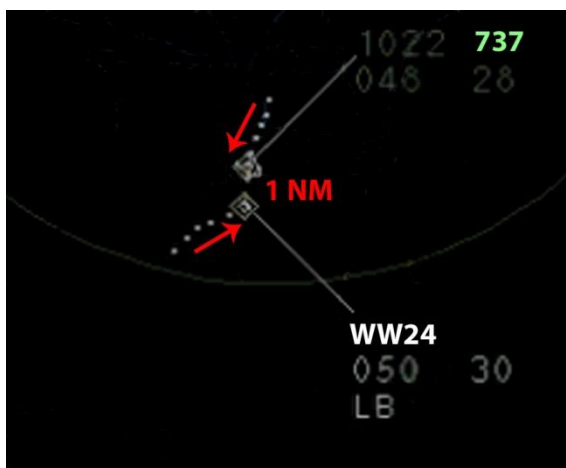
Figure 6: Proximity of aircraft at 1305:34

At 1305:34, there was 1 NM (1.9 km) between the aircraft, with the 737 maintaining 4,800 ft (within the 200 ft radar tolerance for an aircraft maintaining 5,000 ft), at a groundspeed of 280 kts, and the WW24 in the 737's 12 o'clock position, tracking right to left at 5,000 ft, with a groundspeed of 300 kts (Figure 6).

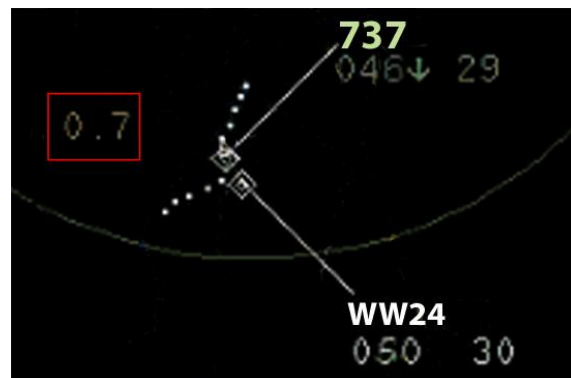
Figure 7: Proximity of aircraft at 1305:44

At 1305:44, the APP (L) controller issued the WW24 flight crew with a safety alert, advising that a 737 was passing behind their aircraft. The transmission did not include the level or direction of travel of the 737. At that time, the aircraft reached their closest point of radar separation of 0.7 NM (1.3 km) (Figure 7).

At the point of closest radar separation, there was 400 ft vertical separation between the two aircraft. The vertical separation was due to the 737 flight crew responding to a resolution advisory (RA)⁶ collision avoidance manoeuvre prescribed by their aircraft's traffic alert and collision avoidance system (TCAS).

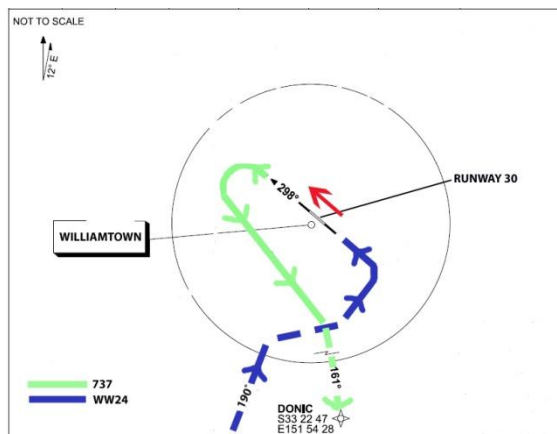
Figure 8: Approach Low separation plan

The APP (L) controller had determined a plan to maintain radar separation between the 737 and WW24, with the aircraft remaining under different control jurisdictions. The APP (L) controller had delayed tracking the WW24 for left base so the aircraft was tracking direct to the airport, with the intention that that would have provided segregation between the aircrafts' tracks (Figure 8). However, that plan was not communicated to the APP (H) controller, who believed that the two aircraft would have been in conflict. The initial response by the APP (H) to resolve the perceived problem by vectoring the 737 exacerbated the situation.
