Collision between freight train 7SP3 and a track mounted excavator near Jaurdi, Western Australia

28 March 2011

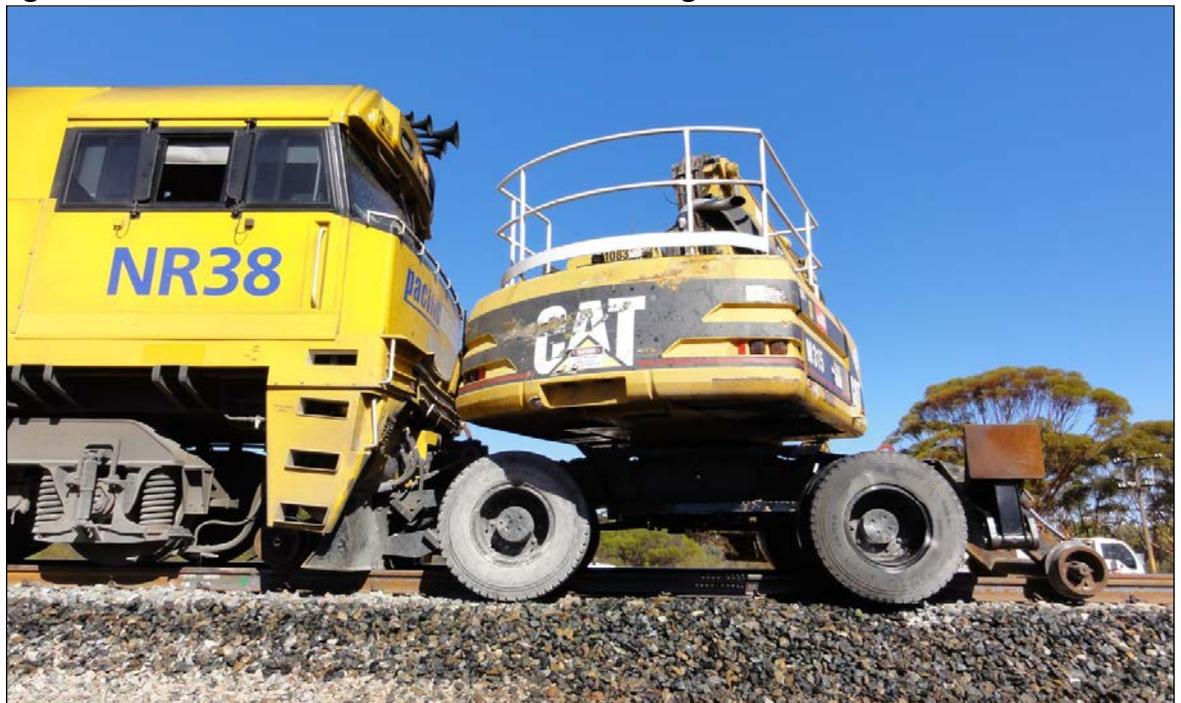
Figure 1: Train 7SP3 and track mounted excavator following the collision

The train driver sustained a minor injury. There was significant damage to the lead locomotive and the excavator, and minor damage to the track as a result of the accident.

Train 7SP3 was travelling at 67 km/h when it collided with the excavator. The front of the locomotive rode up onto, and became wedged on, the trailing components of the excavator. The now interlocked excavator and locomotive continued along the track finally coming to a stop 290 m and 34 seconds after the point of impact.

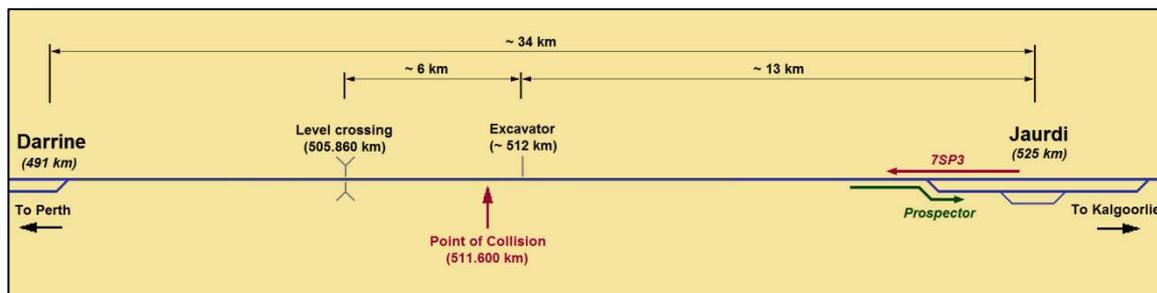
Figure 3: Accident site between Darrine and Jaurdi

However at about 1245 when 7SP3 was at Jaurdi and about to enter the section, the Supervisor (Excavators) instructed the drivers of the excavators to wait about 5-10 minutes after the *Prospector* had passed the level crossing where they were waiting, then get back on track and travel to their work sites (Figure 3).
