# Incorrect aircraft configuration, VH-VWW Singapore Changi International Airport 27 May 2010

## Abstract

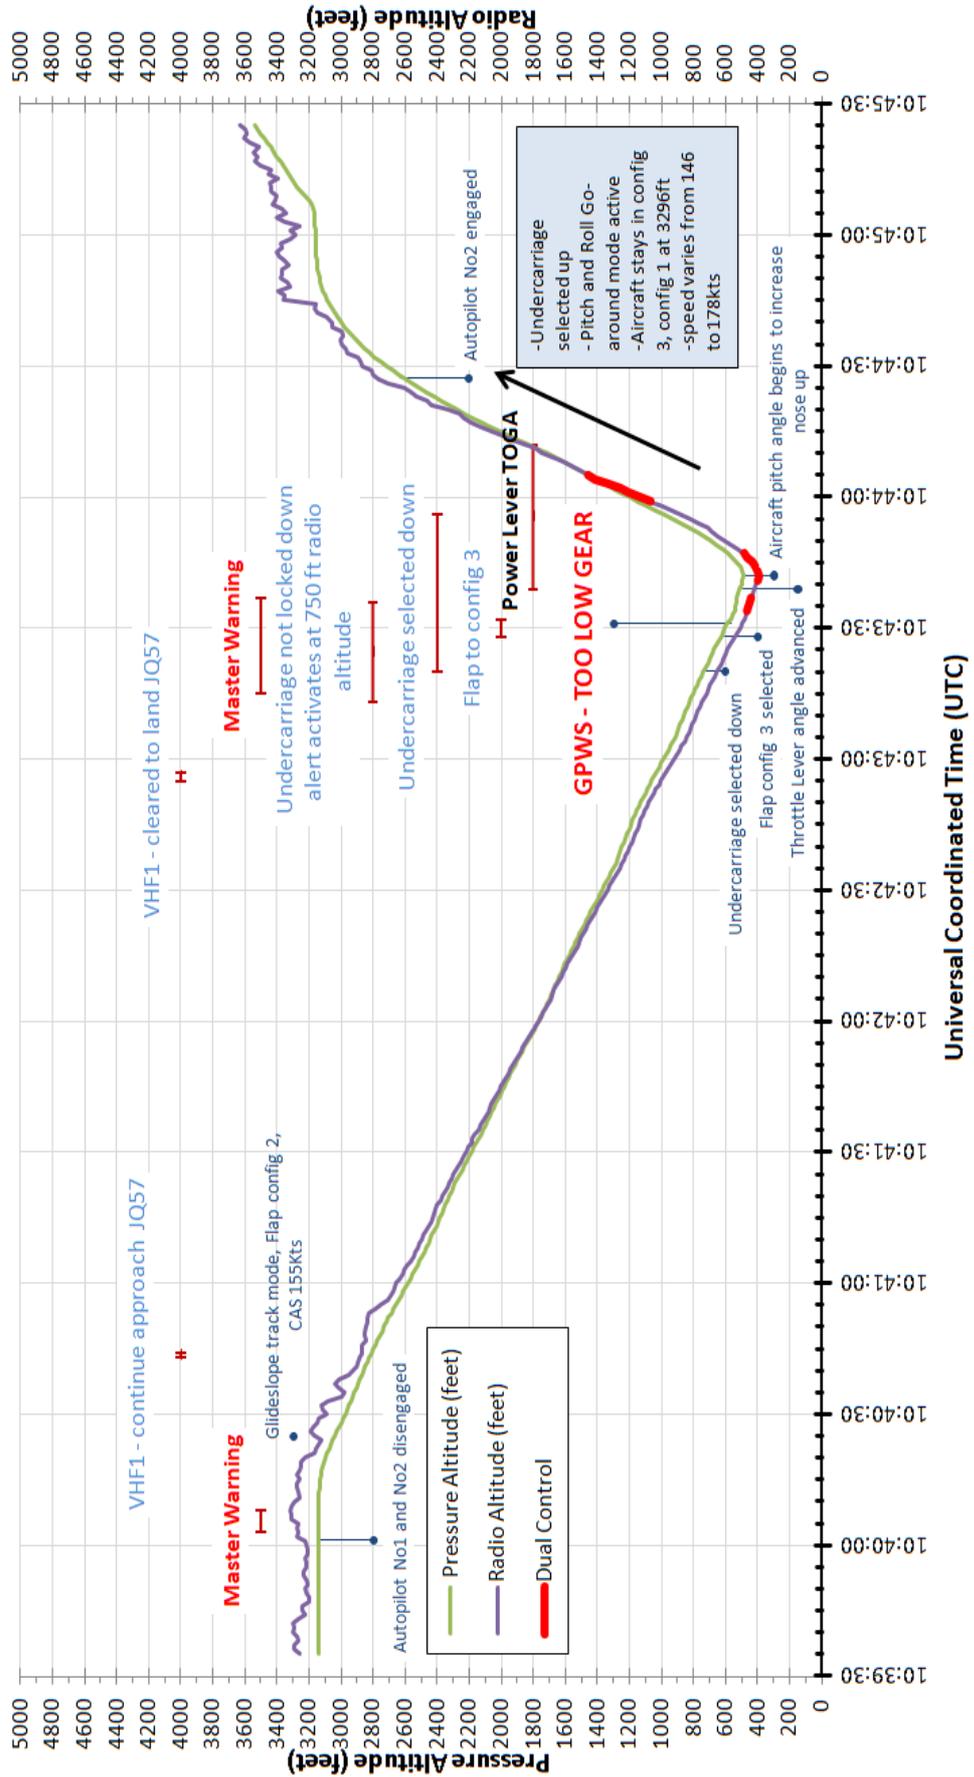
# APPENDIX A: MISSED APPROACH SEQUENCE OF EVENTS

At 1,000 ft, the FO called for 'gear up', which was set by the captain. The FO engaged the autopilot at about 2,600 ft and, after a series of left turns, the aircraft was established on a second ILS approach for RWY 20R. A plot of the recorded data is at Appendix A.
