Cargo hold fire on board *BBC Baltic* at Port Hedland, Western Australia

26 January 2012

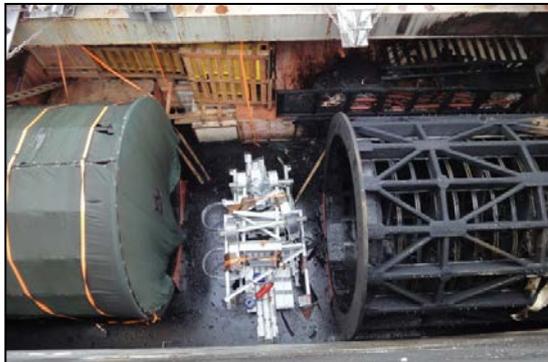
Figure 2: Screen drums in the lower hold

By 1605, the boilermaker in the lower hold had cut off one of the lugs securing a large drum shaped structure located on the starboard side (Figure 2). There were two such screen drums in the after part of the hold, both covered with a tarpaulin. As the boilermaker moved to start cutting the other lug, he noticed a glow and realised that the tarpaulin cover was on fire. He yelled 'fire, fire!' and asked for water while attempting to stamp the fire out with his feet. The boilermaker on the tween deck, who had just started gas-cutting, heard the yells of 'fire' from below and immediately exited the cargo hold. The assistant on the main deck also heard the yells and he stood by there to help. None of the ship's crew was in the hold and no attempt was made to use a fire extinguisher or the other fire-fighting equipment that had been prepared.

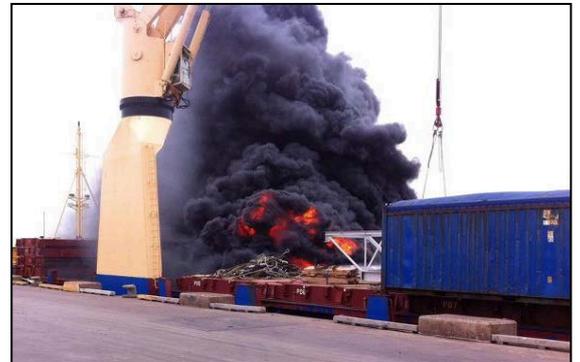
Figure 3: Fire ball seen from the berth

Shortly after 1608, the fire burnt through the oxy-acetylene hoses left on the tween deck and the acetylene ignited resulting in a fire ball and dense black smoke (Figure 3). The master ordered the crew to spray water on the cargo adjacent to the fire and to check that the oxygen and acetylene cylinders had been turned off. By this time, the Cervan Marine workers had left the ship.
