Collision with terrain

Jaspers Brush Aerodrome, New South Wales

4 February 2012

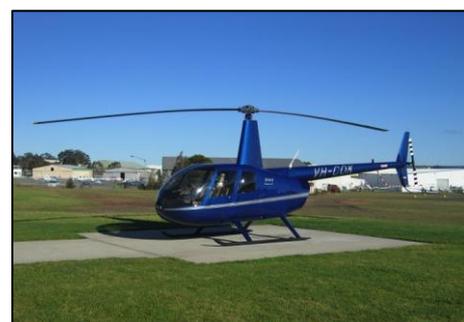
Figure 1: VH-COK

On 4 February 2012, a Robinson Helicopter Company R44 Raven II helicopter, registered VH-COK, was flown to Jaspers Brush Aerodrome, New South Wales (NSW) in preparation for an aerial filming flight (Figure 1). The right rear door and some non-essential equipment were removed from the helicopter in preparation for the filming task. The pilot and camera operator then conducted a short flight at Jaspers Brush to prepare for the filming later that day.

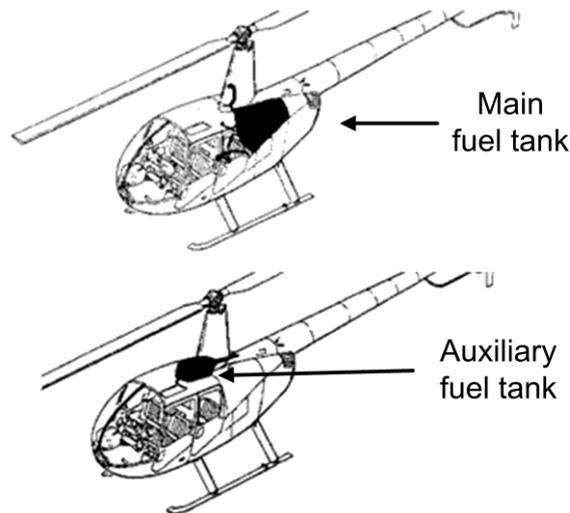
Figure 2: Fuel tanks

The R44 was originally manufactured with two all-aluminium fuel tanks that were installed above the engine firewall, either side of the main transmission (Figure 2). That was the case with VH-COK at the time of the accident.

The main fuel tank was destroyed by the fire and the main rotor gearbox, which was located adjacent to the main fuel tank at manufacture, was displaced from three of its four mounting points. There were holes in the side of auxiliary

fuel tank closest to the main rotor gearbox (inboard tank wall) that appeared to have been a result of the fire. There was superficial damage only to the corresponding outer wall of the tank. About 20 L of fuel was recovered from the auxiliary tank.

On 20 December 2010, the manufacturer issued R44 Service Bulletin 78 (SB 78) requiring that R44 helicopters with all-aluminium fuel tanks be retrofitted with bladder-type tanks as soon as practical, but no later than 31 December 2014. The background information to the service bulletin stated:

The Australian Transport Safety Bureau encourages all operators and owners of R44 helicopters that are fitted with all-aluminium fuel tanks to note the circumstances of this accident as detailed in this preliminary report. It is suggested that those operators and owners actively consider replacing these tanks with bladder-type fuel tanks as detailed in the manufacturer's Service Bulletin (SB) 78A as soon as possible.

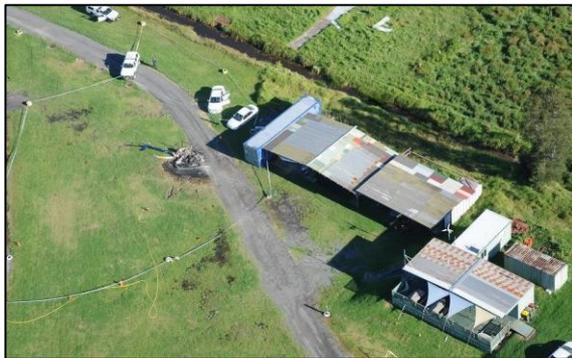
Figure 3: Accident site

The wreckage was located on a grassed area of the aerodrome about 12 m from the nearest structure (Figure 3). All of the helicopter's major components were identified at the accident site (Figure 4).

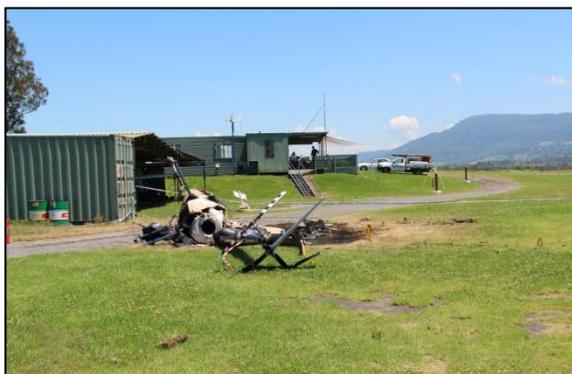
Figure 4: Helicopter wreckage

Much of the wreckage was consumed by a post-impact, fuel-fed fire. There was no evidence of an in-flight fire.

Most of the alloy flight control tubes had been burned away during the post-impact fire, precluding a full examination of the flight control system. Examination of the helicopter's main and tailrotor flight control connections, engine control connections, main and tailrotor drive and its fuselage structure revealed no evidence of any pre-existing anomalies.
