# Total power loss – Gippsland Aeronautics GA-8 Airvan, VH-FCK

Ti Tree, Northern Territory – 6 July 2012

**ATSB Transport Safety Report**  
Aviation Occurrence Investigation  
AO-2012-092  
Final

**Report No.** AO-2012-092

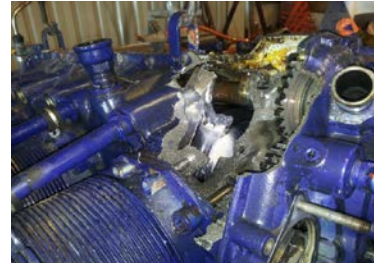
VH-FCK engine damage

The engine was removed from the aircraft and disassembled by a contracted maintenance organisation. The assessment by the maintenance organisation at the time of writing this report was that the failure was a result of a No. 6 connecting rod, big end cap bolt failure (Figure 1)
