# Fuel imbalance Boeing 737, VH-VOL

28 km SW of Gold Coast Airport, Queensland, 15 April 2012

**ATSB Transport Safety Report**  
Aviation Occurrence Investigation  
AO-2012-053  
Final

**Report No.** AO-2012-053

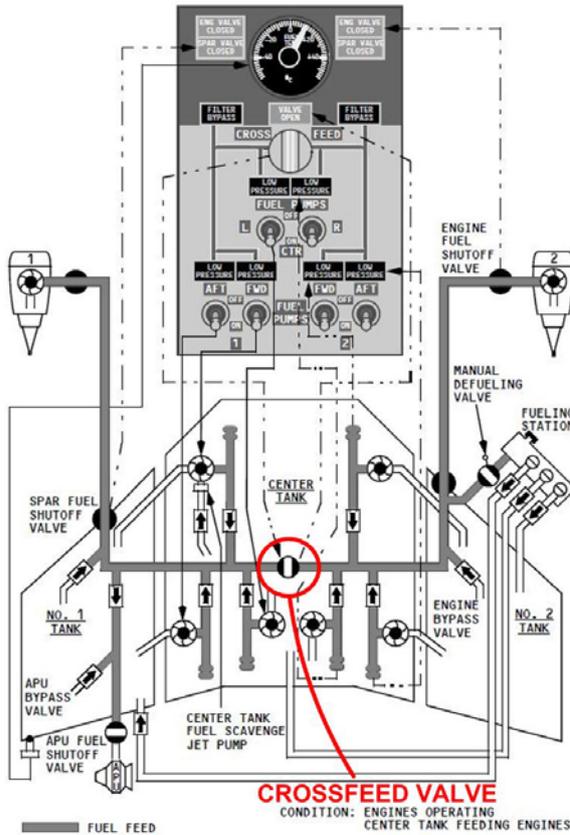
**Figure 1: Fuel system schematic**

Engine fuel feed crossfeed valve

Due to operational requirements, there was a delay in the departure of VOL from the Gold Coast Airport. During that period, the crossfeed valve<sup>4</sup> was selected open and centre tank pumps configured to prevent a fuel imbalance as a result of extended ground operations. Prior to departure, the aircraft was reconfigured for flight, which included the crossfeed valve being selected closed. The operation of the crossfeed valve, as indicated by the crossfeed valve open light was normal.

The crossfeed valve was installed on VOL since manufacture. At the time of the occurrence, the aircraft had a total time in service of 31,858 hours. Due to the reported history of crossfeed valve malfunction, the valve was removed from the aircraft and dispatched to an overhaul organisation for rectification. The subsequent inspection identified wear to the sealing materials and Teflon within the valve body as consistent with the existence of a leak within the valve. However, the overhaul organisation was unable to confirm whether the sealing material degradation would explain a high volume fuel leakage rate. The condition of the valve spline was not identified. The worn sealing material and Teflon was replaced by the overhaul organisation with the incorporation of the modified valve body assembly.

The operator also has a program in place to replace existing crossfeed valves with the modified version at scheduled maintenance servicing. This program is currently under review for acceleration.
