**ATSB TRANSPORT SAFETY REPORT**

Aviation Occurrence Investigation – AO-2012-130  
Preliminary

**Collision with terrain  
36 km SW of Gympie, Queensland  
1 October 2012  
VH-UXG  
de Havilland Aircraft Pty Ltd DH-84 Dragon**

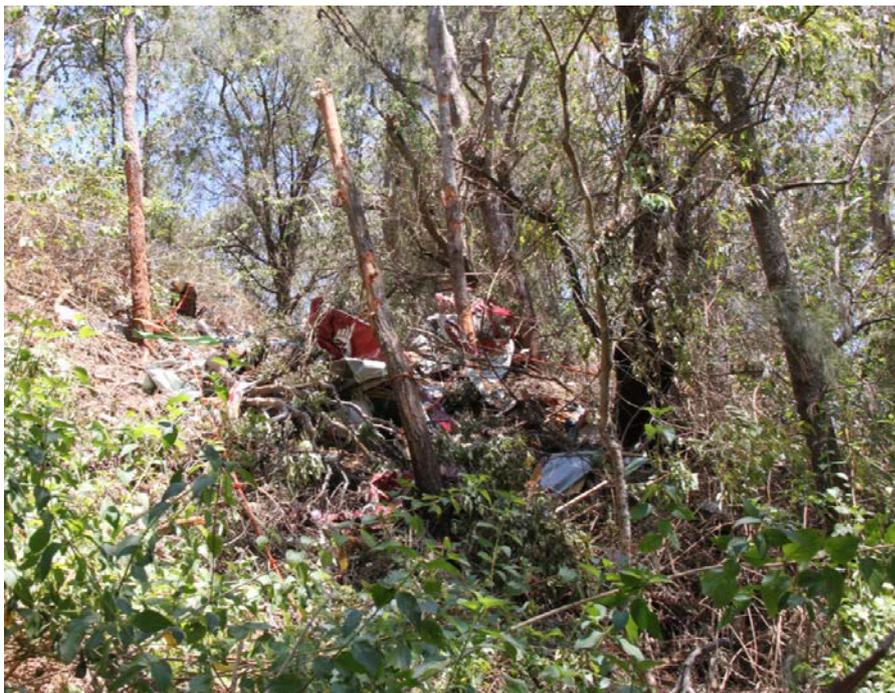
**Figure 2: Aircraft wreckage**

The aircraft was destroyed by impact forces (Figure 2). There was no fire. The accident was not survivable and the six occupants were fatally injured.

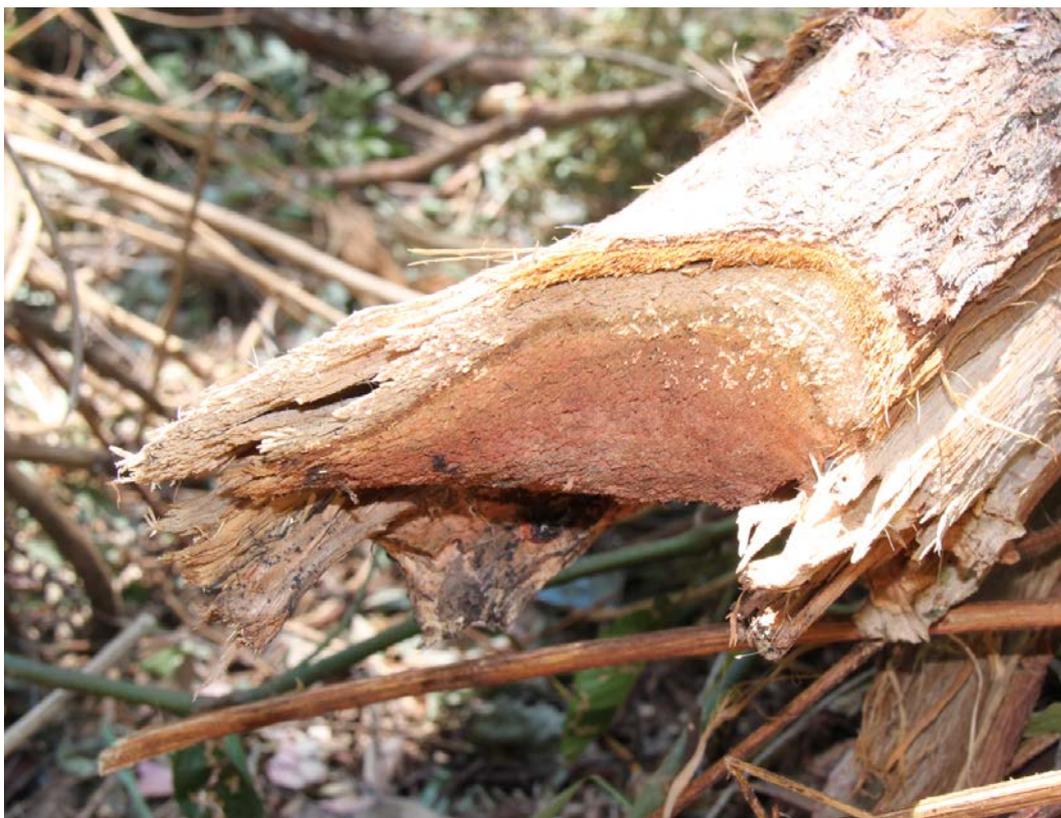
**Figure 4: Slash-type cut to one of the trees at the accident site**

One of the trees sustained an 8 cm deep slash-type cut, consistent with impact by one of the propellers (Figure 4). Both of the aircraft's fuel tanks were ruptured and there was about 7 L of aviation gasoline (AVGAS) remaining in the right fuel tank. There was evidence that fuel had drained from the left fuel tank after the impact with terrain.
