**ATSB TRANSPORT SAFETY REPORT**  
Aviation Occurrence Investigation – AO-2012-133  
Preliminary

**Collision with terrain**  
**Robinson R22 Beta, VH-LLF**  
**130 km west of Halls Creek, WA**  
**3 October 2012**

## Collision with terrain – VH-LLF, Robinson R22 Beta - 130 km west of Halls Creek, Western Australia – 3 October 2012

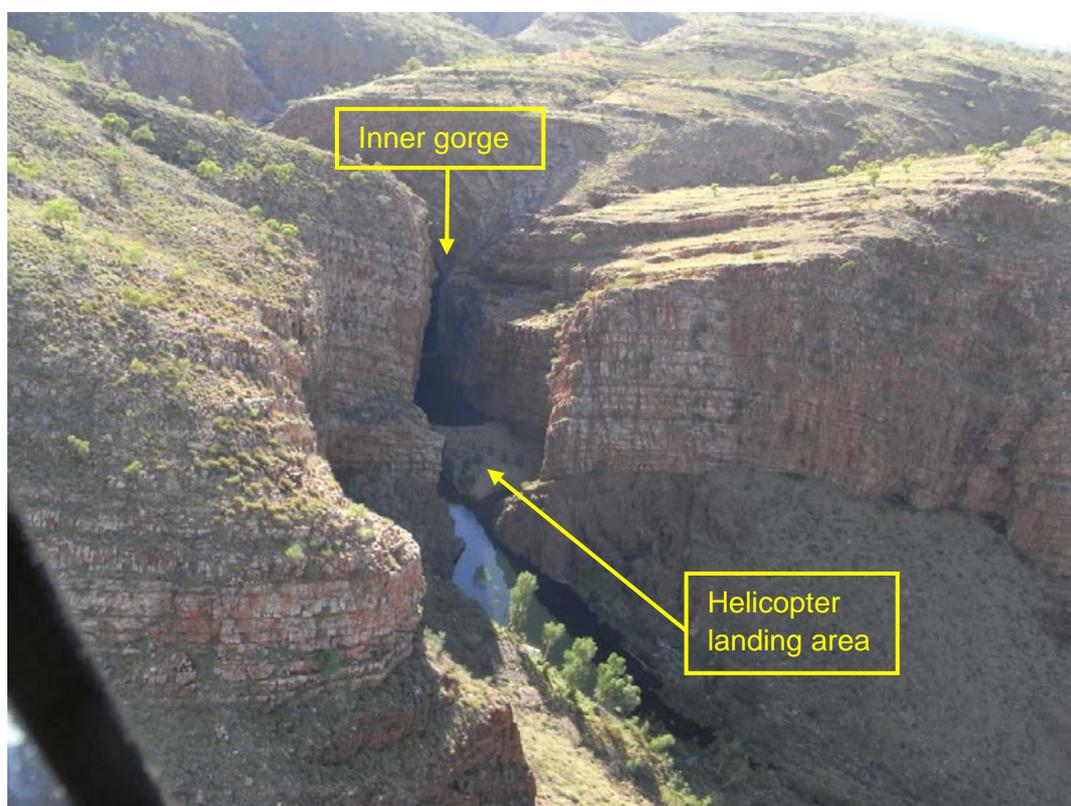
**Figure 1: Aerial view along the gorge**

In the daylight remaining, it was decided to take two station personnel for a flight over the station property. With a passenger on board each helicopter, the pilots overflew the yarded cattle and other parts of the property. At about 1630, the pilots landed on a section of river bed in the Margaret River for some fishing. After about 30 minutes on the ground, it was decided to return to Louisa Downs. Once airborne, the pilots arranged to visit a gorge about 2 minutes flying time away from the fishing spot (the gorge was on the Gliddon River, not far from where it ran into the Margaret River). On arrival at the gorge, the pilots surveyed the area from the air before landing on a pebble-covered sand bar in a relatively open part of the gorge (Figure 1).

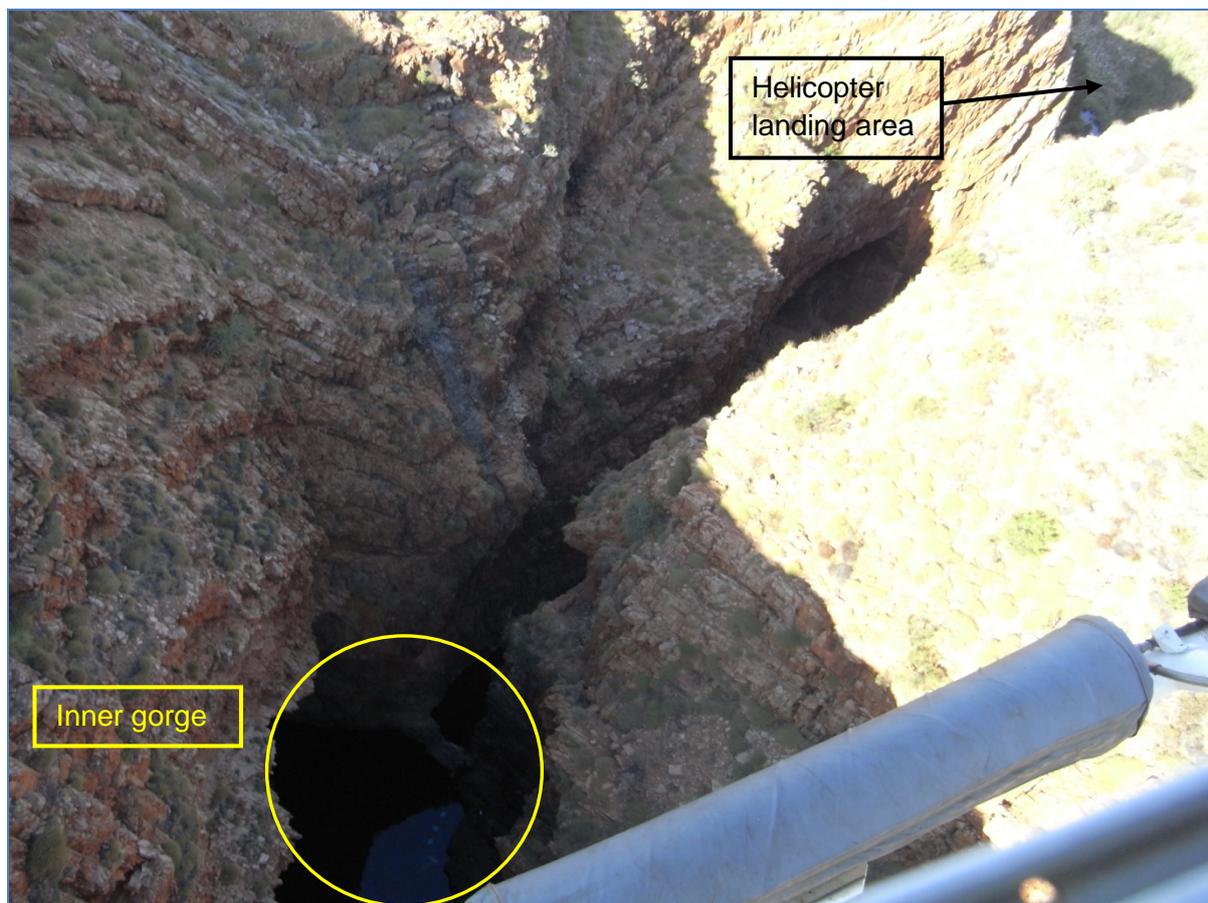
**Figure 2: Overhead view of the inner gorge**

One of the pilots and a passenger swam further into the narrower and obscured part of the gorge (Figure 2), leaving the other pilot and passenger with the helicopters. At some point the pilot who remained at the helicopters indicated that he wanted to explore the gorge further, and departed alone in the helicopter, registered VH-LLF (LLF).
