In-flight fire involving Eurocopter AS-350BA, VH-HEB

51km W Ceduna, South Australia - 19 June 2012

ATSB Transport Safety Report
Aviation Occurrence Investigation
AO-2012-084
Final

Report No. AO-2012-084

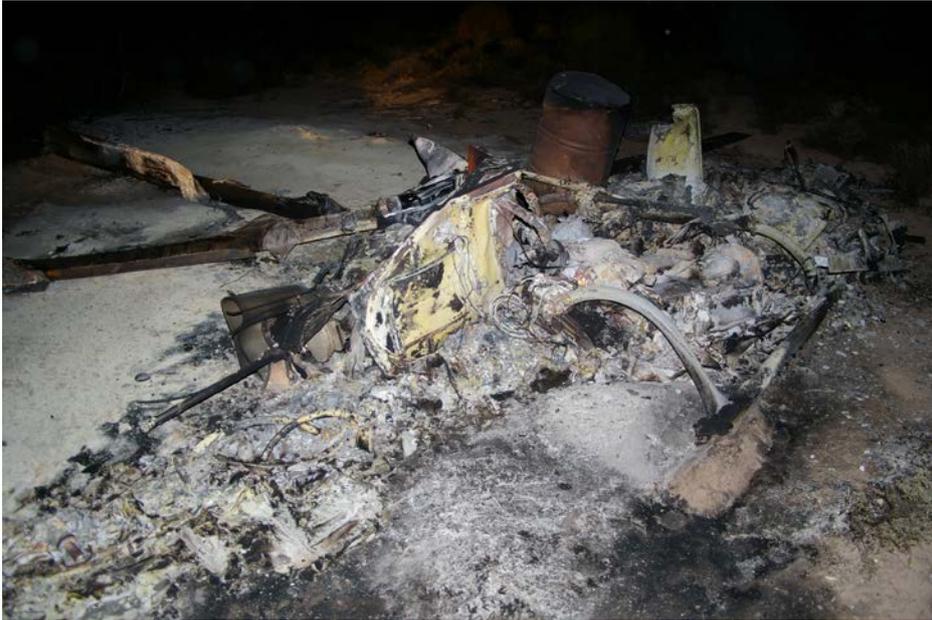
Figure 1: Accident site

About 15 minutes into the flight, the pilot and passenger recalled smelling abnormal fumes in the cockpit. Following a brief discussion with the passenger, the pilot elected to conduct an emergency landing about 51 km west of Ceduna. Once the helicopter was on the ground, the passenger exited and noticed smoke and fire emanating from the aft cargo compartment. The fire spread to the cabin area where the fuel drum was secured. The pilot and passenger left the vicinity of the helicopter and the helicopter was destroyed as a result of the fire (Figure 1). The cause of the fire could not be determined.

The ignition source of the fire was not established; however the spillage during the refuelling process may have provided an initial fuel source for the fire.

- For all future remote area operations additional equipment will be carried; including satellite phones and personal EPIRBs.
- The operations manual has been amended to include specific procedures for the carriage of large containers of fuel.
