Wheels up landing involving Beech A36, VH-SQI

Kumarina Roadhouse airstrip, Western Australia, 12 November 2012

ATSB Transport Safety Report
Aviation Occurrence Investigation
AO-2012-151
Final – 27 February 2013

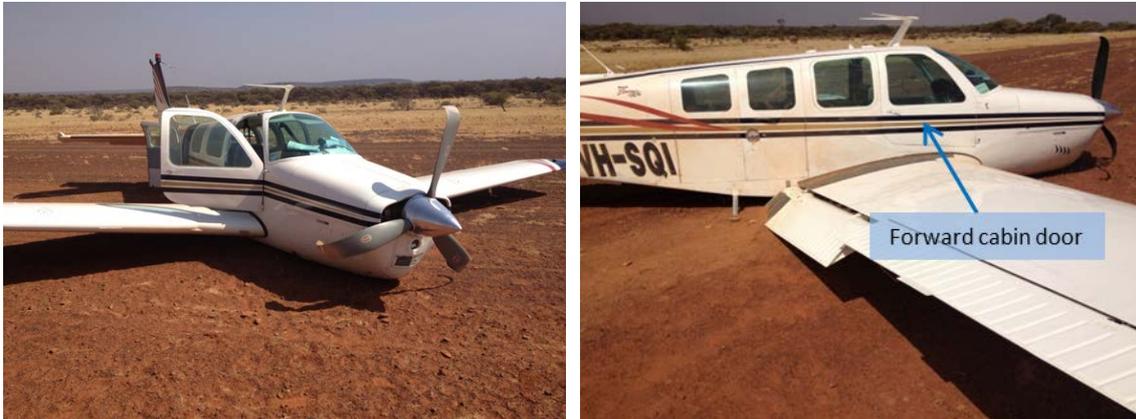
Figure 1: VH-SQI

During the flare², the pilot realised he had not done his pre-landing checks and had forgotten to lower the landing gear. The aircraft landed with the wheels up and skidded to a halt about 200 m down the runway. The pilot and passenger were uninjured, however the aircraft was substantially damaged.
