ATSB TRANSPORT SAFETY REPORT

Marine Occurrence Investigation

MO-2011-011

Fatality while storing the products tanker

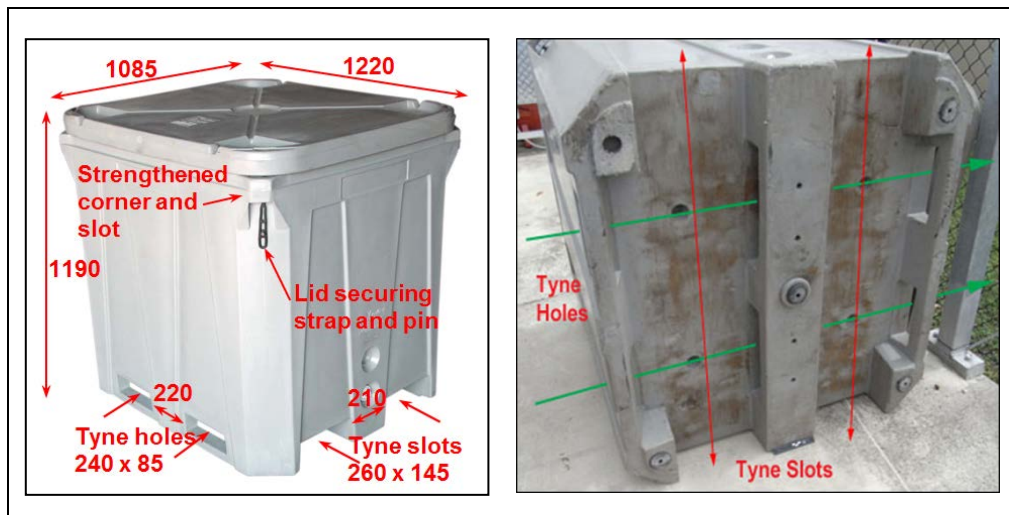
The plastic insulated stores container involved in the accident (Figure 4) was of a design which had been in production since the mid-1970s. The container had a high volume capacity and was designed to withstand the rigorous work and physical environment in which it was used. The container was made of food grade polyethylene in a sandwich construction of varying thickness.

Figure 4: Stores container

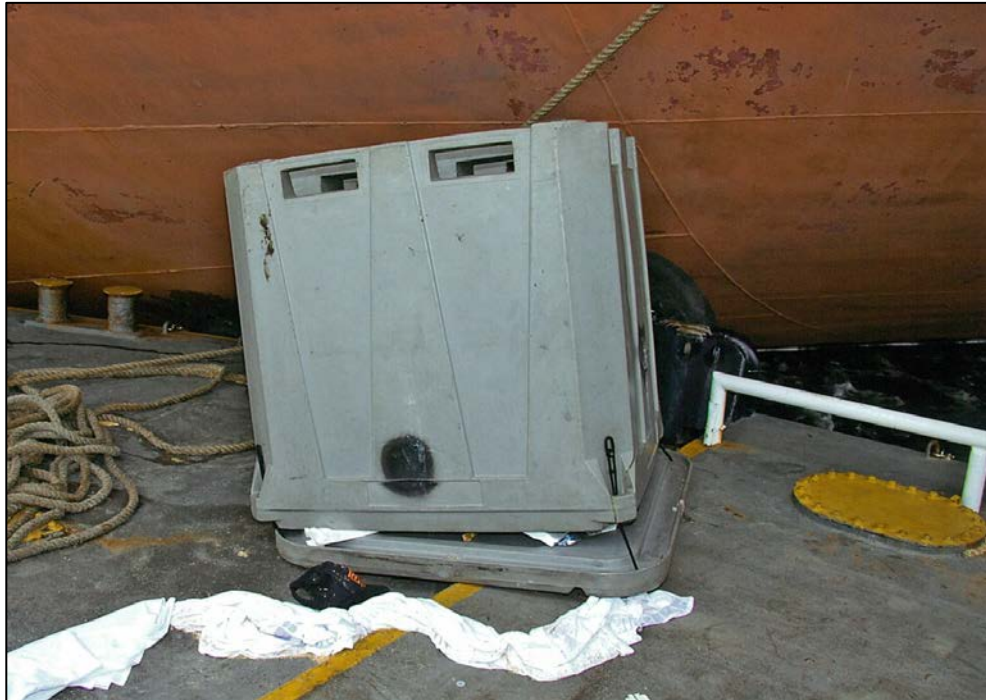
When the two deckhands reached the tug master, they saw that the container was not lying on the tug master but above him, wedged between the pallets of stores forward and aft of where he lay. The two deckhands moved the container onto the barge's forward deck (Figure 7), away from the tug master, and began providing first aid to the seriously injured man. After checking his vital signs, the second deckhand hurried aft to the tug's wheelhouse to raise the alarm.

Figure 7: The fallen container lying on the barge's deck

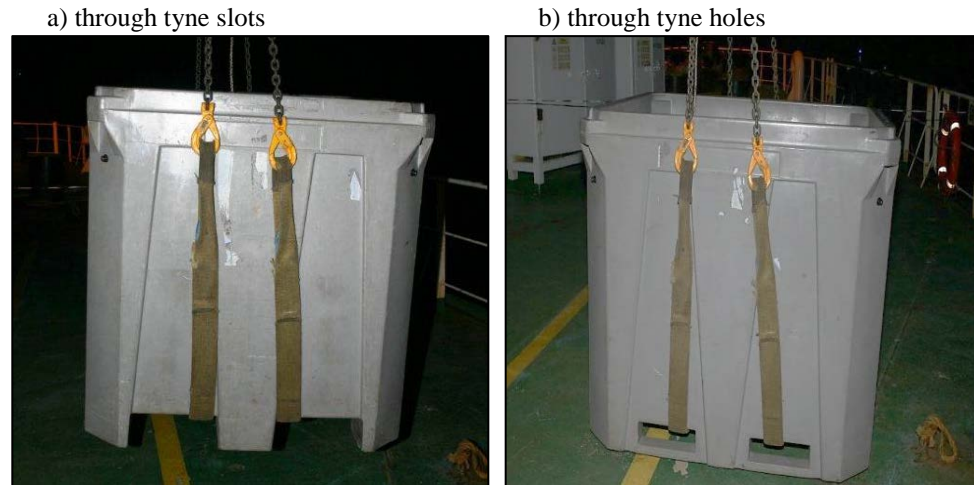
The container had been poorly rigged¹¹ for the lift from the ship to the barge. There were no markings on the container to indicate how it was to be slung and the crew of *British Beech* did not adequately consider how the container should be slung and lifted. This included the weight of the load being rigged, the positioning of the webbing slings and the effect the movement of the loose packages in the container might have on its stability during the lift. Consequently, the slings were positioned through the container base tyne slots (Figure 8a) and the container, when lifted clear of the ship, was easily unbalanced and dislodged from the slings.

Figure 8: Possible slinging arrangements for the container with the equipment in use at the time of the accident

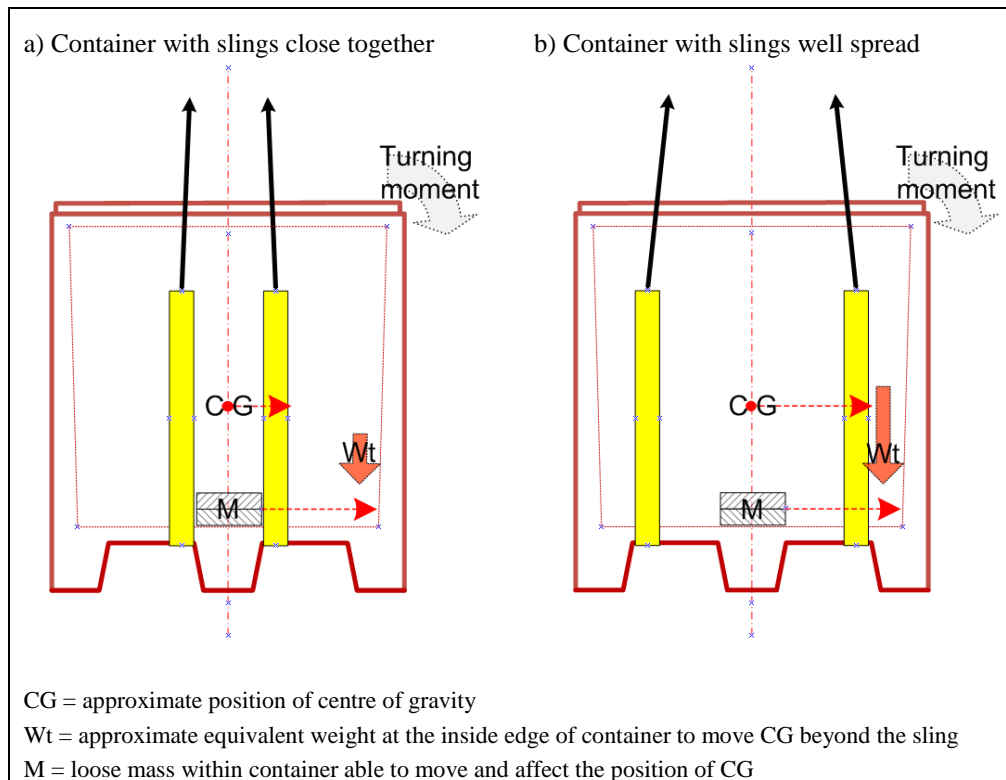
Figure 9: Comparison of sling position on stores container

Therefore, when lifted, the container needed a significantly smaller external force to topple it from the slings than if the slings had been positioned to the extremities of the tyne slots. In addition, the loose packages placed in the container, as they moved about, further reduced the external force needed to topple the container.
