Released in accordance with section 26 of the *Transport Safety Investigation Act 2003*

# Safety summary

### Train T842 at Cleveland Station

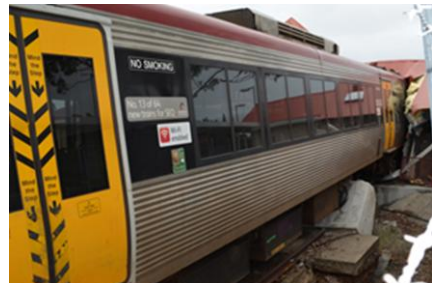
At about 0940 on 31 January 2013, a Queensland Rail passenger train failed to stop at the Cleveland station platform and collided with the end-of-line buffer stop, the platform and the station building at a speed of about 31 km/h. There were 19 people on board the train (including the driver and a guard); three people were on the platform and five were in the station building. A number of people were treated for minor injuries and transported to hospital for further examination.

Based on evidence available to date, the ATSB has found that local environmental conditions resulted in the formation of a contaminant substance on the rail running surface. This caused poor adhesion at the contact point between the train's wheels and the rail head. The braking effectiveness of T842 was reduced as a result of reduced adhesion and the train was unable to stop before hitting the end-of-line buffer stop.

The ATSB has recommended that Queensland Rail take action to address the safety risk associated with contaminated rail running surfaces which lead to reduced wheel/rail adhesion.

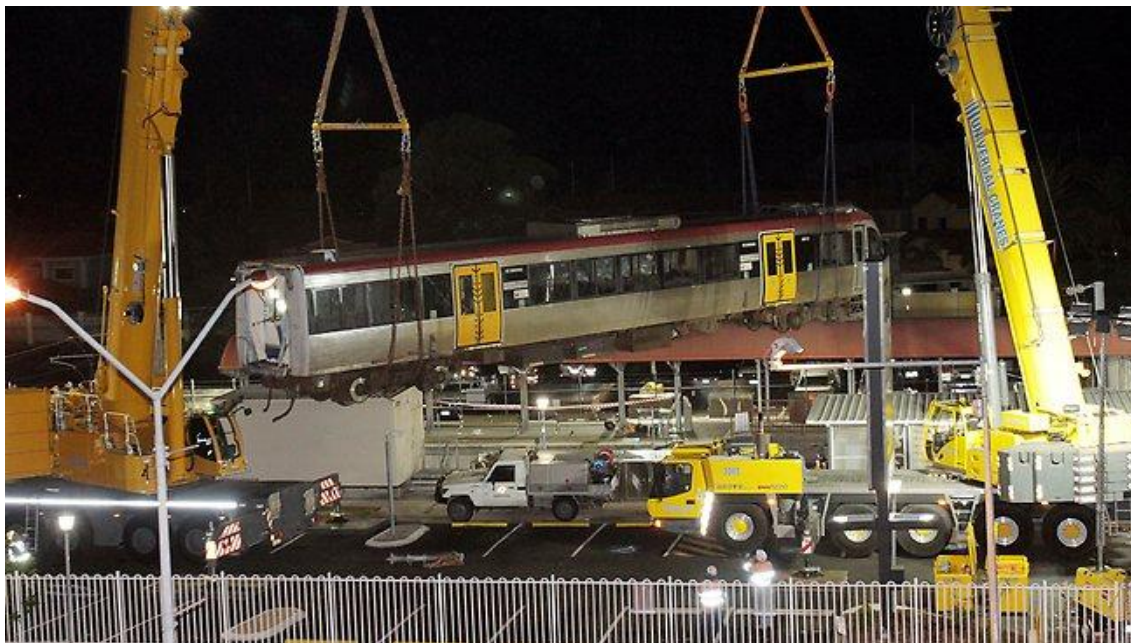
**Figure 2: Recovery from IM5173**

The two leading cars of train T842 had sustained significant damage and had to be lifted by crane from the site onto low bed loaders to be transported by road.

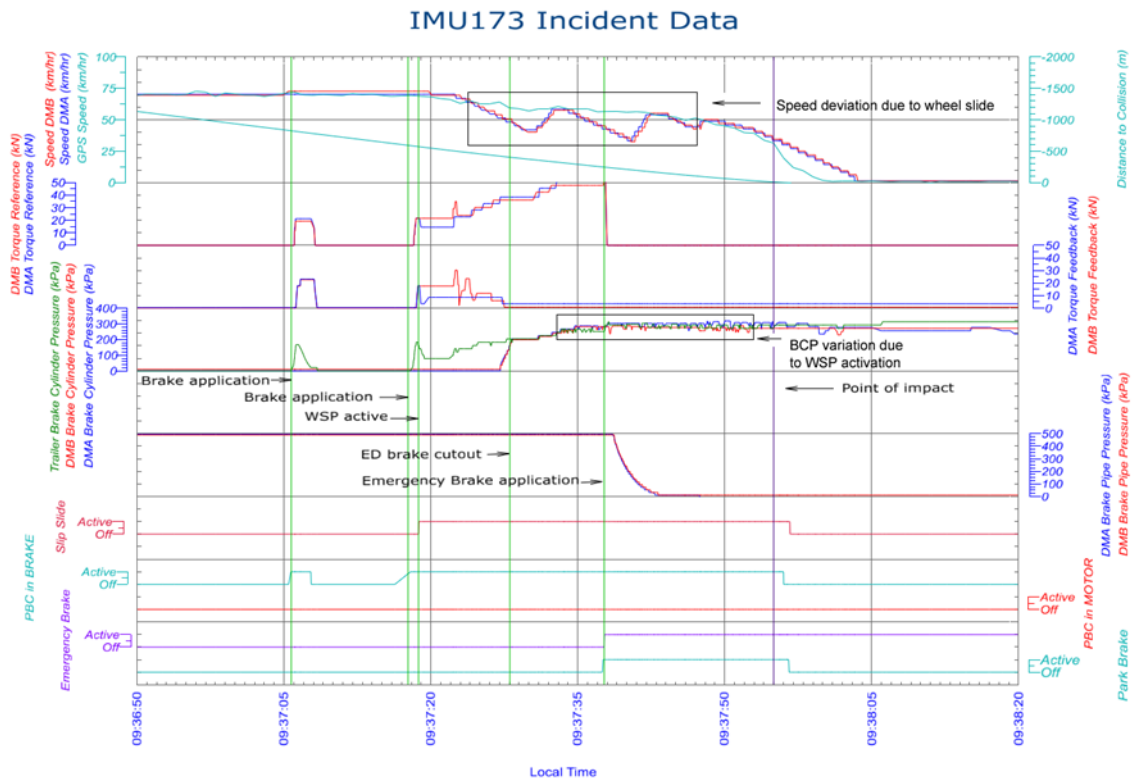
**Figure 6: Extract of data log from IMU5173**

Analysis of information extracted from IMU 5173’s data logger (Figure 6) shows the train was travelling about 69 km/h (0937.18) when the driver made a service brake application to slow the train about 590 m from the Cleveland Station. Less than one second later, the WSP system detected slide. Brake cylinder pressures, particularly after the application of the emergency brake at 56 km/h, display numerous fluctuations as the WSP system intervened to apply and release the brakes in attempting to control the slide. Fluctuations in speed were also recorded where the WSP system remained active throughout the service brake and emergency brake applications until the point of impact.
