Wake turbulence event involving a Boeing 737, VH-YIO

258 km SE of Bali International Airport (Denpasar), Indonesia, 13 September 2012

ATSB Transport Safety Report
Aviation Occurrence Investigation
AO-2012-121
Final – 23 April 2013

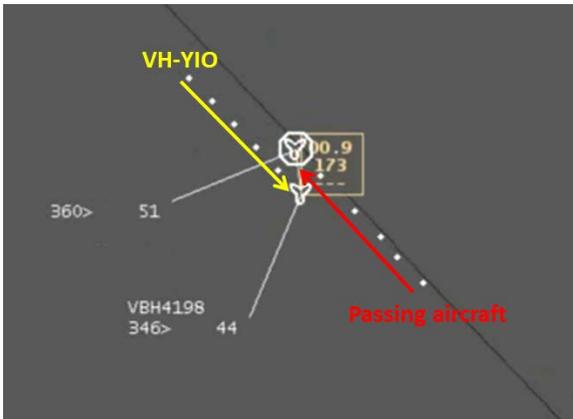
At 1639, the aircraft became established in the cruise and the seat belt sign was turned off. Shortly after, the crew observed opposite direction traffic on the aircraft's traffic alert and collision avoidance system (TCAS), about 1,000 ft above and slightly to the left. The crew observed the aircraft pass to the left. Airservices Australia surveillance data indicated the aircraft passed at about 1640, with about 0.9 NM lateral and 1,400 ft vertical separation (Figure 1).

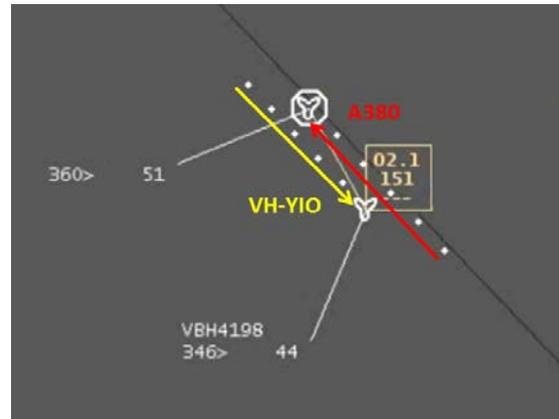
Radar surveillance data indicated that, at the time of the event, there was about 2.1 NM lateral and 1,400 ft vertical separation (Figure 2) between the aircraft and the correct ATC separation standards were being applied at the time.

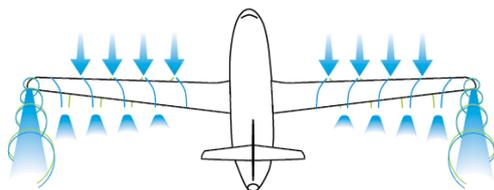
Figure 3: Wake vortices

The phenomenon that creates wake turbulence results from the forces that lift the aircraft. Lift is produced by a differential in pressure over the wing surfaces. High pressure air below an aircraft’s wing flows around the wingtips to the low pressure air on top of the wing. This results in vortices being generated from the wings. When viewed from behind, the left wing vortex rotates clockwise and the right wing vortex rotates counter-clockwise. The region of rotating air behind the aircraft is where the wake turbulence occurs (Figure 3). The strength of the vortices is predominantly determined by the weight, speed and wingspan of the aircraft.

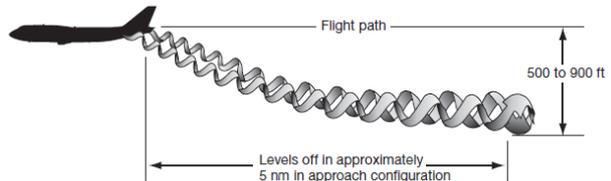
Figure 4: Movement of wake vortices

Wake vortices spread laterally away from the aircraft and generally descend at an initial rate of about 300 to 500 feet per minute for about 30 seconds. The descent rate decreases and eventually approaches zero when about 500-900 ft below the flight path (Figure 4). The life span of the wake vortices is about 30 seconds for a wind speed of 5-10 kts; up to 85 seconds for wind speeds less than 5 kts; and up to 100 seconds in still air.

An Airbus Flight Operations Briefing Note on *Wake Turbulence Awareness/Avoidance* also recommends that, during the cruise (if necessary), the crew may offset from the cleared track by up to a maximum of 2 NM, in order to alleviate the effects of wake turbulence⁶.
