On 1 May 2012, the pilot of a Piper PA 25-235/A9 (Pawnee) aircraft, registered VH-GWS, was conducting agricultural operations from a local airstrip near Hallston, Victoria. Shortly after takeoff, the aircraft collided with terrain near the base of a gully and was destroyed by a post-impact fire. The pilot was fatally injured.

On 1 May 2012, the pilot of a Piper PA 25-235/A9 (Pawnee) aircraft registered VH-GWS commenced aerial agricultural operations near Hallston, Victoria.

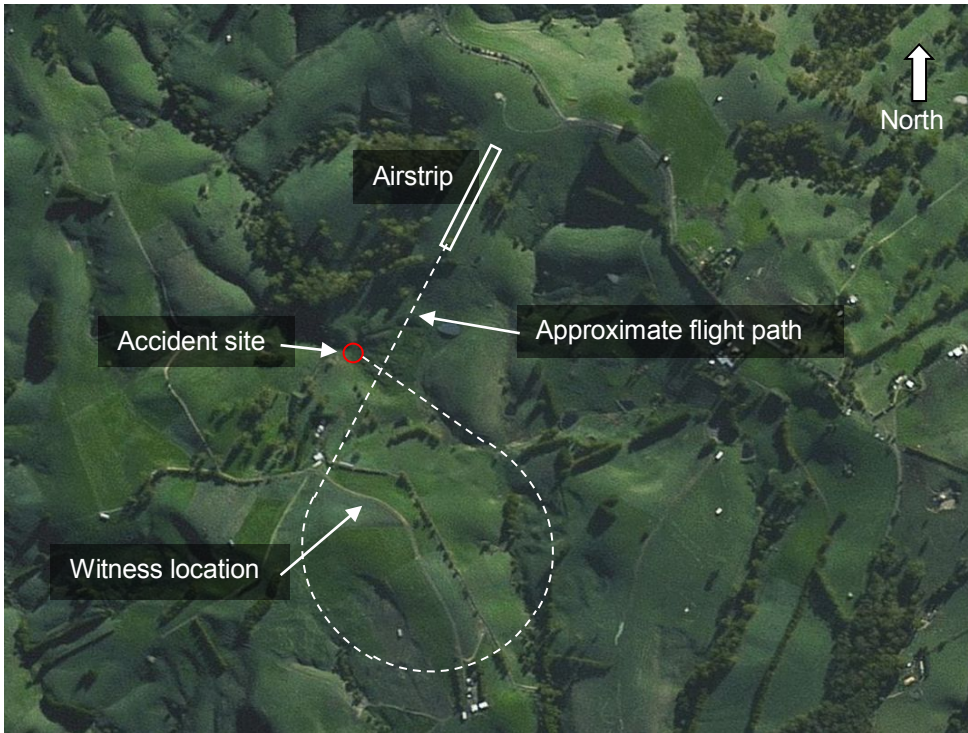
**Figure 1: Accident location**

Witnesses to the south-west of the airstrip (Figures 1 and 2) observed the aircraft become airborne and fly overhead at a very low altitude before disappearing from view. Shortly thereafter, the aircraft reappeared to the east of the witnesses and was observed descending into a gully while releasing some of the fertilizer load. The witnesses reported that the engine was making a continuous, even noise for the duration of the flight, but that it was noticeably quieter than other aircraft that had previously used the same airstrip.

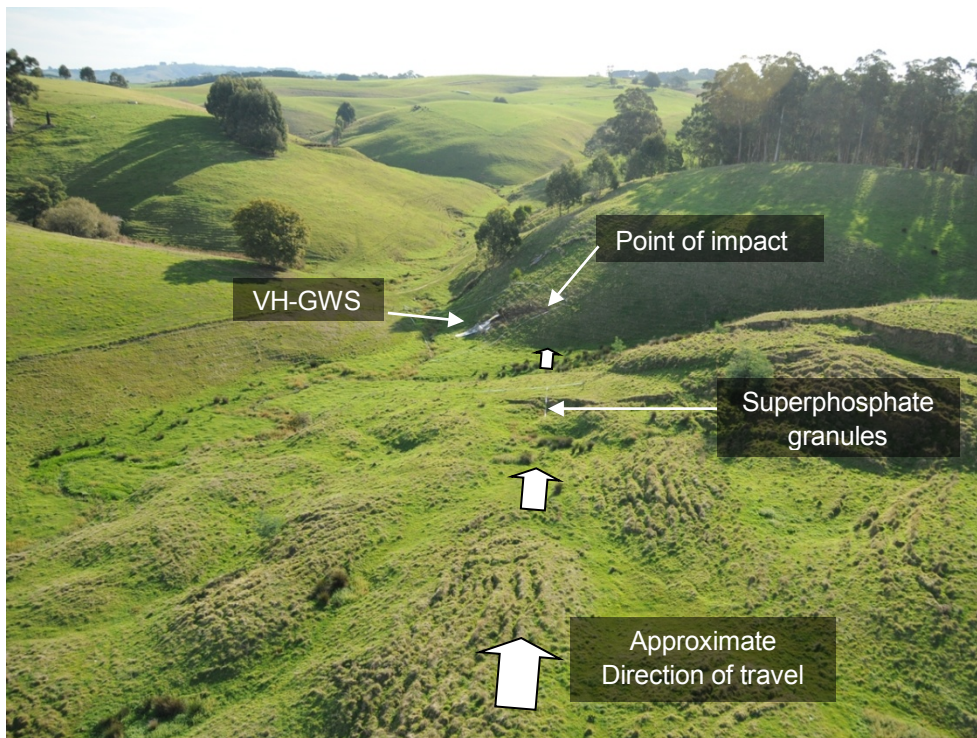
**Figure 3: Accident location**

The aircraft was situated in a gully, near the base of an incline of approximately 30° (Figures 3 and 4). Ground scars at the point of impact were consistent with the aircraft contacting the soft terrain in a left wing down attitude, slightly greater than the slope of the terrain. The aircraft came to rest near the base of the incline, approximately 16 metres from the point of first impact. It remained upright and was oriented roughly in the direction of travel. Granulated superphosphate was found scattered along the ground scars as well as back along the flight path, which was consistent with the witness accounts that some product had dropped from the aircraft before it struck terrain. A significant quantity of the fertiliser load was also found in the remains of the hopper.

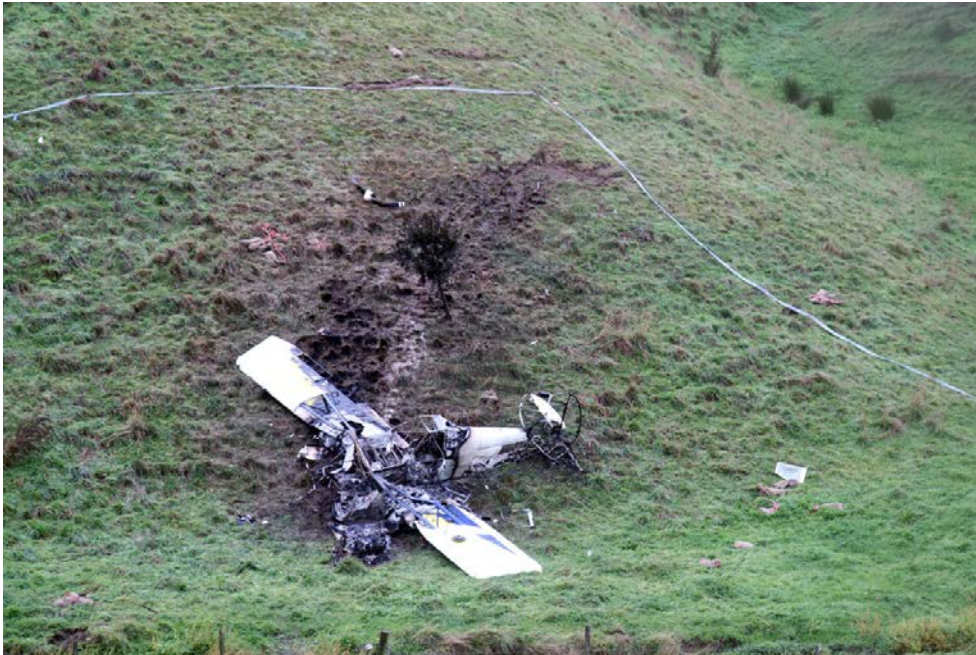
**Figure 4: Accident site**

The fuselage forward of the cockpit sustained significant damage from the impact and a post-impact fire consumed the majority of the fuselage and inboard wing sections. There was no damage observed that could not be attributed to the impact or to the fire.
