Runway incursion between a Fairchild SA227, VH-WBA and a vehicle

Leinster aerodrome, Western Australia, 14 January 2013

ATSB Transport Safety Report
Aviation Occurrence Investigation
AO-2013-015
Final – 29 May 2013

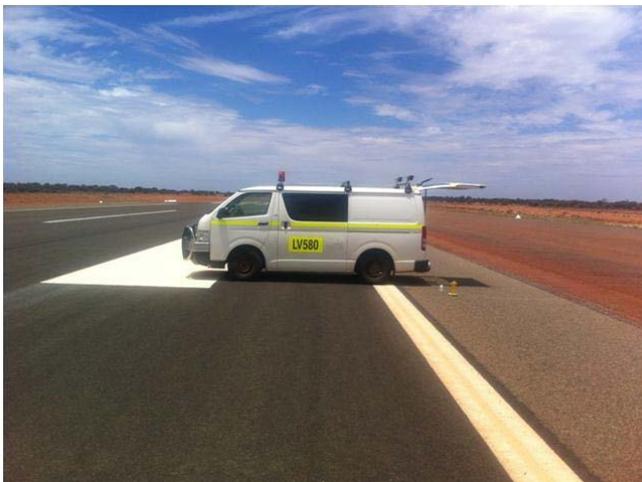
Figure 1: Vehicle location on runway

At about 1045 Western Standard Time,¹ the aerodrome reporting officer (ARO), who was a qualified electrician, arrived at Leinster aerodrome to continue a works order that required the levelling of the runway lights. The ARO went to the terminal office to retrieve a hand held radio and then drove onto the taxiway. Before entering the runway, he made a broadcast on the Leinster common traffic advisory frequency (CTAF) using the hand held radio, indicating he was entering runway 10/28. The ARO reported that he received the voice identification of 'Leinster aerodrome' from the aerodrome frequency response unit (AFRU).² He proceeded to the end of runway 28 and commenced work. As the temperature was above 40°C, the ARO positioned the vehicle on the edge of the runway to provide some shade from the sun while he worked on the runway light (Figure 1).

- the vehicle was located near the first touchdown marker on runway 28, which was about 160 m from the runway end. There were five surrounding aerodromes that used the same CTAF frequency as Leinster.

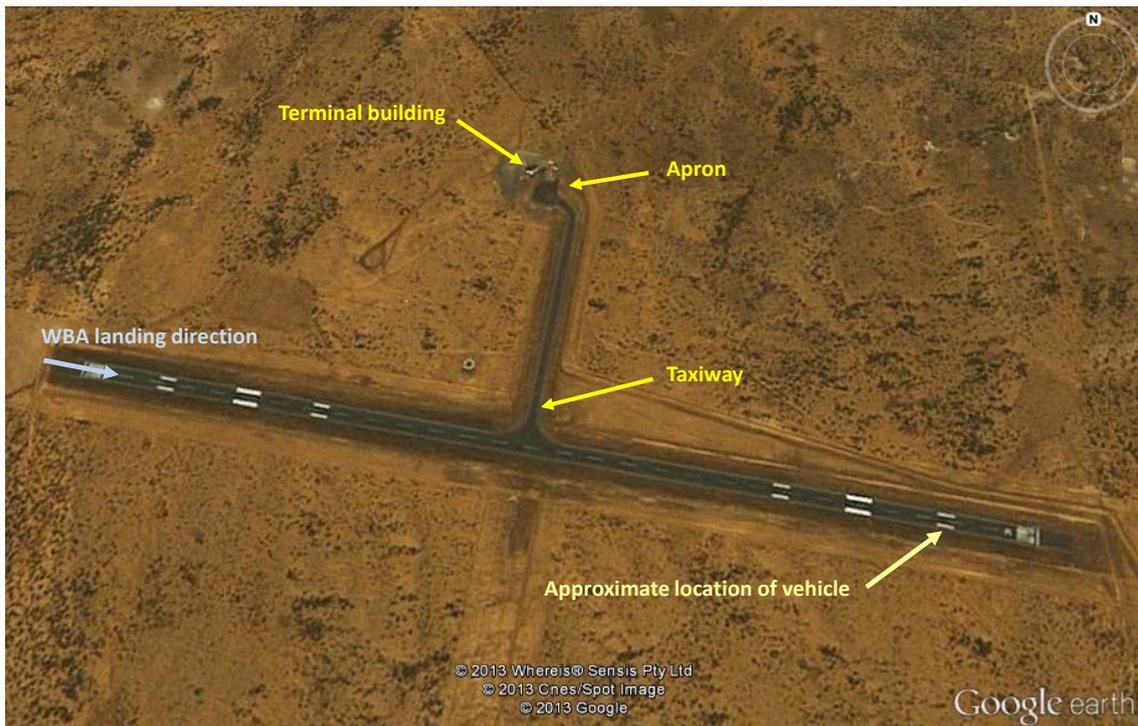
Figure 2: Location of vehicle on the runway

The crew of WBA taxied past the vehicle and used the turning node at the end of the runway to turn around. The aircraft was then taxied back along the runway to the taxiway that led to the terminal (Figure 2). The crew made a broadcast on the CTAF again to contact the vehicle driver, but did not receive a response. The ARO reported that he heard the radio transmission, but it was unintelligible. The crew continued to the terminal and after shutting down, they made another broadcast on the CTAF, with no response received.
