Wildlife strikes involving a Mooney M20J, VH-CYK

Hedlow (ALA), Queensland, 24 March 2013

ATSB Transport Safety Report
Aviation Occurrence Investigation
AO-2013-058
Final – 29 May 2013

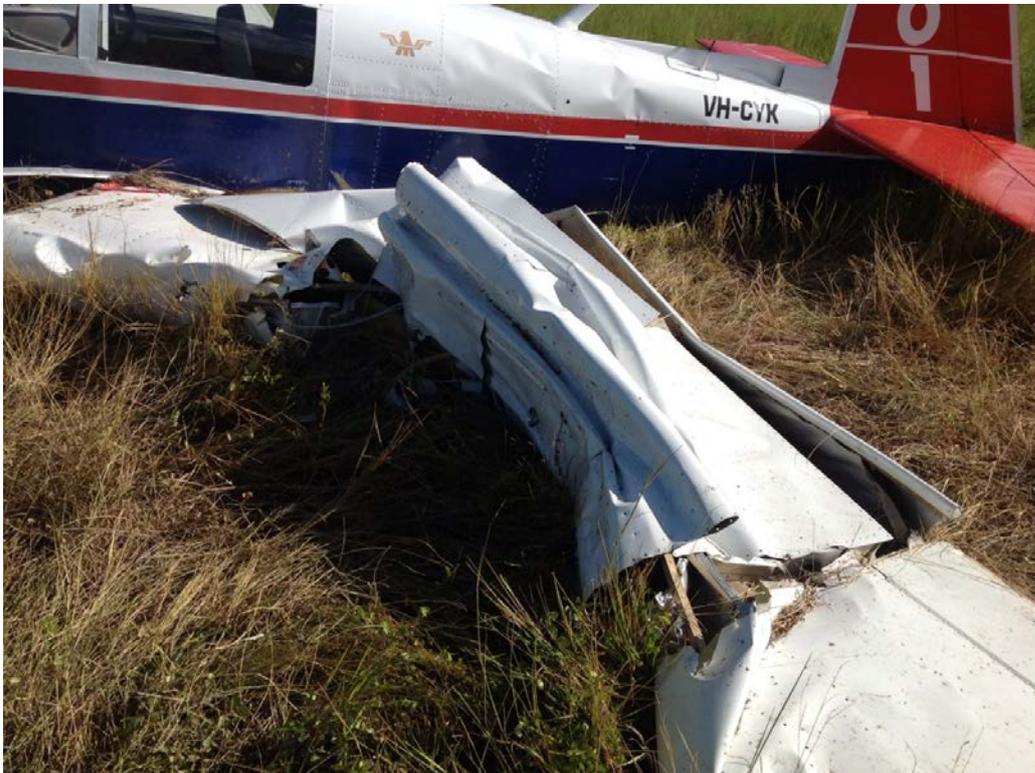
Figure 1: Aircraft damage

As the pilot reached over to raise the landing gear lever, the aircraft's left wing struck a bull. The aircraft then landed in the paddock. The pilot shut down the aircraft and the occupants exited. The aircraft sustained substantial damage (Figure 1) from hitting the bull and one passenger received minor injuries. The bull was put down as a result of the injuries it sustained.
