Wirestrike involving Robinson R44, VH-HGF

18 km E of Ballarat Airport, Victoria, 23 February 2013

ATSB Transport Safety Report

AO-2013-042

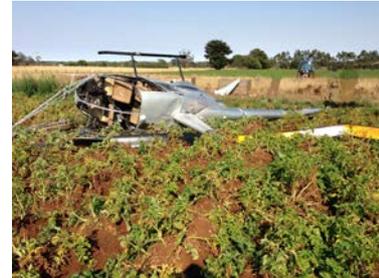
Helicopter damage

As the helicopter approached the paddock from the south, at 50 kt and at spray height, the pilot remembered a wire that extended halfway across the southern boundary of the paddock to a pump house. The pilot judged that it was too late to attempt to pull up over the wire and attempted to avoid the wire by flying underneath it. The vertical stabiliser contacted the wire and the tail rotor gearbox separated from the tail boom. The nose of the helicopter momentarily pitched upwards before the helicopter began to spin to the right. The pilot closed the throttle in an attempt to recover control, but the helicopter landed hard and rolled over. The pilot was able to exit the helicopter with minor injuries. The helicopter was substantially damaged. There was no fire.

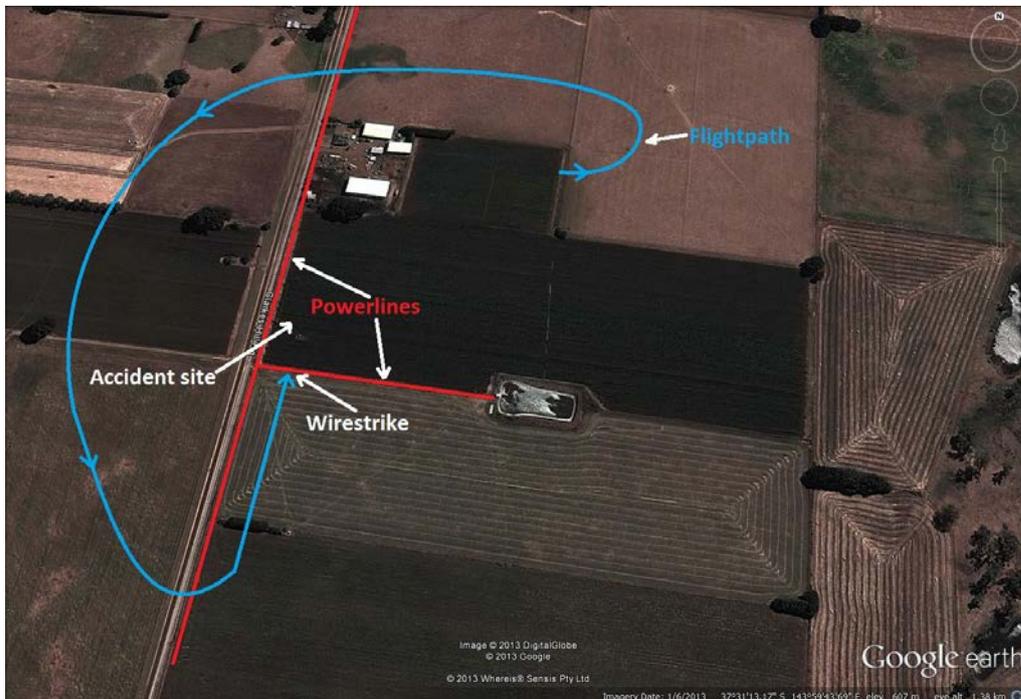
Figure 1: Accident site

At about 0915 Eastern Daylight-saving Time,¹ the pilot changed the orientation of the application runs across the paddock from west to east, to south to north. The change in direction of the application runs was required to apply chemical to areas of the paddock that could not be sprayed on the west to east runs, due to a power line located on the western boundary of the paddock (Figure 1).

The pilot reported performing a thorough inspection of the paddock prior to commencing low level operations within the paddock. The pilot also commented that it was his usual practice to perform an additional hazard check prior to changing the orientation of the application runs. However, on this occasion, he did not perform this additional check. The pilot further commented that he knew the wire was there, but at the time was concentrating on other obstacles in the paddock, including an irrigator, the wire on the western boundary and tall trees located near the house (Figure1).

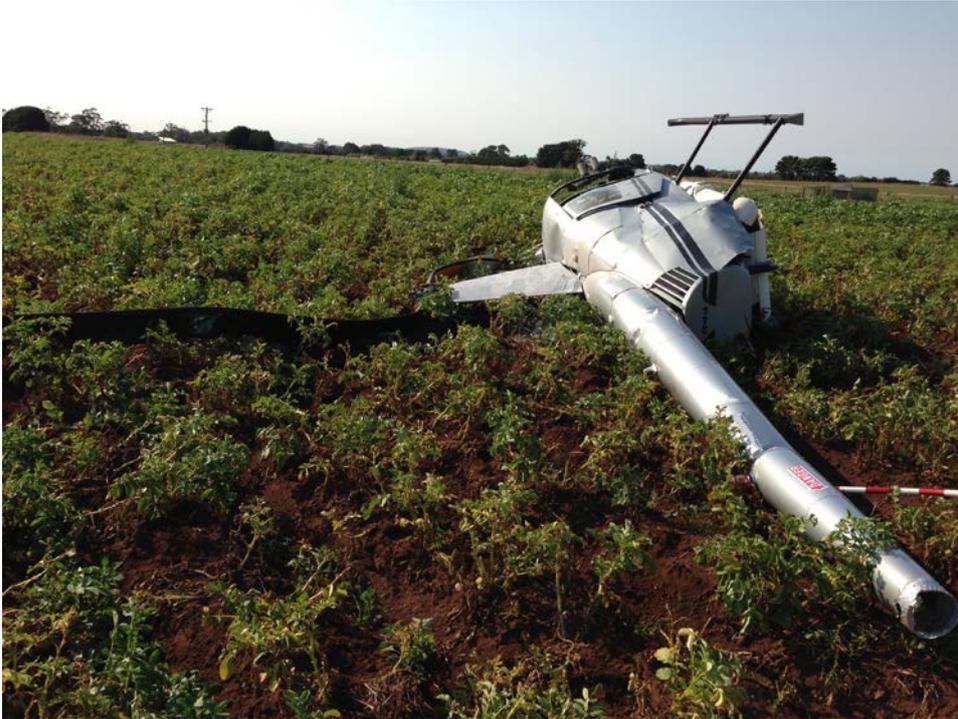
Figure 2: Helicopter damage

About 3 weeks prior to the accident, the helicopter had been fitted with bladder-type fuel tanks, in accordance with the Robinson Service Bulletin SB-78. This action reduced the risk of a post-impact fire.
