Collision with terrain involving AS350, VH-EWM

31 km WSW of Hobart, Tasmania, 7 February 2013

ATSB Transport Safety Report
Aviation Occurrence Investigation
AO-2013-026
Final – 28 June 2013

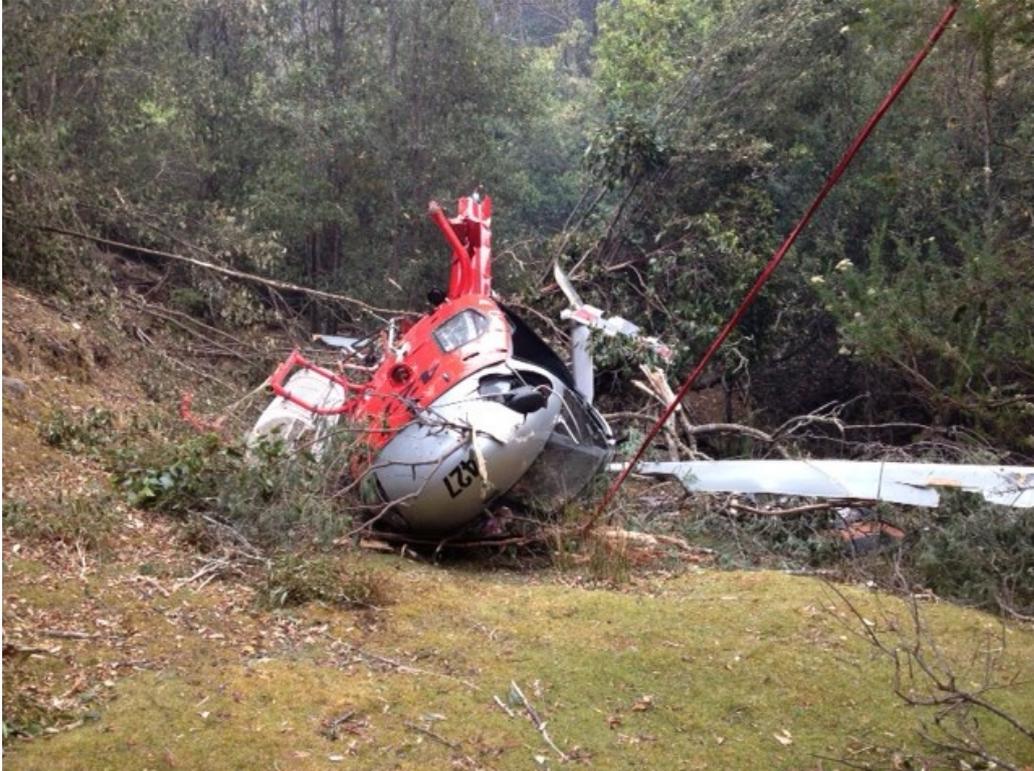
Figure 2: VH-EWM at the accident site

On 7 February, 2013 at about 1655 Eastern Daylight-saving Time¹ a Eurocopter AS350 B2 helicopter², registered VH-EWM (EWM) was conducting water-bombing operations near Hobart, Tasmania, when it collided with terrain (Figures 1 and 2). The pilot, the sole person on board, suffered minor injuries and the helicopter sustained substantial damage.

The pilot slowed EWM in preparation of making the next water drop. Approaching the hover at about 80 ft above ground level, and immediately following the loss of translational lift³ (TL), the helicopter suddenly commenced an uncommanded left yaw and descent. Without any warnings or alarms, the helicopter rotated rapidly 2-3 times to the left. The pilot raised the collective to decrease the rate of descent, and countered the yaw with anti-torque pedal input; however the rate of yaw increased. The pilot reported that “in a very short period of time” the helicopter was in the trees. The speed of events did not give the pilot time to dump the Bambi bucket, release the water, or broadcast a Mayday call. The helicopter came down in the upright position but when close to the ground, it rolled to the left, about 130° from the vertical (Figure 2).

As the ATSB did not attend the accident site, or examine the helicopter, the reason for the accident could not be conclusively established. The described behaviour of the helicopter by the

pilot was consistent with Loss of Tail rotor Effectiveness (LTE). In this condition of flight, the tail rotor loses aerodynamic efficiency. Factors which contribute are:

- Low airspeed
- High power
- An adverse relative wind
