TCAS warning between a Cessna 310R, VH-AEY and a Fokker F28-100 VH-FKJ

near Karratha Airport, Western Australia, 22 May 2013

ATSB Transport Safety Report
Aviation Occurrence Investigation
AO-2103-090
Final – 17 September 2013

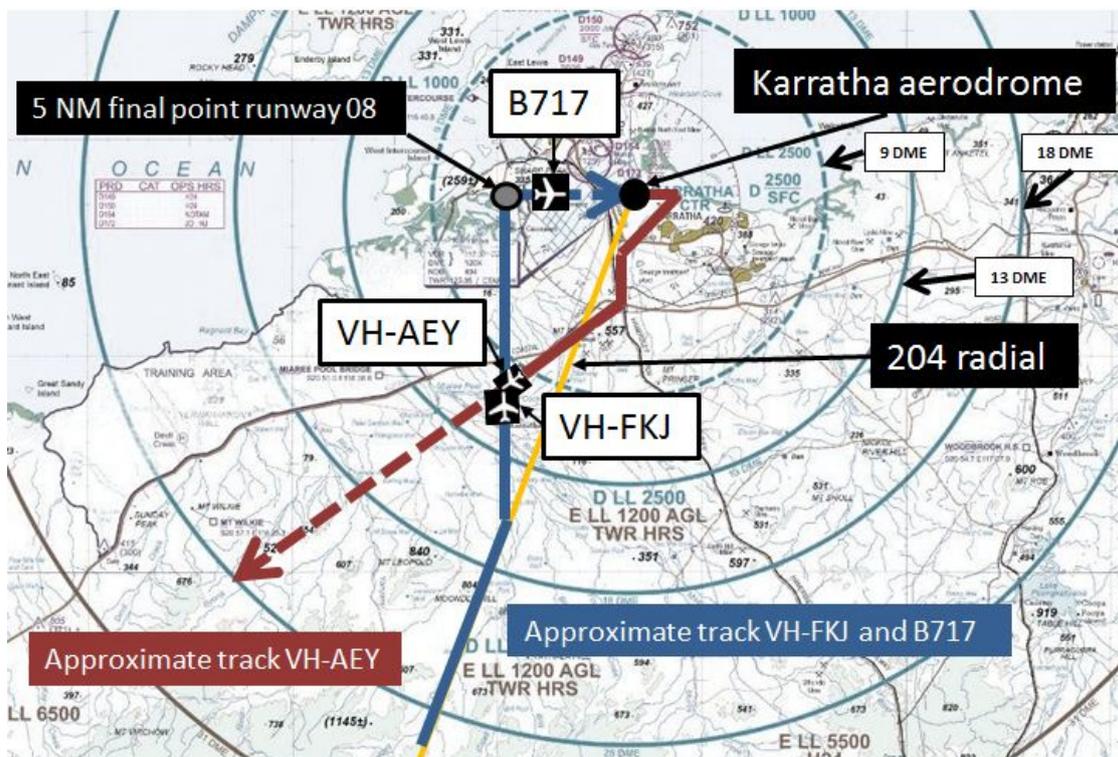
Figure 1: Approximate positions of the B717, VH-FKJ and VH-AEY at 0720

At about the same time, the pilot of AEY made a visual scan and saw the F100 (FKJ) coming towards AEY in a 10 o'clock, high, position, about 1 to 2 NM away. The pilot pushed forward on the control column and the aircraft descended about 200 ft as FKJ passed overhead. At 0720, the crew of FKJ received a TCAS resolution advisory (RA)⁶ climb instruction, which they complied with. The TCAS display showed that AEY passed about 700 ft below FKJ (Figure 1).

The pilot reported that the B717 had been misidentified as the F100, resulting in believing that separation was being maintained. The pilot commented that if traffic information had been provided by ATC on the B717, the F100 may have been correctly identified.

As a result of this occurrence, the operator of AEY advised the ATSB that they have asked their pilots conducting VFR flights from Karratha to request an ATC clearance to depart at 1,500 ft until 10 NM, before climbing and turning to intercept the planned track.

As a result of this occurrence, the operator of FKJ discussed with company pilots, the need to maintain see-and-avoid principles when approaching an airport. This will be reviewed regarding an upcoming company flight safety awareness publication.
