Weather related event involving a Boeing 737, VH-YFF

Gold Coast Airport, Queensland, 28 January 2013

ATSB Transport Safety Report
Aviation Occurrence Investigation
AO-2013-025
Final – 31 October 2013

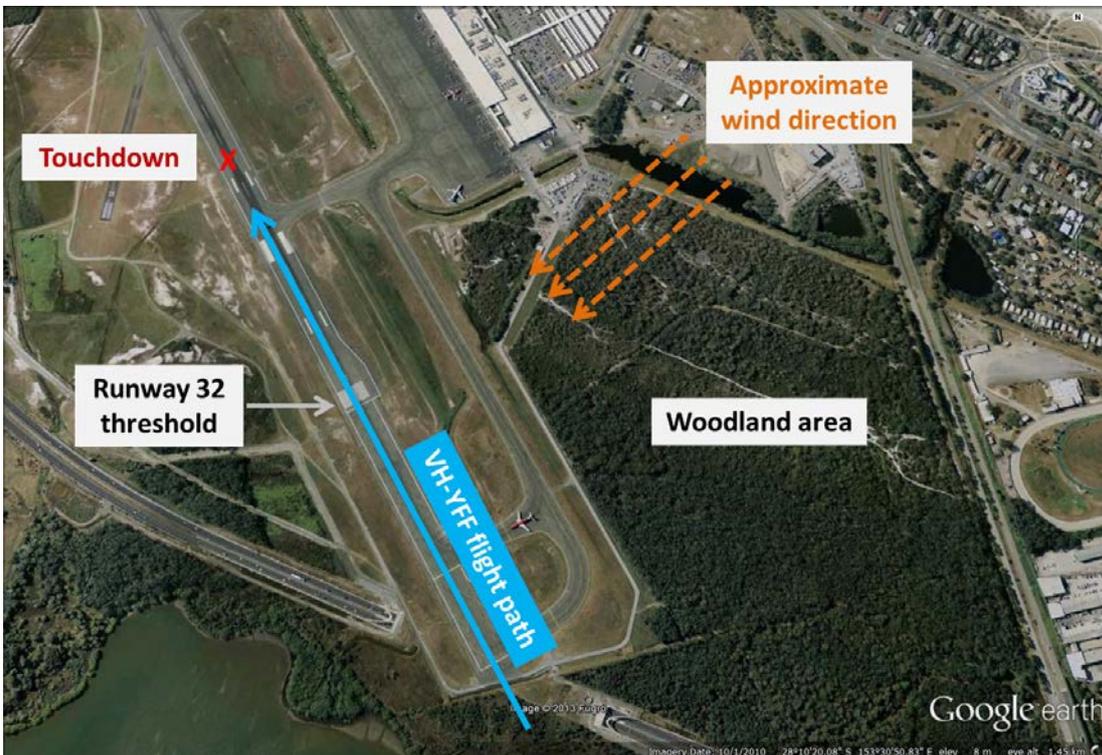
Figure 1: Gold Coast Airport and VH-YFF touchdown location

At about 2229, the aircraft touched down about 200 m further along the runway than intended (Figure 1). The autobrakes activated and the captain selected reverse thrust. The FO recalled the aircraft touched down on, or slightly right of the runway centreline. At that time, they were experiencing light rain.

- The turbulence and undershoot windshear experienced prior to landing was due to the high ground and woodland area located to the east of the runway 32 threshold (Figure 1), which had the effect of reducing the aircraft's airspeed.

- **Woodland area:** The woodland area located near the runway 32 threshold can affect the flow of wind when a strong right crosswind exists.

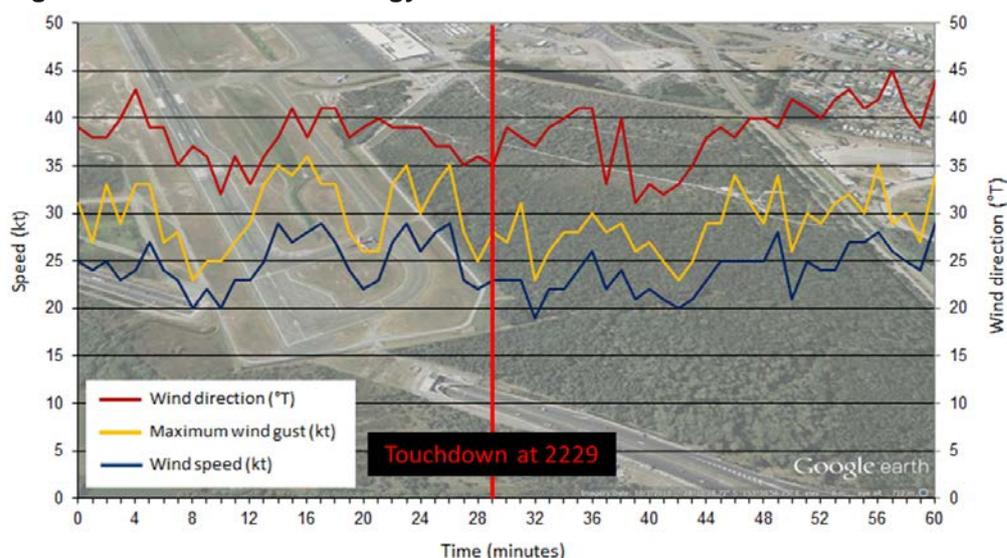
Figure 2: Bureau of Meteorology one-minute data

The BoM subsequently provided the Australian Transport Safety Bureau (ATSB) with one-minute interval data recorded by the AWS. A graphical depiction of the wind speed (kt), maximum wind gust (kt) and wind direction (°True) between 2200 and 2300 is shown in Figure 2.

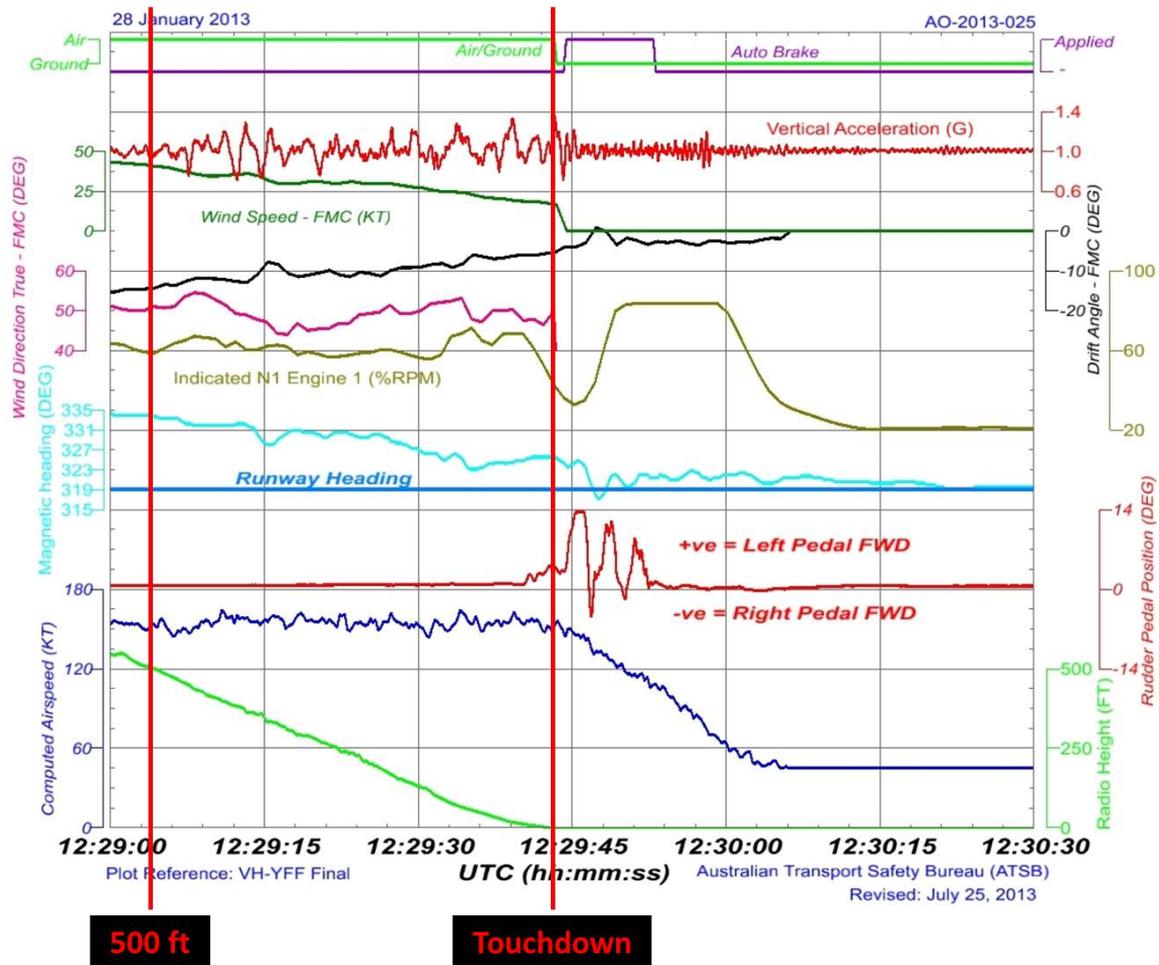
Figure 3: Summary of flight data

The aircraft was fitted with a quick access recorder (QAR) and following the incident, the data was downloaded and provided to the ATSB.⁸ The data showed the following (Figure 3):

- The wind speed and direction recorded by the aircraft’s flight management computer was about 41 kt and 51° (True) at 500 ft, 25 kt and 52° (True) at 100 ft, and 17 kt and 50° (True) on the ground.
- The recorded values of the vertical acceleration showed that the aircraft experienced mild turbulence during the descent and at about 500 ft, this increased to moderate turbulence.
- At about 115 ft AMSL, engine thrust was increased.
- The autobrakes activated on touchdown and then about 8 seconds later, manual braking was commenced.
- Prior to landing, left rudder had been applied. This application was continued until several seconds after touchdown when right rudder was applied. Over the following 6 seconds, additional rudder movements were made to align the aircraft with the runway centreline.
