TCAS event between an ATR72, VH-FVH and a Bombardier DHC-8-315, VH-TQZ

Port Macquarie, New South Wales, 12 February 2013

ATSB Transport Safety Report
Aviation Occurrence Investigation
AO-2013-038
Final – 31 October 2013

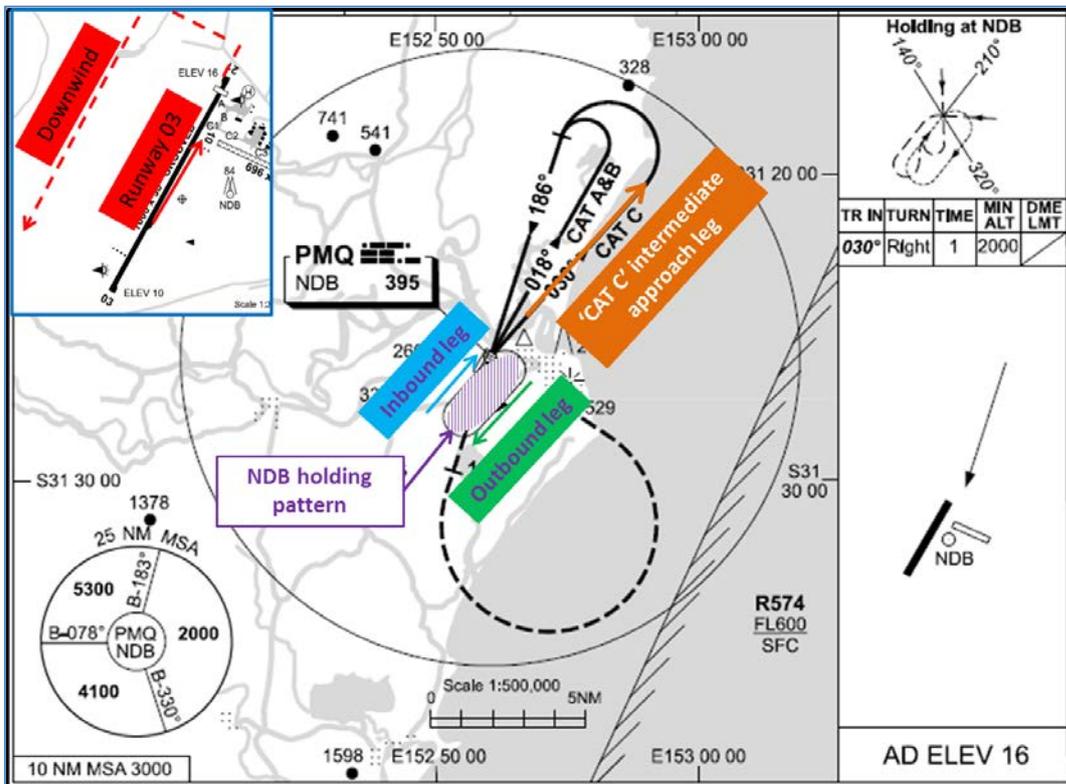
Figure 1: Port Macquarie NDB approach

- The inbound leg of the NDB holding pattern was positioned west of the runway and was aligned with the intermediate approach leg of the 'CAT C'⁸ NDB approach (Figure 1). The captain was of the understanding that the inbound leg was directly aligned with the runway.
- There was a considerable amount VFR and IFR traffic operating in the area at the time.

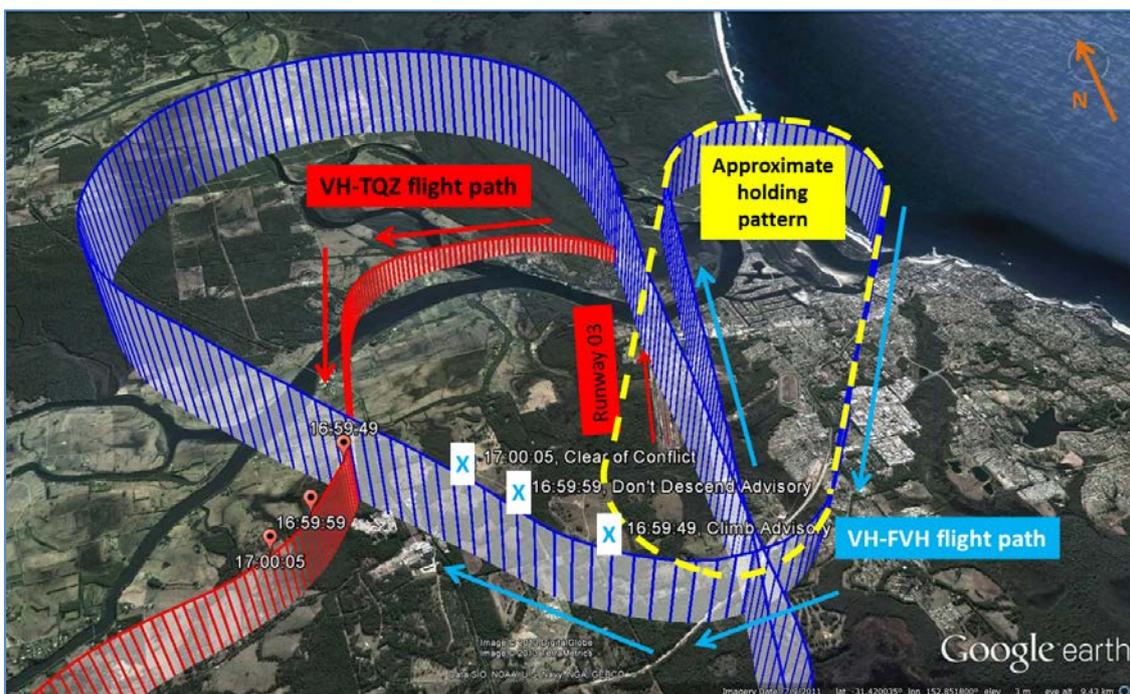
Figure 2: Summary of flight data

The flight data recorders (FDR) were downloaded from TQZ⁹ and FVH and the data provided to the ATSB. The data showed the following (Figure 2):

- At 1659:49, while at 3,536 ft, the crew of FVH received a TCAS RA to climb.
- At 1659:53, FVH commenced a climb.
- At 1659:52, separation between FVH and TQZ reduced to about 290 ft vertically and 1.6 NM horizontally.
- At 1659:55, TQZ was observed commencing a descent.
- At 1659:59, the crew of FVH received a 'do not descend' TCAS RA.
- At 1700:05, the crew of FVH received a 'clear of conflict' TCAS message.
