Wheels up landing involving a Cessna 210, VH-ZMT

Ramingining aerodrome, Northern Territory, 4 June 2013

ATSB Transport Safety Report
Aviation Occurrence Investigation
AO-2013-093
Final – 31 October 2013

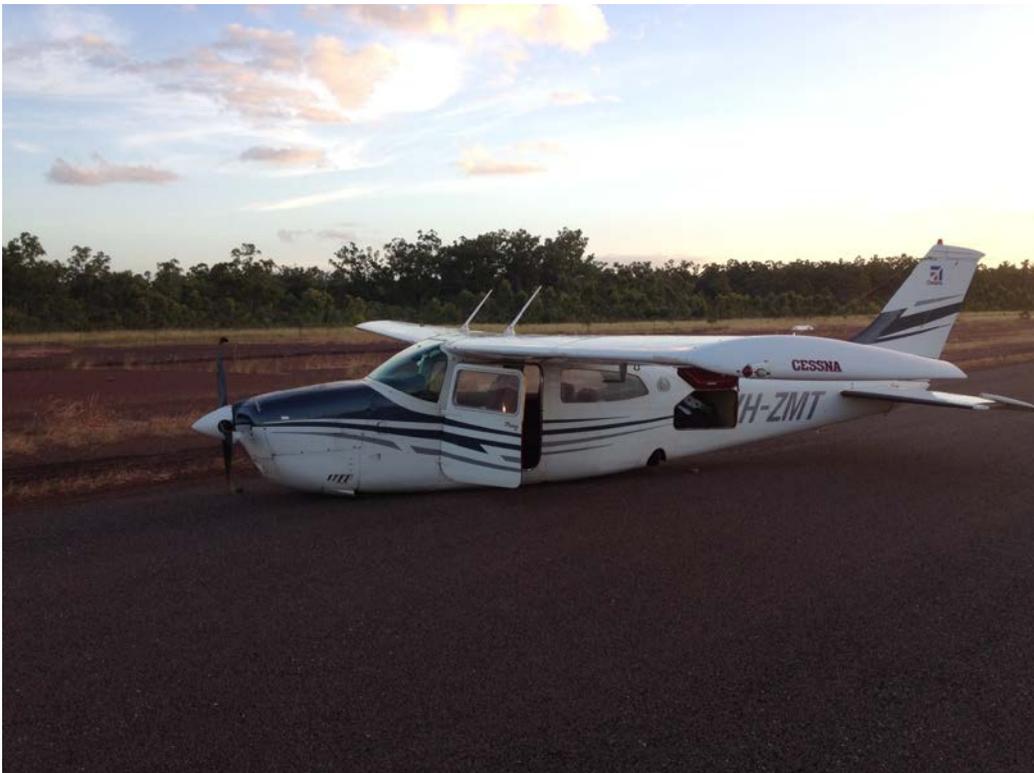
At about 100 ft, the pilot reduced the engine power to the idle position. During the landing flare,¹ the pilot felt that it was unusually smooth and the aircraft sank further than normal. The aircraft touched down and the pilot reported hearing a scraping sound and noticed that the propeller had come into contact with the ground. He then realised that the aircraft had landed with the landing gear retracted. The pilot stated that the aircraft's landing gear warning horn² did not sound at any stage during the landing.

Figure 1: VH-ZMT after landing

As a result of this occurrence, the aircraft operator has advised the ATSB that they have issued a Flight Operation Service Notification to all pilots highlighting the requirement to follow checklists, including the pre-landing checklist.
