Departure from an incorrect intersection involving an Embraer ERJ 190, VH-ZPC

Perth, Western Australia, 21 June 2013

ATSB Transport Safety Report
Aviation Occurrence Investigation
AO-2013-112
Final – 31 October 2013

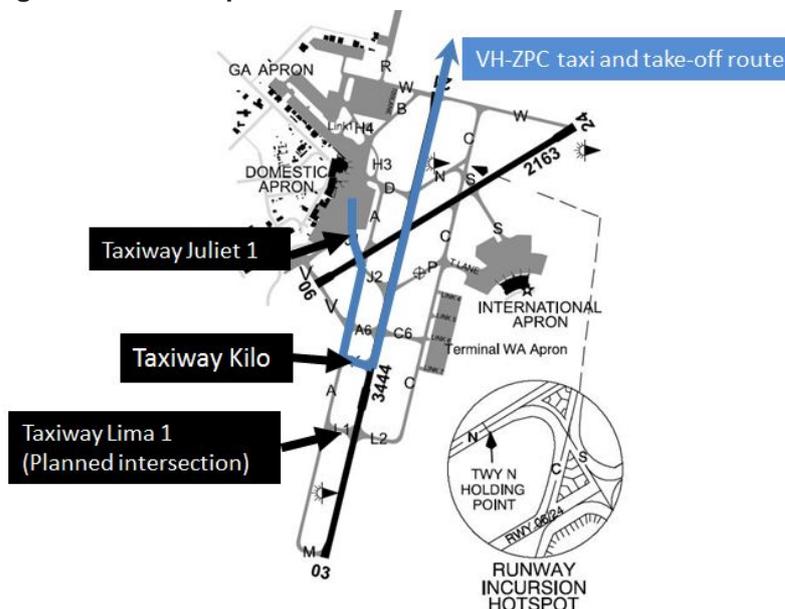
Figure 1: Perth Airport

The FO recalled the captain responding that they should use runway 03 and use 'Kilo' intersection 'to make it worthwhile'. This placed the thought in the FO's mind that the take-off distance from intersection 'Kilo' was greater than from 'Lima' (Figure 1). As there were no take-off figures in the manual for 'Kilo', the FO entered the data for a departure from the intersection of taxiway 'Lima' on runway 03, into the flight management system (FMS). The FO was then under the impression that the take-off distance from 'Kilo' was greater than from 'Lima' and the figures entered would have included a buffer for a take-off from anything longer than intersection 'Lima'.

There is a taxiway opposite the runway intersection at 'Lima' but not at 'Kilo' and sighting this may have alerted them to being at an incorrect intersection. The captain reported that he now includes the intersection departure in the standard take-off review.

- The data for the 'Kilo' intersection departure at Perth will be included in the operator's manual for the Embraer ERJ 190.
- An article highlighting the possibility of incorrect intersections will be presented in the next safety publication to be distributed to all crew.
- The need to check the departure intersection will be highlighted during a briefing to check and training captains.
