Loss of control involving Robinson R22, VH-EGN

Camden Airport, New South Wales, 7 August 2013

ATSB Transport Safety Report
Aviation Occurrence Investigation
AO-2013-123
Final – 31 October 2013

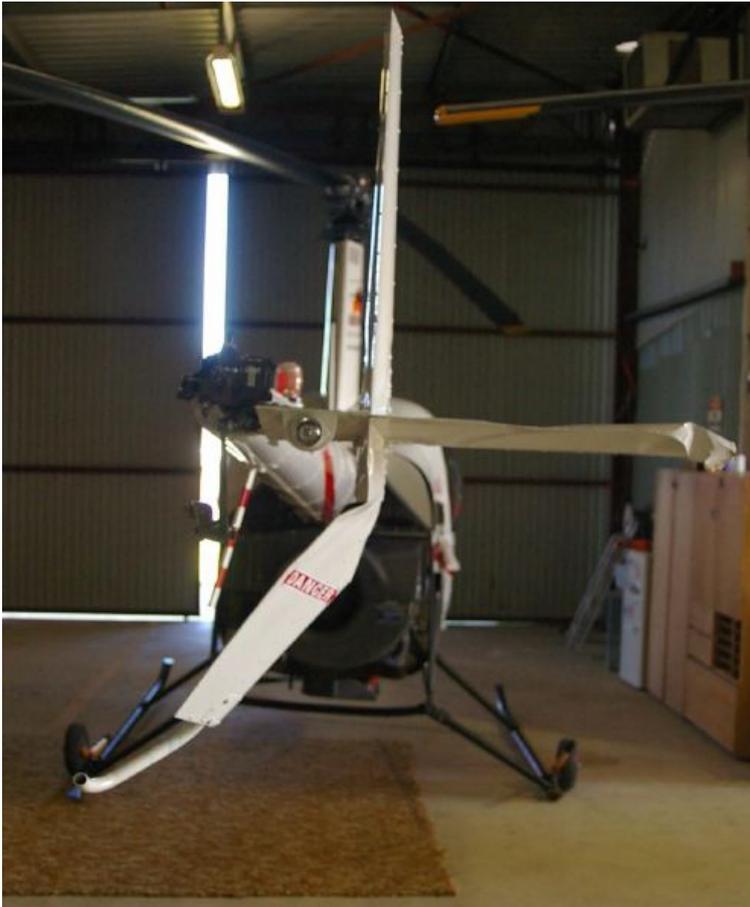
Figure 2: VH-EGN damage

The helicopter commenced turning left. When in a downwind position, the student reported that the helicopter weather-cocked into wind and the rotational speed rapidly increased. The student attempted to stop the rotation by applying full right pedal, but the helicopter continued to rotate left. The student lowered² the collective to land EGN and the right skid contacted the ground followed by the tail rotor.

The helicopter was shut down and the student exited. The student was not injured, but the helicopter sustained substantial damage (Figure 2).

The operator has amended Part E of their Operations Manual to extend the time that a student pilot is monitored by an instructor returning to the parking area at the hangar. The new amendment now states:

Annex 1 Section E2.25 TAXIING BY STUDENT PILOTS

Solo taxi by student pilots shall only be permitted after 'first solo'. At all other times, taxiing shall be conducted as part of dual training under the strict supervision of an approved helicopter instructor.

Student pilots may only return to the hangar parking area after having completed a minimum of 5 hours taxiing to/from hangar dual with an instructor on-board after having achieved First Solo.
