Loss of separation between an Airbus A320, VH-VFJ and a Bell 412, VH-VAO

Avalon Airport, Victoria, 4 July 2013

ATSB Transport Safety Report
Aviation Occurrence Investigation
AO-2013-115
Final – 31 October 2013

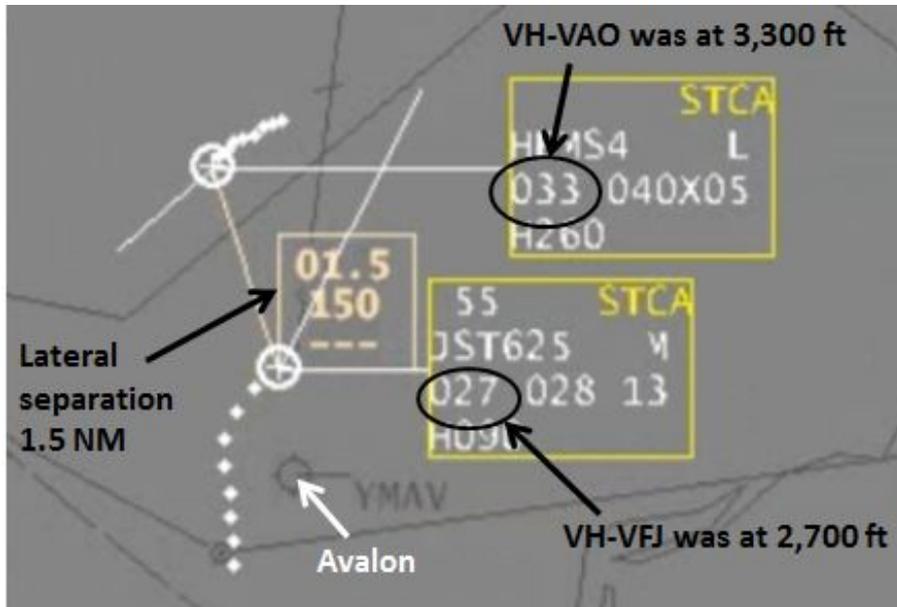
Figure 1: The positions of VH-VAO and VH-VFJ at 2040

The controller then instructed the crew of VFJ to make an immediate right turn and advised them of the location of VAO, 500 ft above and 2.3 NM ahead. As VFJ turned right, vertical separation reduced to 600 ft and lateral separation to 1.5 NM (Figure 1). The crew of VFJ continued the right turn and subsequently landed at Avalon without further incident. The pilot of VAO continued tracking west for his destination.

This incident demonstrates that, while expediting traffic is an important objective for a controller, safety must always be the first consideration. In attempting to facilitate the helicopter’s departure, the controller unintentionally placed it in the missed approach path of the aircraft. The strong westerly wind compounded the situation by slowing the helicopter and negating the effect of its westerly heading.
