**TECHNICAL ANALYSIS REPORT No: 18/01**

OCCURRENCE No: 200101776

# **Examination of Engine Gas Generator Fairing Panels**

**Boeing 747-438, VH-OJJ**

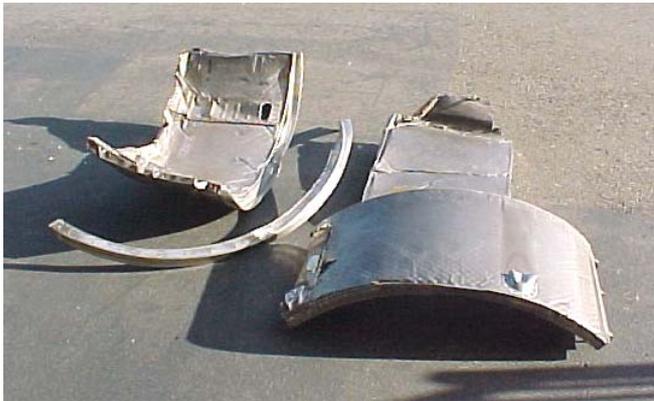
**Figure 1.** Combustion fairing panel sections as recovered from the Sydney 34L runway undershoot area.

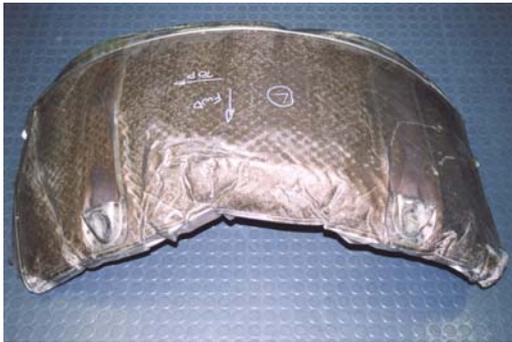
The smaller left fairing panel was recovered intact. The forward edge of the panel showed extensive inward crushing and structural distortion (figures 3 & 4). Traces of yellow paint were found on the surfaces of the two partly flattened external vents (figure 5).

**Figure 3 (Top Left).** Left (smaller) fairing panel exterior, showing the crushing damage along the forward facing edge.

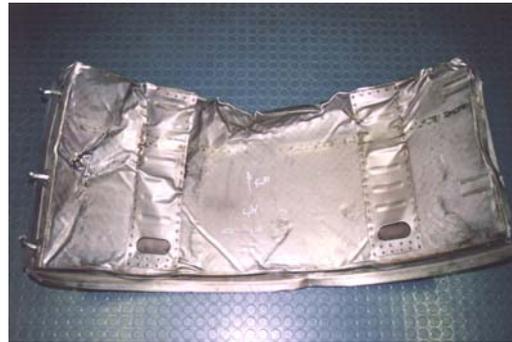
**Figure 4 (Top Right).** Interior of the left fairing section.

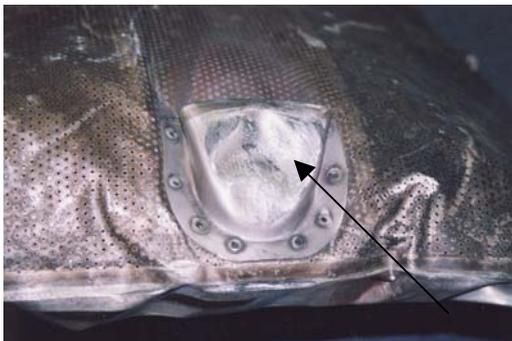
**Figure 5 (Bottom Left).** Damaged air vent within the left fairing, showing evidence of the yellow paint used inside the engine bypass duct.

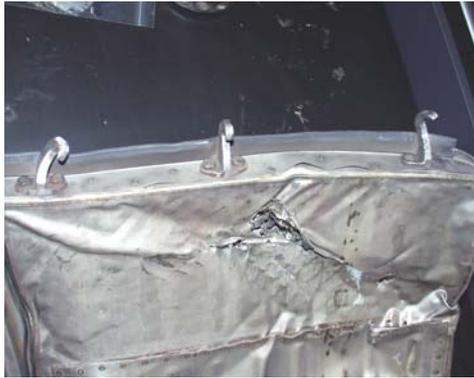
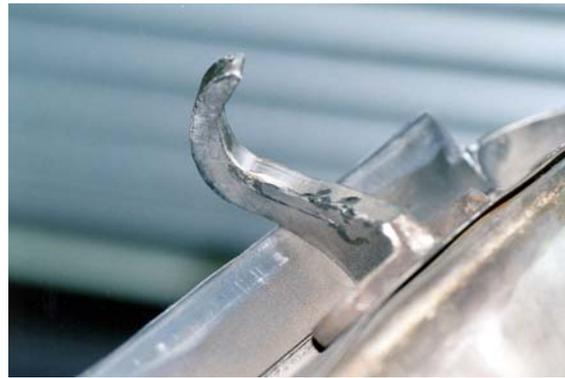
The three mounting hooks along the upper edge of the fairing panel showed varying degrees of mechanical damage and distortion (figure 6). The forward hook had opened extensively and showed backward and sideways bending (figure 7). Contrastingly, the centre and rear hooks had not opened to any great degree, although the rear hook had bent inward and showed evidence of a forceful impact with the runway surface.

**Figures 6 & 7.** Mounting hooks along the top edge of the left fairing panel. Note the degree of distortion and opening of the right hook, which is the forward hook when installed on the engine.

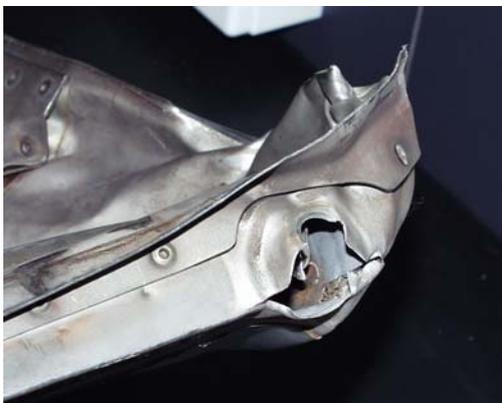
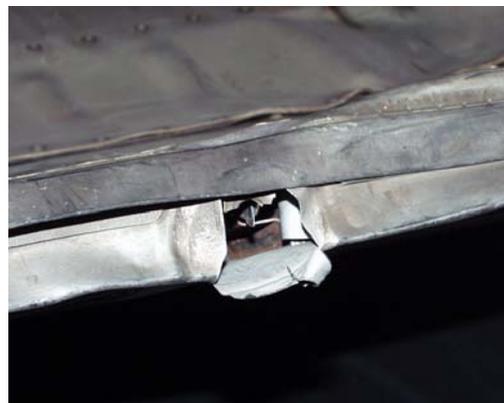
Two adjustable clevises, which engage with a lever and hook arrangement on the right fairing, are normally located along the lower edge of the panel. In this case, both components had been physically torn from their mounts, producing considerable damage to the lower edge of the fairing (figures 8 & 9).

**Figures 8 & 9.** Mounting points for the clevis fittings along the lower edge of the left fairing panel. Both had been physically torn from the structure of the panel.

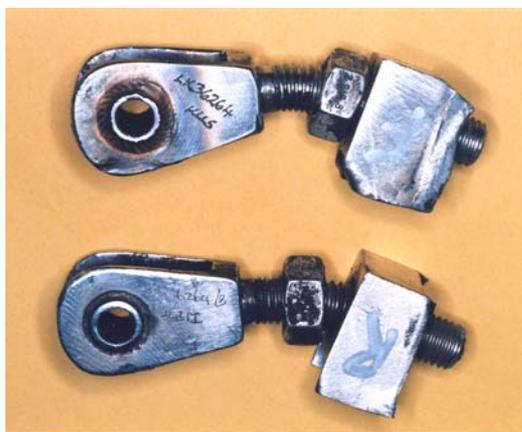
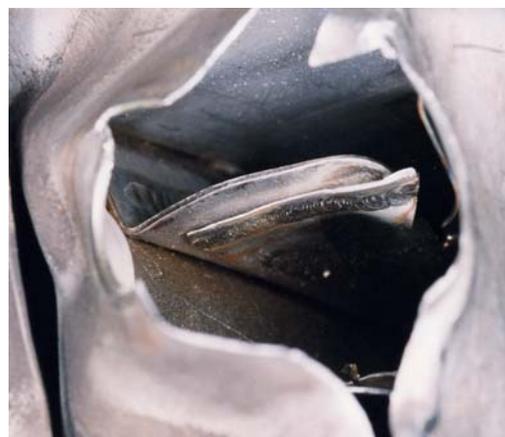
The clevises themselves were recovered from the runway area and showed similar levels of threaded shank bending (figure 10). Both had failed at the point of connection between the mounting blocks and the sheet metal structure of the fairing panel. Several of the fractures between clevis mount and fairing were adjacent to weld seams (figure 11), although no evidence of welding defects or other related manufacturing faults was noted. All fractures were ductile in nature and were often associated with areas of plastic deformation of the associated panel structure (figure 12).

**Figures 10 & 11.** Clevis fittings and mounting blocks torn from the panel structure. Note the degree of bending overload present on the clevis shafts and the failure alongside the welded joint between mounting block and sheetmetal panel structure.

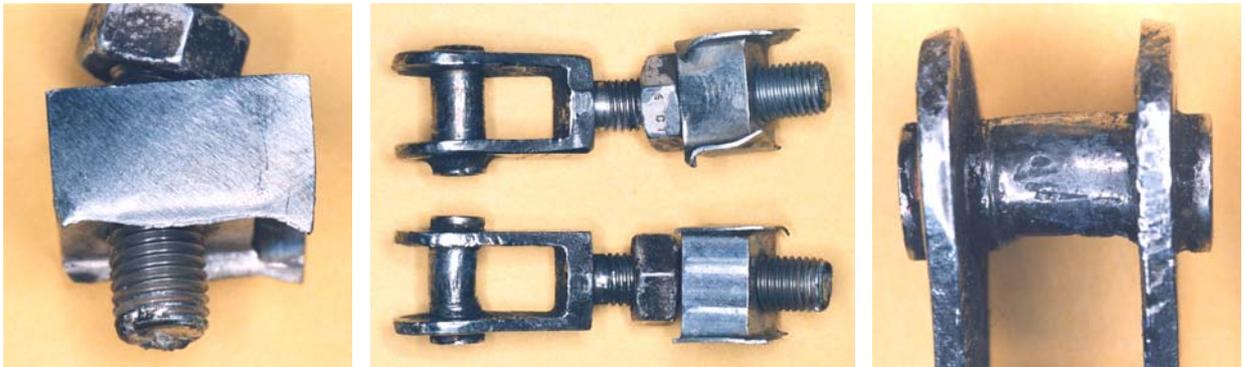
The clevises themselves showed varying degrees of wear and damage – most obviously to the pin of the rear unit, which presented appreciable outward bending and wear of the inside surfaces (figures 13 & 14).

**Figure 12.** Clevis mounting block, showing clear evidence of a ductile overload fracture along the base.  
**Figures 13 & 14.** Clevis fittings showing wear and distortion of the pins – most prominent on the forward fitting.

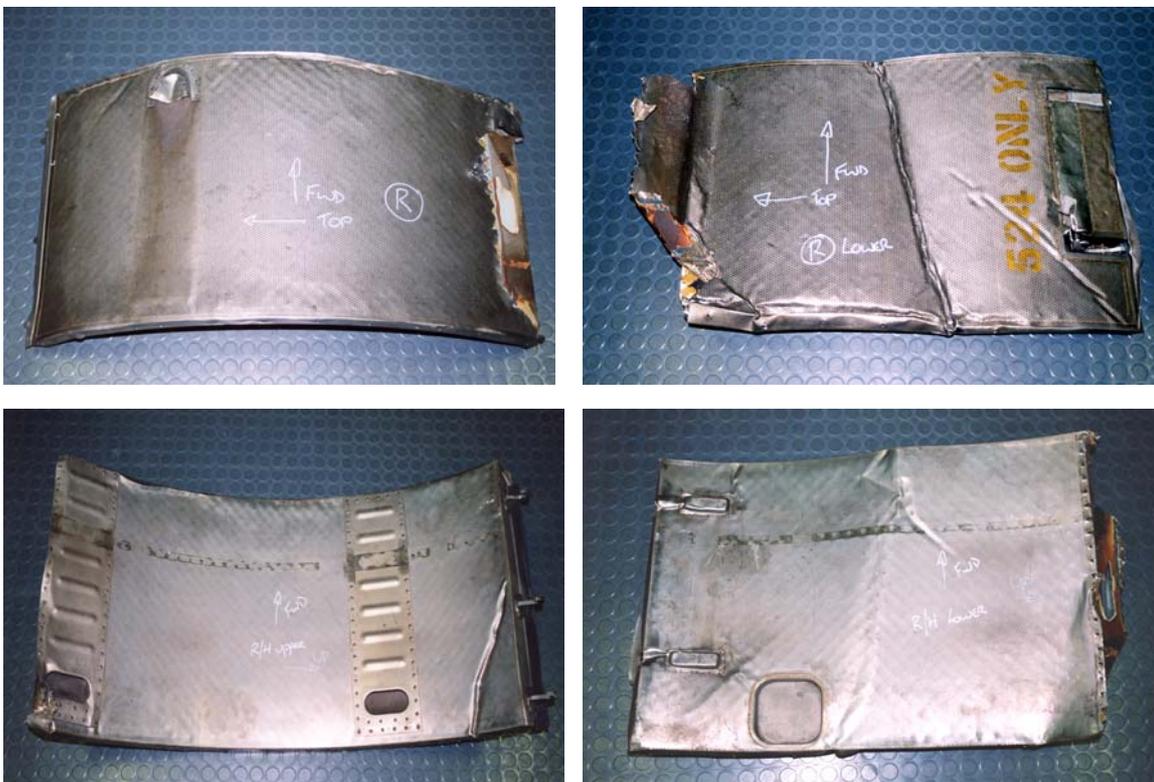
This unit was the largest of the three panels which surround the engine core and was recovered in two pieces – having fractured along a central join between the fabricated sections (figures 15 – 18). The failure of the panel along this location was characterised by torn and lifted sheet metal from the outer surface and by a seam of rivets that had been overloaded and torn from the connecting surfaces (figure 19). The single-piece fire seal strip (figure 20) had been torn away completely during the panel liberation and was recovered at some distance from the panel sections.

**Figures 15 & 16 (Top).** Exterior surfaces of the right fairing panel, which had fractured into two sections.  
**Figures 17 & 18 (Btm).** Interior surfaces of the right fairing panel sections.

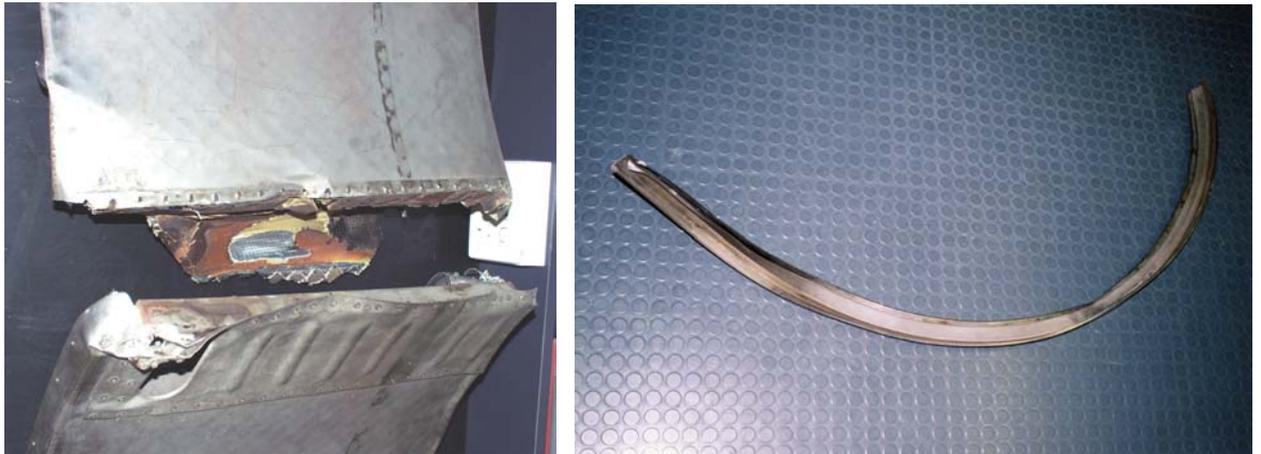
**Figures 19 & 20.** Fracture of the right fairing panel section – characteristic of bending overloads. The fire seal strip (R) had also torn away from the panel and was recovered some distance from the panel sections.

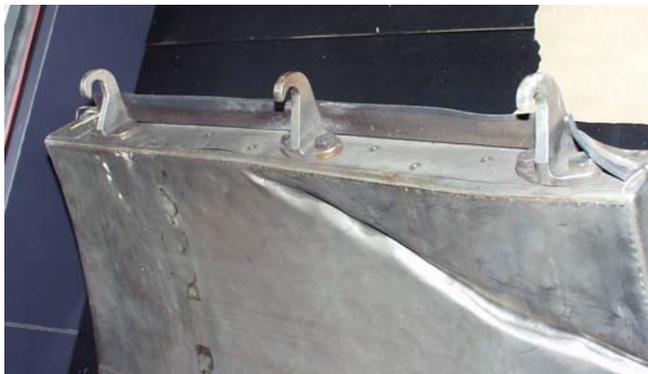
The three mounting hooks on the upper edge were comparatively undamaged and showed no appreciable wear across the throat (figure 21).

**Figure 21 (Left).** Mounting hooks along the top edge of the right fairing panel. All were sound and undistorted.

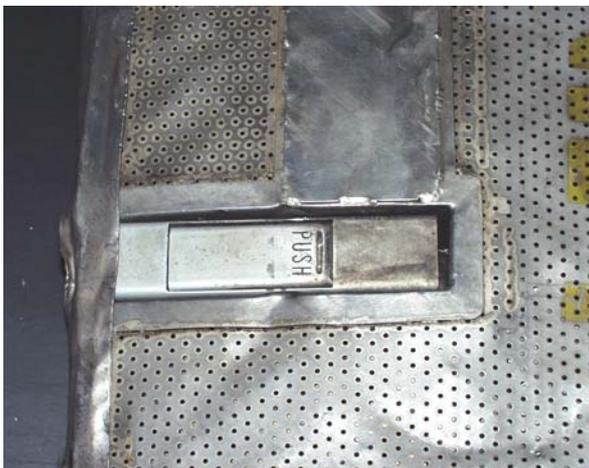
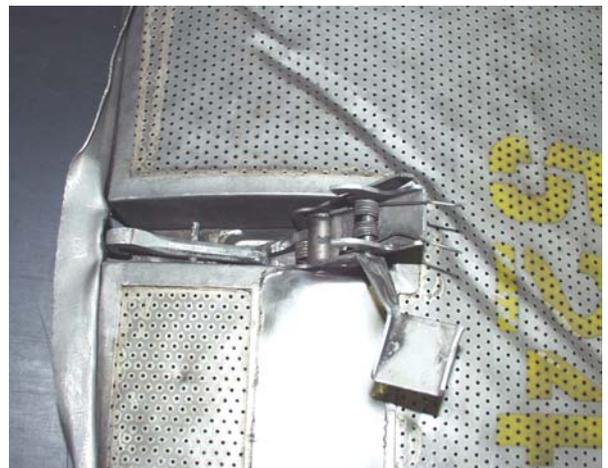
The right fairing panel contained two lever-action hook latches, which engaged with the clevises on the mating left panel. Hooks from both latches were found intact and undamaged, although the rear aluminium alloy latch lever had sustained distortion and damage consistent with having struck another object whilst in the open position (figures 22 & 23). No appreciable wear or other operational damage was noted within the hooks or on the pivoting sections of either latch assembly.

**Figures 22 & 23 (Bottom).** Latch positions at the base of the right panel. Although damaged by the ejection event, both hooks and mounting points were sound.

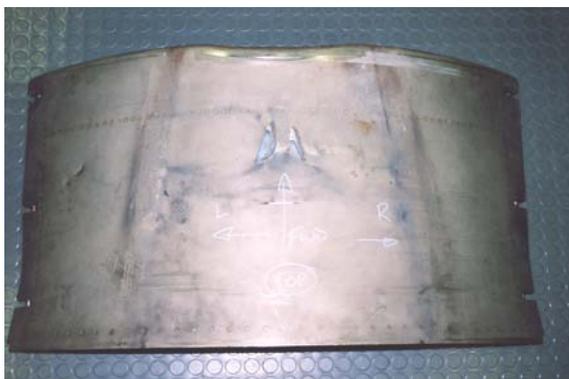
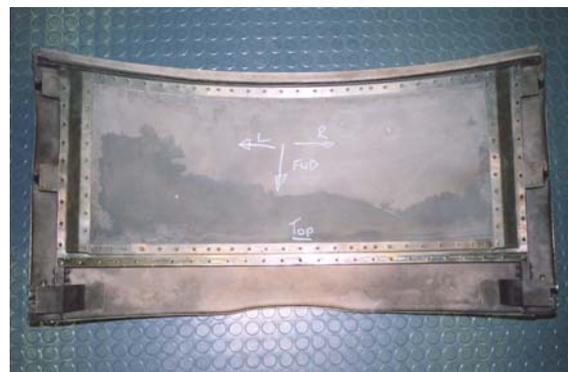
This panel completed the full circumferential shroud of the engine core gas generator section and was located between the engine core and the pylon mount (figures 24 & 25). The panel remained in place on the aircraft during the event and was removed in Los Angeles when the fairing set was replaced. The left and right upper panel hooks engage with inset pins within the upper panel body and are held in place by the clamping action of the two clevis-hook latches previously examined. The three pins on both ends of the panel showed no appreciable physical damage or failure that could be considered contributory to the loss of the fairings. The forward pin socket on the left side showed some disruption and folding of the sheetmetal around one side, with prominent gouging along a defined path on one side of the socket (figure 26).

**Figures 24 & 25 (Top).** Undamaged internal and external surfaces of the upper fairing panel section, which sits above the engine core and was not released.

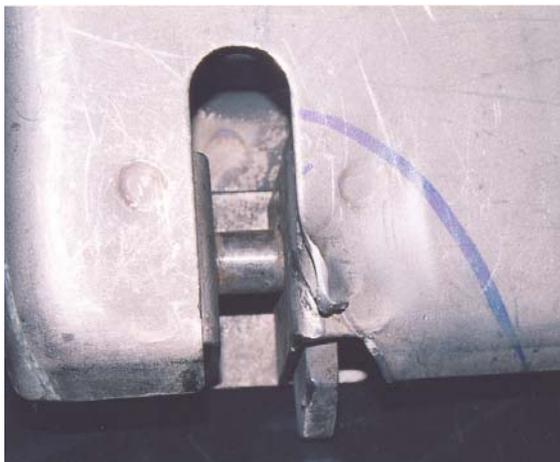
**Figure 26 (Left).** Forward pin and socket on the left side of the upper fairing panel. Note the gouging and distortion damage consistent with the damage to the forward hook on the left panel.

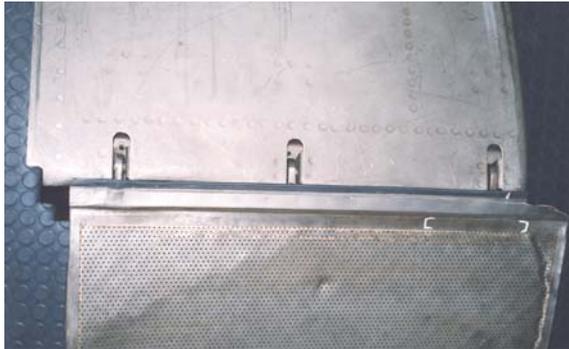
Correct assembly (figure 27) is typified by the absence of a gap between the sealing edge of the side panel and the mating surface of the upper panel. Aligned, yet uncoupled panels (figure 28) clearly show this gap and the incorrect position of the hooks in respect to the socket pins (figure 29).

**Figure 27 (Top Left).** Mounting hooks along the top edge of the right fairing panel correctly engaged with the upper panel.

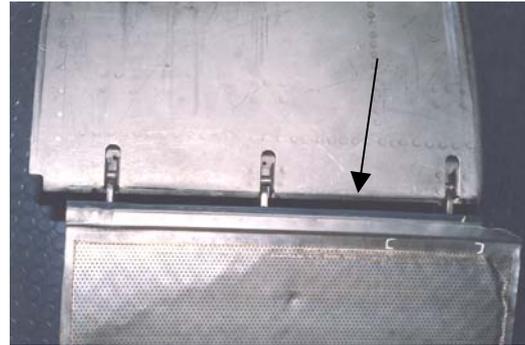
**Figure 28 (Top Right).** Mounting hooks incorrectly engaged. Note the distinct gap between the upper panel and the right panel-sealing strip (arrowed).

It is concluded that the separation of the fairing panels was precipitated by incorrect engagement of the right panel hook mounts during installation. This would have permitted the fairing to slide downward and around the core, moving the left panel outward and away from the core and into the bypass airstream of the accelerating engine. In this circumstance, the panel would have been immediately torn away from the hook mounts and ejected forcefully to the rear, taking the connected right panel with it and producing the secondary damage to the bypass duct and flap trailing edges. The nature of the damage to these surfaces was consistent with a solid object impact.

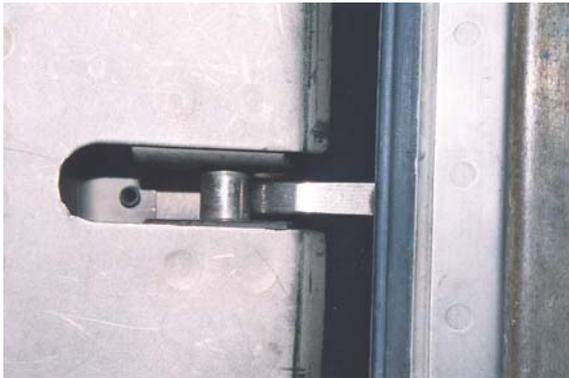
**Figure 29 (Left).** Close view of an incorrectly mounted panel hook.

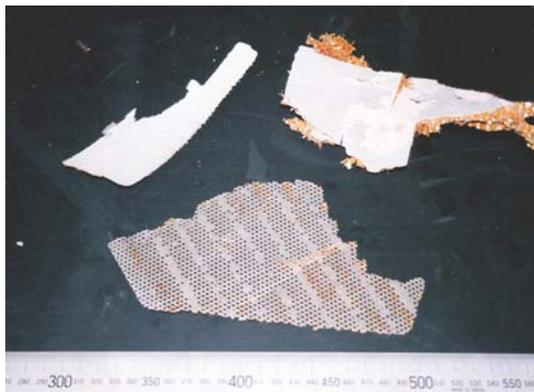
Several fragments of composite materials (figure 30) that were not part of the combustion fairing assembly were recovered from the runway undershoot area during the sweeping operation. Two fragments gave the appearance of having originated from the flap trailing edge, as evident from the supplied photographs showing the aircraft damage (figures 31 & 32). The third fragment was considered to be from the inside surface of the engine bypass duct.

**Figure 30 (L).** Debris recovered from the runway with the panel sections. The top two pieces are sections of the wing flap, the lower piece is part of the acoustic material within the engine bypass duct.

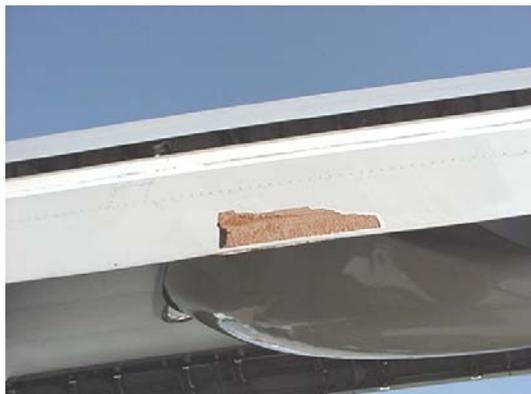
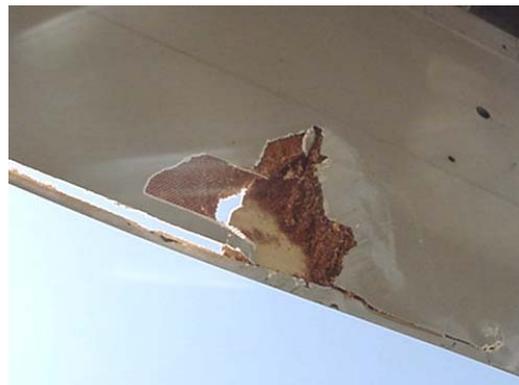
**Figures 31 & 32 (Btm).** Damage to the underside and trailing edge of the centre wing flap extension. Note the impact marks present on the undersurfaces.
