Ground proximity event between a Boeing 737, VH-VZA and a security vehicle

Sydney Airport, New South Wales, 26 August 2013

ATSB Transport Safety Report
Aviation Occurrence Investigation
AO-2013-135
Final – 10 December 2013

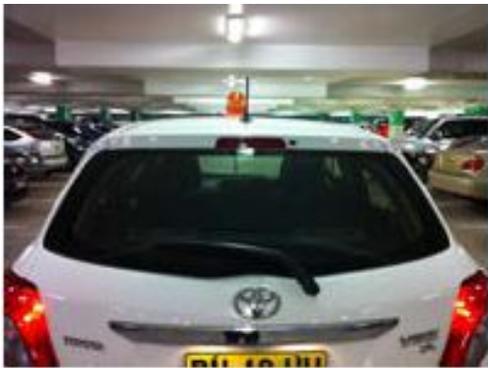
Figure 1: Security vehicle

At about the same time, the captain observed the lights of a white security vehicle⁴ (Figure 1) approaching from about 50 m away and about 90° to the right of the aircraft. He estimated the speed of the vehicle was about 30km/h, about the same as VZA's taxi speed.

found it in the off position, so turned it back on. The security vehicle continued toward the aircraft then came to an abrupt stop about 10 m to the right of the aircraft's nose. The car then reversed clear of the aircraft and passed behind VZA, and continued on its journey to Terminal 1.

As a result of this occurrence, the operator of the security organisation has advised the ATSB that they will be conducting a review of their vehicle patrol requirements, focusing on staff safety knowledge, competency, driving skills and physical fitness. At the time of publication, the company had already conducted preliminary meetings to further define the scope of the review.

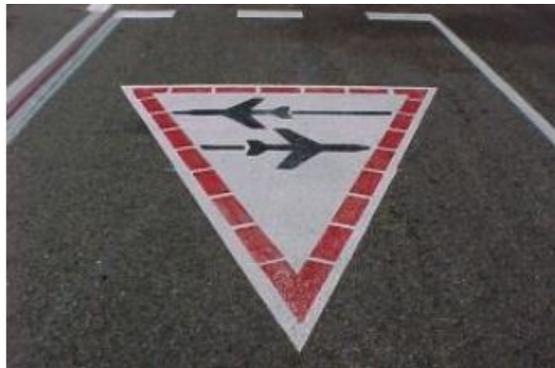
Figure 2: Vehicle GIVEWAY sign on airside road

The driver also reported that, once a vehicle on the airside road passes the give way point (Figure 2 and 3), the vehicle is angled to the right. This restricts sighting aircraft taxiing from the left, especially at night.

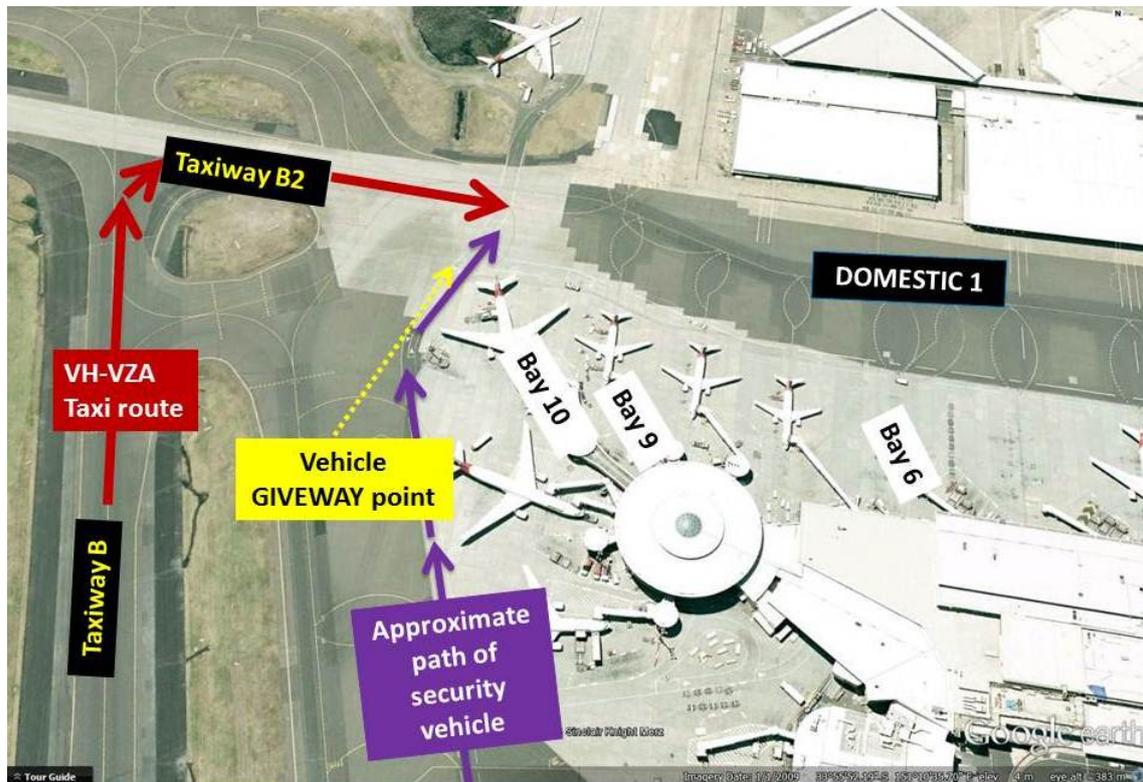
Figure 3: Sydney Airport Domestic 1

After landing, at about 2010 Eastern Standard Time,¹ VZA was cleared by air traffic control (ATC) to taxi to Bay 6 of the Domestic 1 (DOM 1) apron² area at Sydney Airport, via taxiway 'Bravo' (B) then 'Bravo 2' (B2) (Figure 3).

He further stated that the DOM 1 entry and exit area, where the airside road crosses, was busy, but well lit. He was surprised that the driver of the security vehicle did not see the aircraft.

As the vehicle approached the intersection of the airside road and taxiway B2 (Figure 3), he reported slowing to between 25 to 30 km/h. He looked to his left, but did not see the lights of VZA.

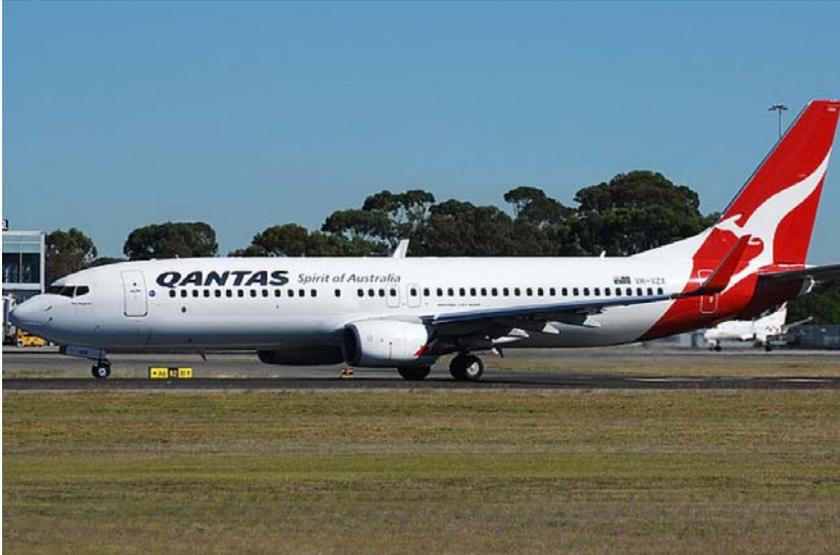
Figure 4: VH-VZA

On 26 August 2013, a Qantas Airways Boeing 737 aircraft, registered VH-VZA (VZA) (Figure 4), was completing a scheduled passenger flight from Cairns, Queensland to Sydney, New South Wales.
