Partial power loss involving a Bell 47G, VH-RTO

9 km SE of Essendon Airport, Victoria, 15 August 2013

ATSB Transport Safety Report
Aviation Occurrence Investigation
AO-2013-129
Final – 10 December 2013

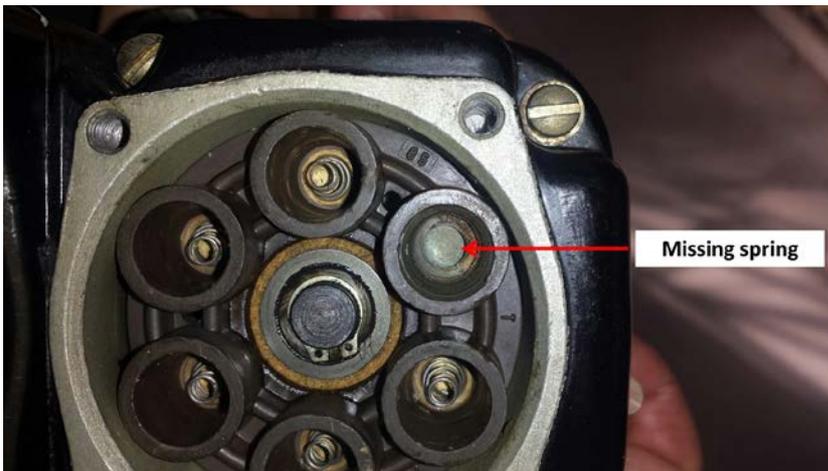
Figure 2: Left magneto distributor block

An engineering inspection identified that a spring in the distributor block of the left magneto was missing (Figure 2), which resulted in cross firing in the distributor and an associated loss of power. A new spring was fitted and the left magneto tested, with nil faults found. It could not be determined when or how the spring went missing.
